Beachwatch

State of the beaches 2021–22

South Coast Region

Department of Planning and Environment

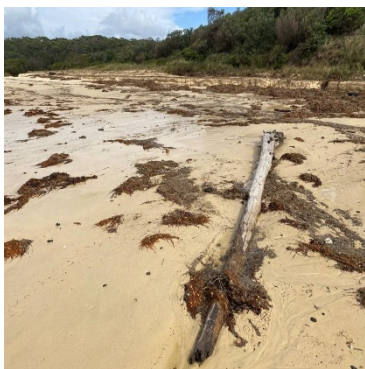
Debris washed up at Racecourse Beach following extreme wet weather in March 2022

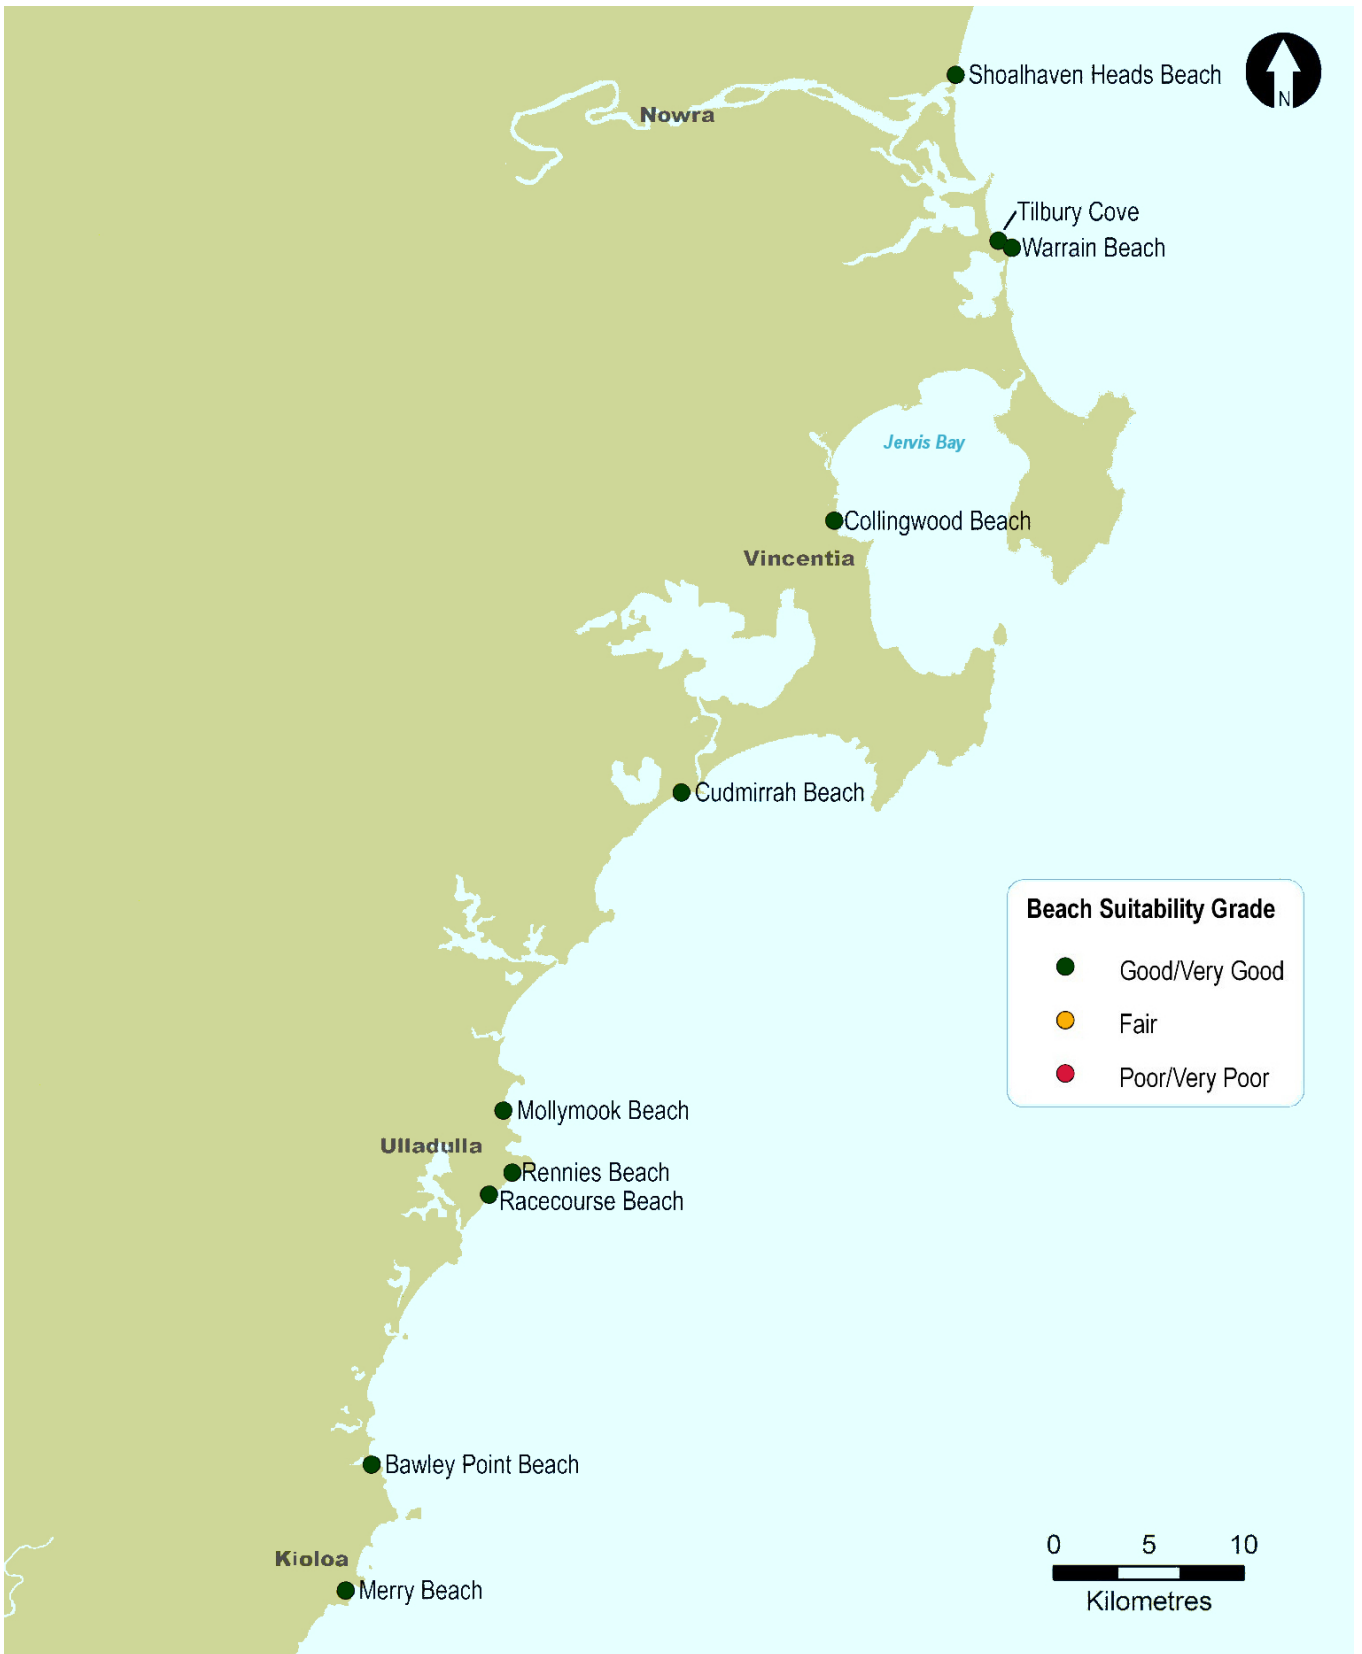
Sampling sites and Beach Suitability Grades in Shoalhaven City Council

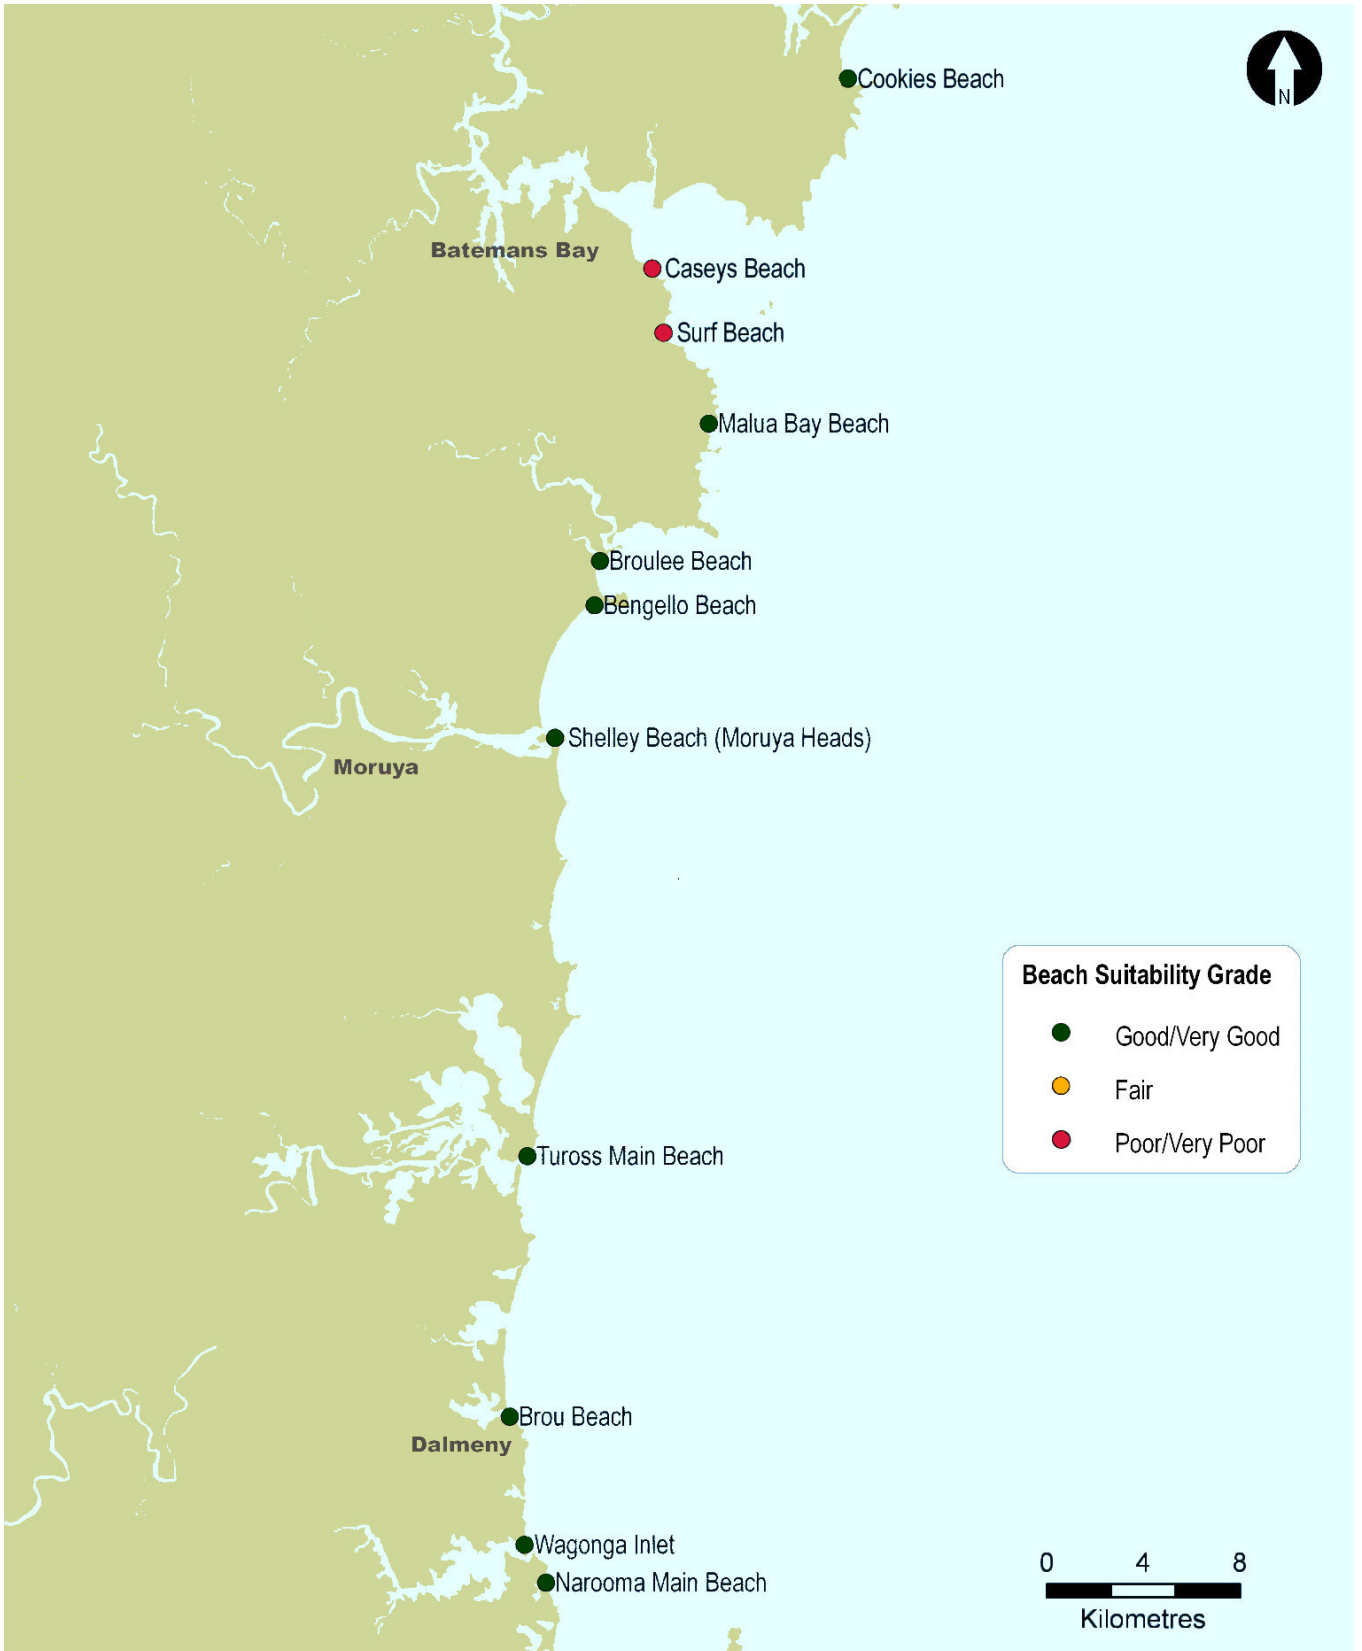
Sampling sites and Beach Suitability Grades in Eurobodalla Shire Council

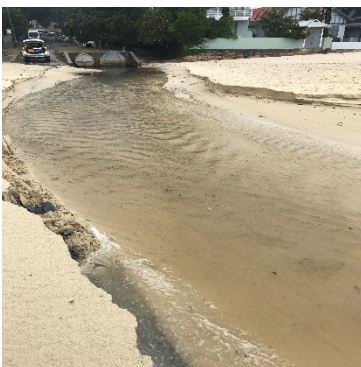
Stormwater drain flow
Photo: Beachwatch/DPE

Stormwater in urban areas often contains sewage from leakages, overflows or sewer chokes when the sewerage system fails.

Sewage overflows can occur in wet weather when the network has exceeded capacity due to rainwater entering the system. The mix of sewage and rainwater discharges from designated overflow points and drains to waterways, usually via the stormwater system. Overflows from the sewerage system can also occur in dry weather due to mechanical failure or power outage.

Sewer chokes occur due to blockages in the pipes usually due to tree roots, oil, grease or debris. This causes sewage to back up and escape via sewer inspection points, designed overflow structures or cracks in the pipes, then drain to waterways, usually via the stormwater system.

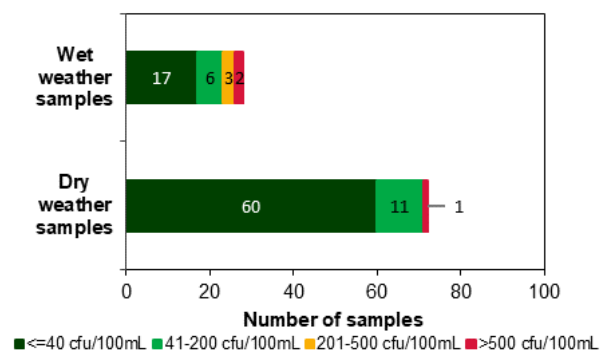
Enterococci levels in wet and dry weather conditions are presented for each swimming location as a bar graph. All data collected during the assessment period is included in the analysis. Dry weather is defined as no rainfall recorded in the previous 24 hours. Each bar is colour coded to show the number of enterococci results up to 40 cfu/100 mL, between 41 and 200 cfu/100 mL, between 201 and 500 cfu/100 mL and greater than 500 cfu/100 mL. These categories reflect the Microbial Assessment Category thresholds and are coloured on the graph as dark green, light green, amber and red respectively.

It is expected that swimming sites with lower levels of flushing will show some elevated bacterial results in dry weather samples (no rainfall in the previous 24 hours) due to the longer time needed to recover from a rainfall event. At some estuarine and lake/lagoon swimming locations the impacts of stormwater pollution on beach water quality may be detected up to 3 days after rainfall.
