Ballina Shire Council

Program outline

Ballina Shire Council monitored nine locations over the 2008–2009 summer swimming season. These were the ocean beaches of Seven Mile and Shelly, three sites in Lake Ainsworth, one site at The Serpentine and three sites in Shaws Bay.

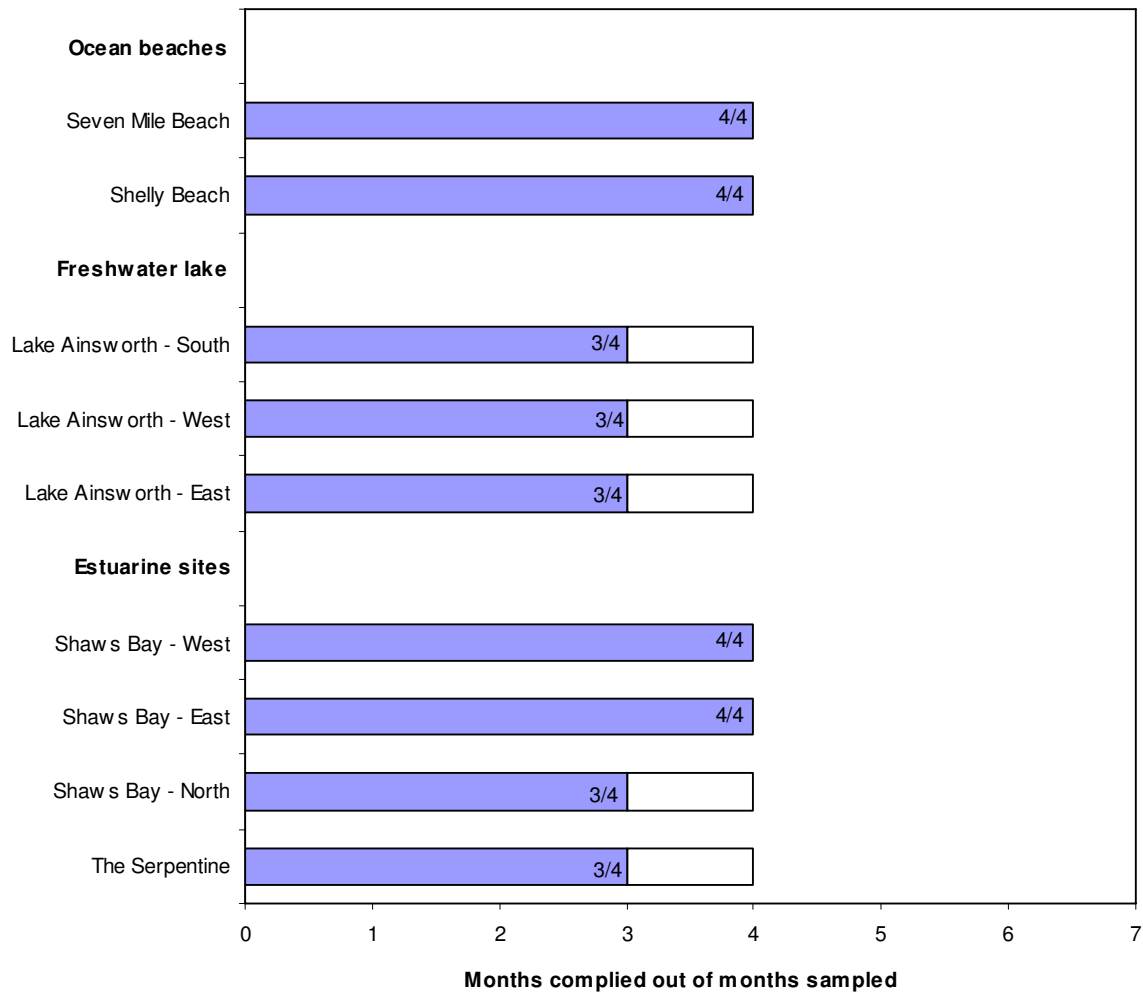
Figure 2: Summary of compliance with NHMRC (1990) microbiological guidelines for swimming at Ballina Shire Council swimming sites during the 2008–2009 summer swimming season

Seven Mile and Shelly beaches complied with the NHMRC (1990) swimming water quality guidelines in all four months monitored over the 2008–2009 summer season (Figure 2).

All three locations complied with the NHMRC (1990) swimming water quality guidelines in three of the four months. Lake Ainsworth West failed the guidelines in January 2009, and Lake Ainsworth East and South failed the guidelines in February 2009. All sites failed because of elevated levels of enterococci.

The Serpentine is a popular swimming location situated in a tributary of the Richmond River. The site passed NHMRC (1990) swimming water quality guidelines in three of the four months. The site failed to comply with guidelines in February 2009 owing to elevated levels of enterococci following rainfall.

Shaws Bay East and Shaws Bay West complied with the NHMRC (1990) swimming guidelines in all four months. Shaws Bay North failed in December 2008 owing to elevated levels of enterococci.

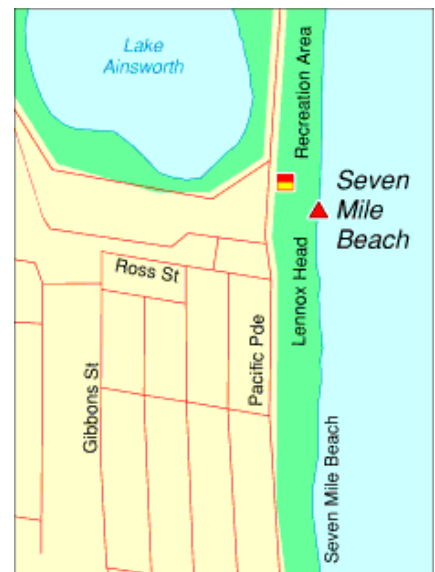
Seven Mile Beach is a long shore beach that extends for over eight kilometres. It is of considerable economic importance, forming the basis of tourism to the region. The beach is used throughout the year, but is particularly popular during the summer period. There are numerous facilities, including car parks and a surf club. The sampling site is located adjacent to the surf club at the southern end of the beach.

Urban stormwater from the town of Lennox Head has a potential impact upon the waters at this site. A gross pollutant trap has been installed at the stormwater outlet, reducing the amount of litter, sediment and other pollutants discharged to the beach. Other pollution sources include general litter and faecal deposits from domestic animals.

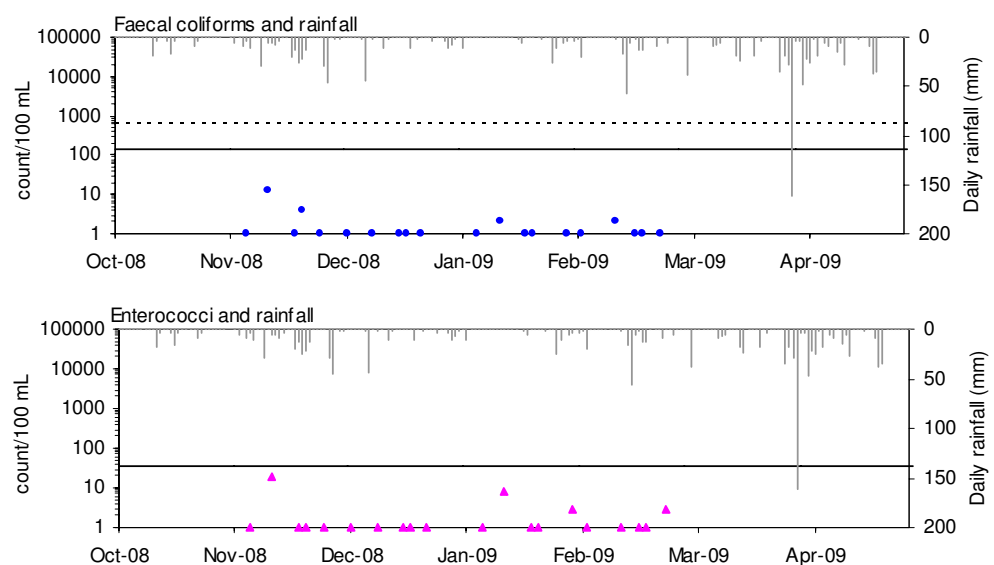
Levels of faecal coliforms and enterococci were consistently low over the monitoring period.

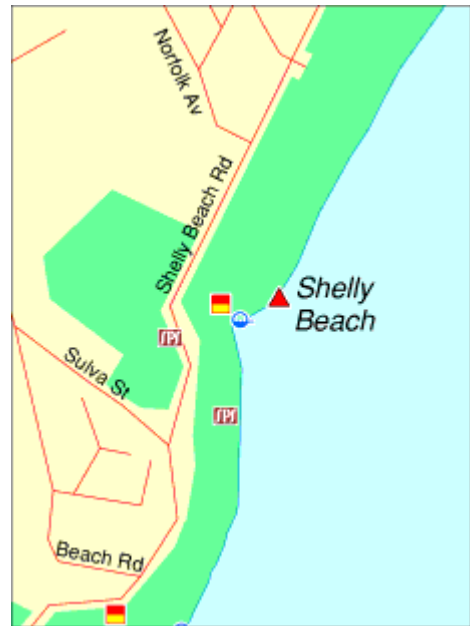
Shelly Beach faces south-east and is approximately 700 metres long. It is backed by a narrow coastal reserve and urban development. Carparks are situated at each end of the beach and the surf club is located at the southern end. Shelly Beach is the main swimming beach for Ballina and is significant for local tourism.

During wet weather, stormwater from the wetland behind Shelly Beach flows to the southern end of the beach, adjacent to the rock platform. The wetland is affected by urban stormwater runoff. A sewage pumping station located adjacent to the wetland is also a potential source of pollution. General litter is a further source of contamination at this site.

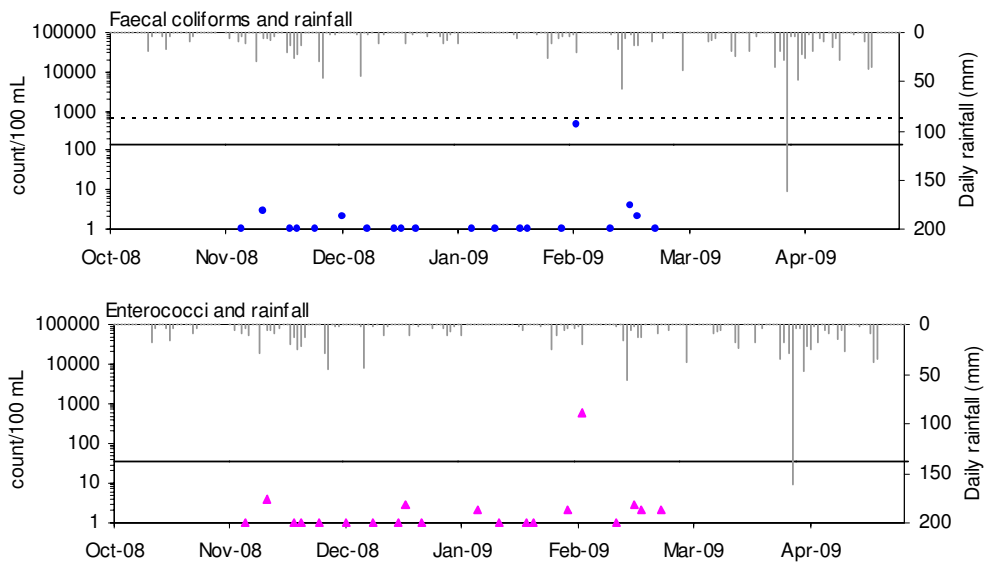
Levels of faecal coliforms and enterococci were generally low over the monitoring period. A single elevated result was measured in early February 2009 in response to rainfall.

The levels of indicator bacteria measured at Seven Mile Beach over this summer swimming season were generally very low. Faecal coliform and enterococci levels were also low at Shelly Beach, with a single elevated result recorded in early February 2009 in response to rainfall.

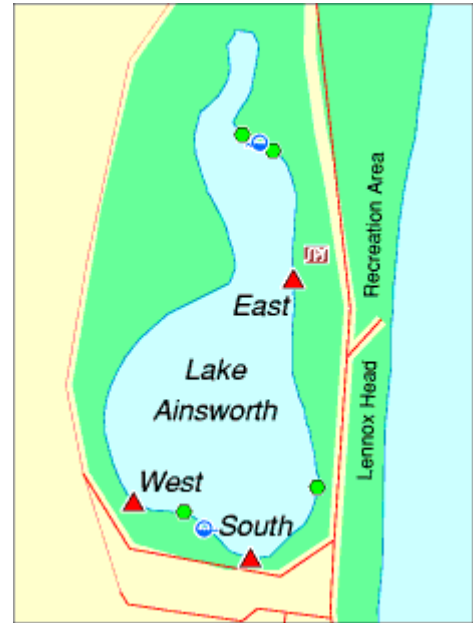
The sampling site is located on the eastern side of Lake Ainsworth, a coastal freshwater lake. The lake is situated to the west of Seven Mile Beach and north of the township of Lennox Head. The lake is used extensively and is of high social and economic importance.

Urban stormwater runoff enters the lake during wet weather through a number of stormwater drains. There is a history of blue-green algal blooms at the site that pose a potential health risk for lake users.

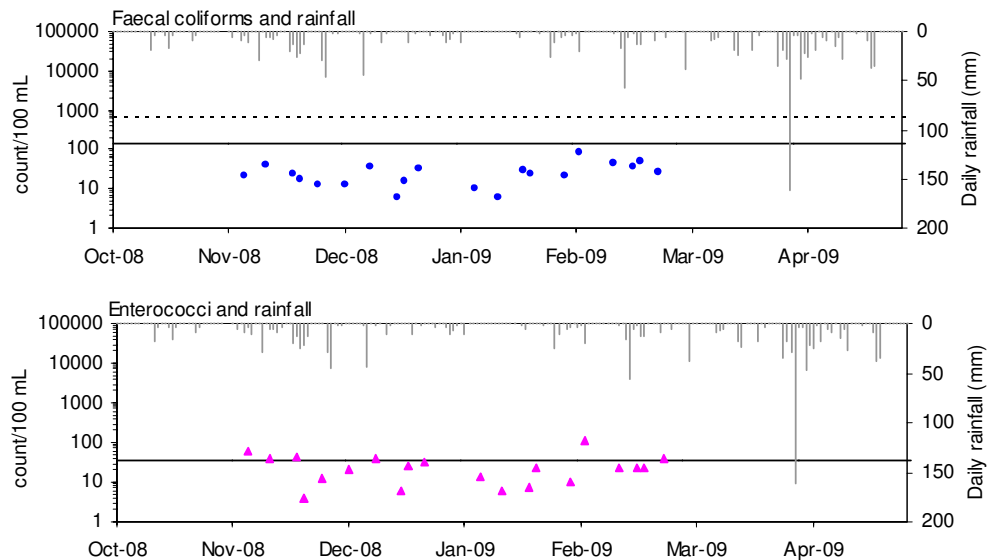
Levels of faecal coliforms on the eastern side of Lake Ainsworth remained below the guideline values during the monitoring period. Enterococci levels just exceeded the geometric mean guideline on a number of occasions, generally in response to rainfall.

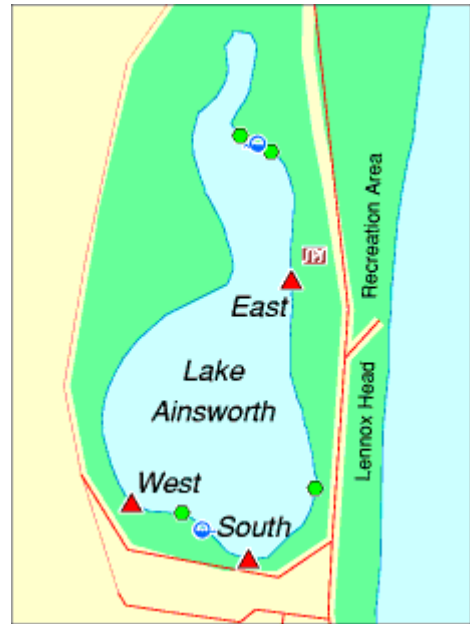
The sampling site is located at the main swimming site in the south of Lake Ainsworth, a coastal freshwater lake. The lake is situated to the west of Seven Mile Beach and north of the township of Lennox Head. The lake is used extensively and is of high social and economic importance.

Urban stormwater runoff enters the lake during wet weather through a number of stormwater drains. There is a history of blue-green algal blooms at the site that pose a potential health risk for lake users.

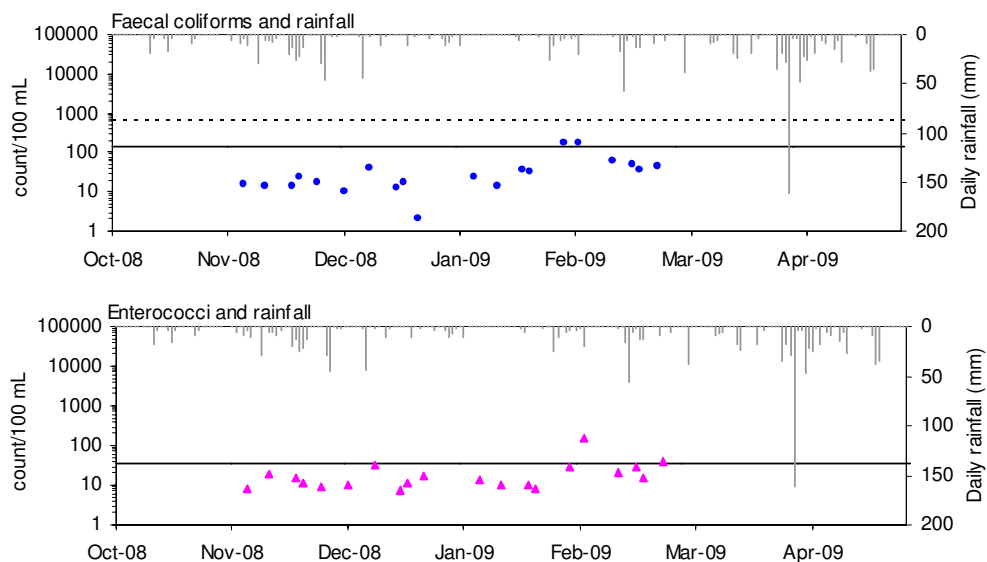
Bacterial levels on the southern side of Lake Ainsworth generally remained below the guideline values during the monitoring period. Slightly elevated results were recorded in early February 2009 in response to heavy rainfall.

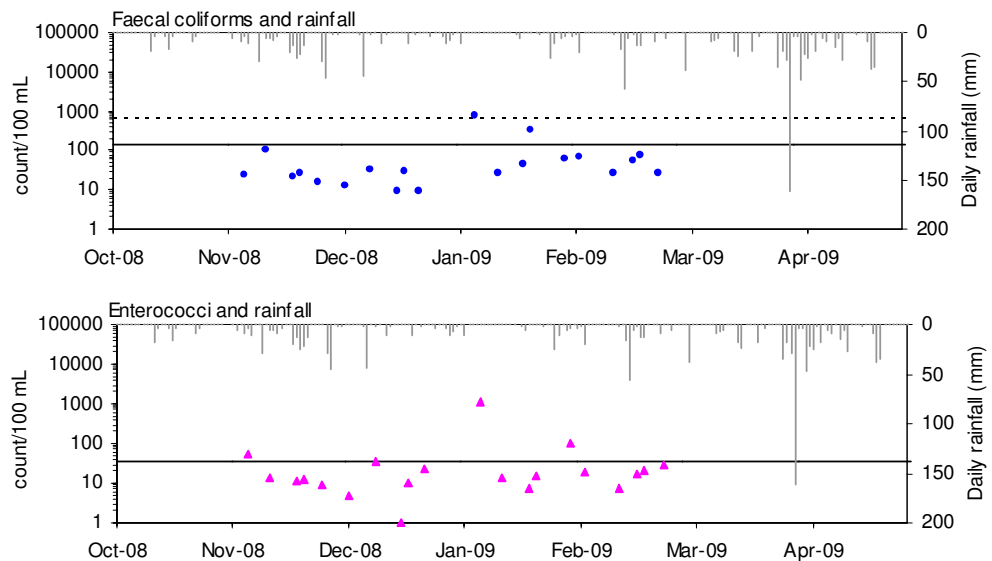
Bacterial levels on the western side of Lake Ainsworth generally remained below the guideline values during the monitoring period. Elevated faecal coliform levels were recorded on two occasions in January 2009 during dry weather conditions. Enterococci levels exceeded the geometric mean on three occasions.

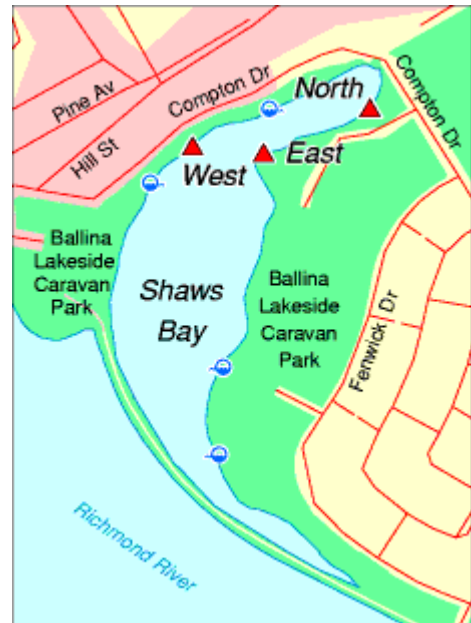
Pollution sources There are several major stormwater outlets in the vicinity of the site, as well as numerous small drains. Previous monitoring has revealed faecal contamination and nutrients in the stormwater. Gross pollutant traps have been installed, reducing the amounts of litter, sediment and other pollutants discharged to the bay.

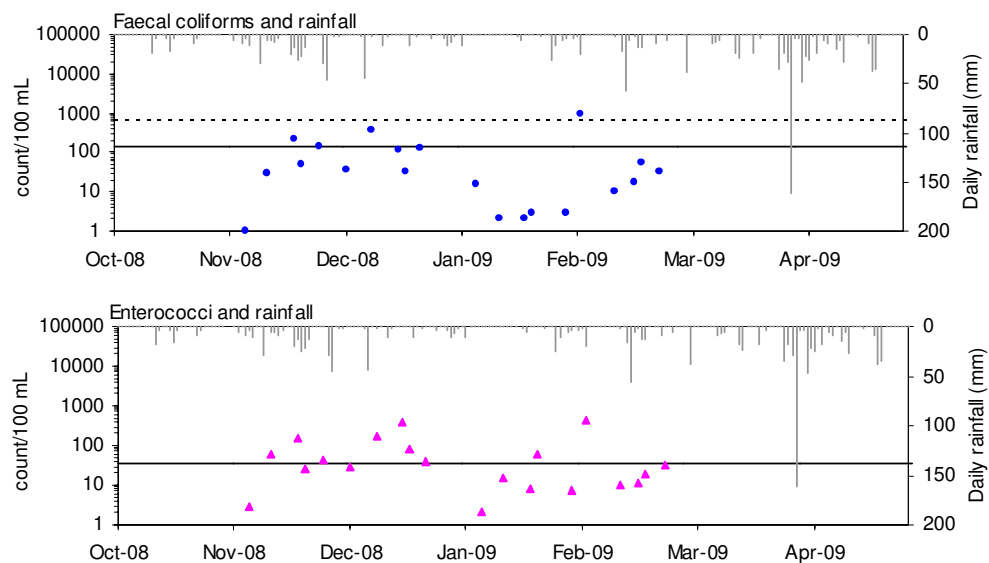
Timeseries plots Levels of faecal coliforms and enterococci at Shaws Bay North exceeded the guideline limits on a number of occasions during the monitoring period, with most elevated results recorded in response to rainfall.

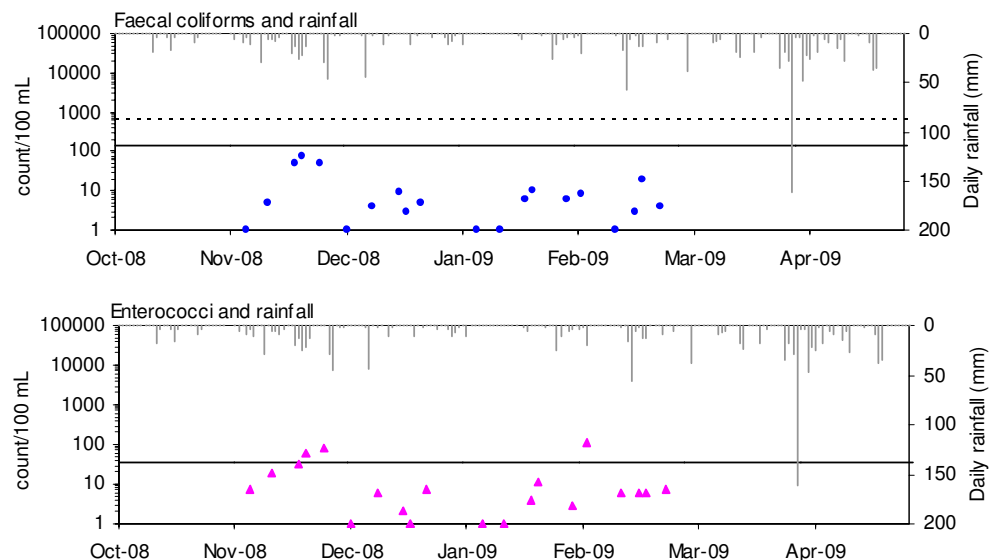
Levels of faecal coliforms at Shaws Bay East remained below guideline limits throughout the monitoring period. Enterococci levels more frequently exceeded the geometric mean guideline limit, usually in response to heavy rainfall.

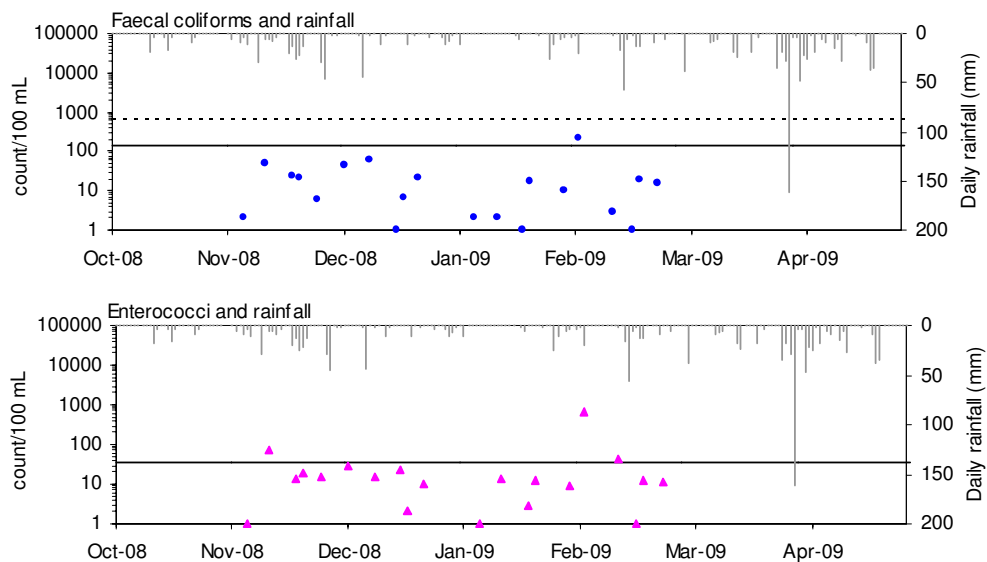
Timeseries plots Levels of faecal coliforms and enterococci at Shaws Bay West generally remained below the median guideline level during the monitoring period. Elevated bacterial levels were measured in early February 2009 in response to rainfall.

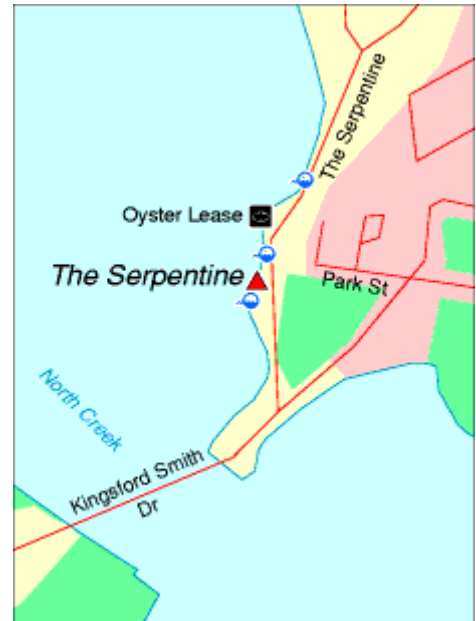
The Serpentine is situated in North Creek, a tributary of the Richmond River. It is a popular swimming and fishing location for local residents, tourists, and particularly families, over the summer months. The shore is lined with urban development. The waterway is characterised by flat, shallow sandbars. The sampling site is located between two stormwater outlets.

Urban stormwater runoff may affect the site, especially during wet weather. Rural and industrial land uses in the upper catchments may also affect water quality during wet weather. General litter and domestic pet droppings are further potential pollutants.

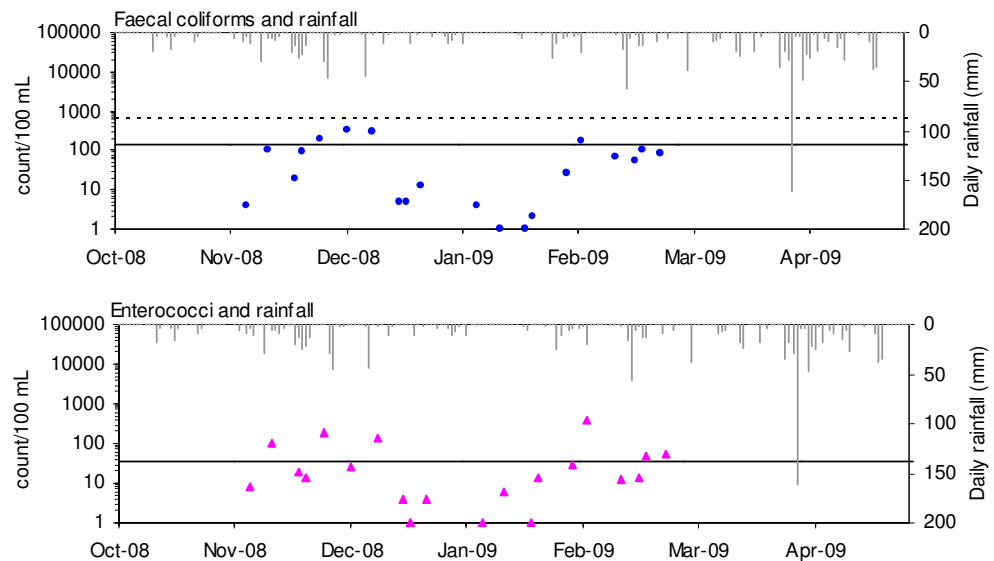
Levels of faecal coliforms and enterococci at The Serpentine exceeded the median guideline levels on a number of occasions during the monitoring period, with most elevated results recorded following rainfall.
