## Bega Valley Council

## **Program outline**

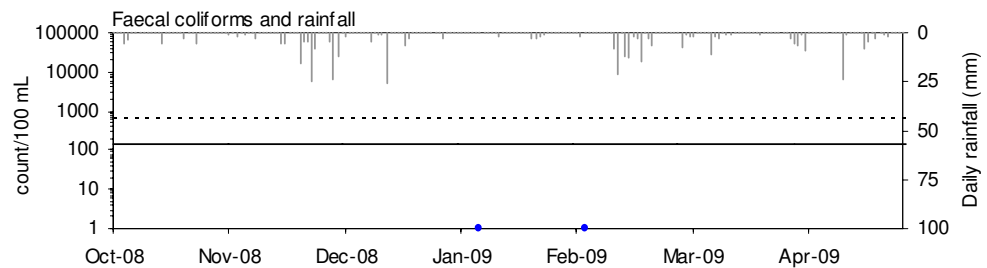
Although only two samples were collected from this site, levels of faecal coliforms were very low.

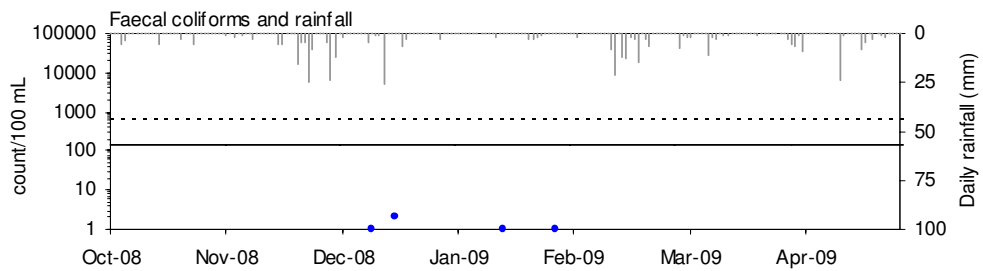
**Timeseries plots** Although only four samples were collected from this site, levels of faecal coliforms were very low.

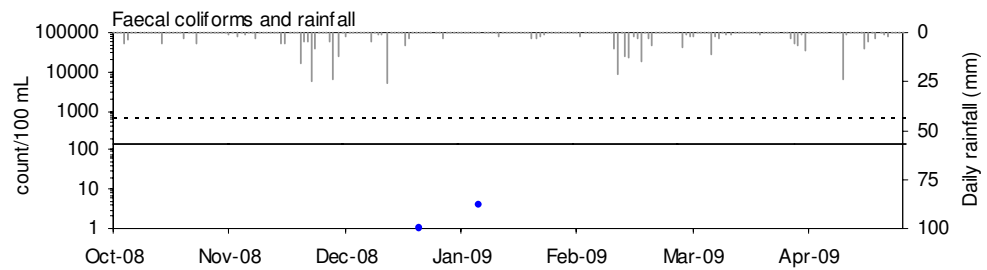
Although only two samples were collected from this site, levels of faecal coliforms were very low.

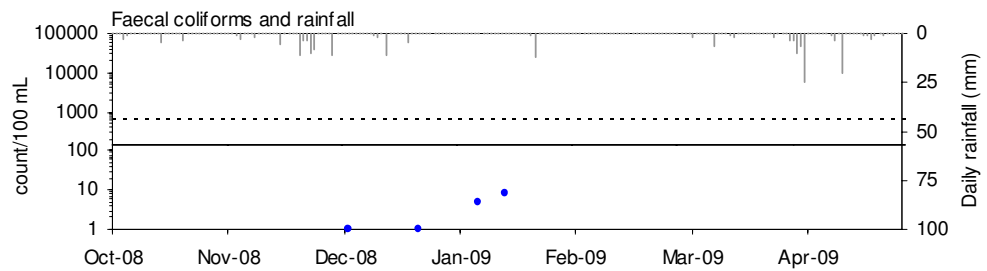
**Timeseries plots** Although only four samples were collected from this site, levels of faecal coliforms were very low.

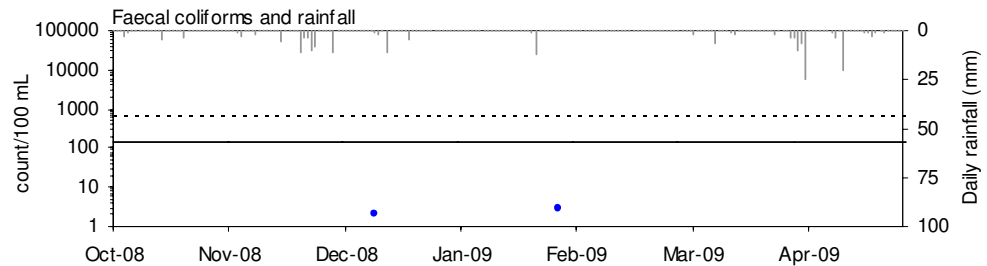
Although only two samples were collected from this site, levels of faecal coliforms were very low.

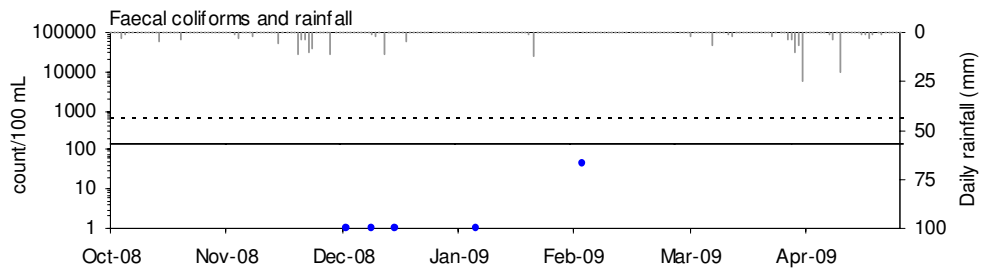
**Timeseries plots** Although only five samples were collected from this site, levels of faecal coliforms were low.

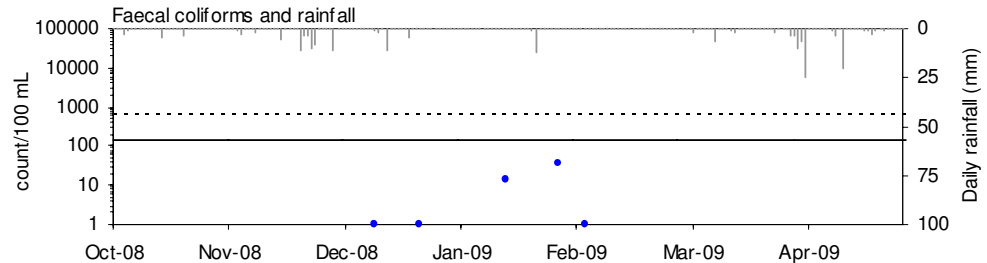
Although only five samples were collected from this site, levels of faecal coliforms were low.

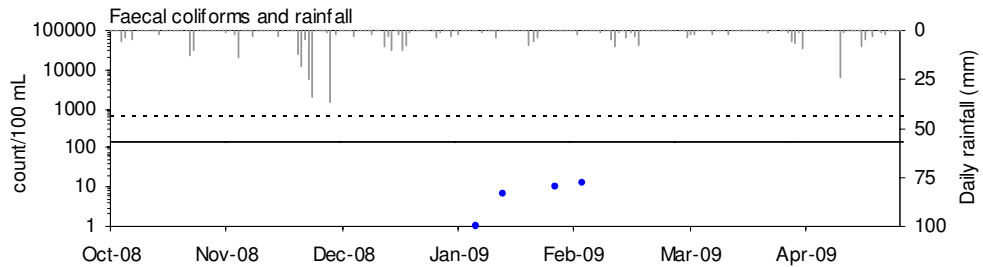
**Timeseries plots** Although only four samples were collected from this site, levels of faecal coliforms were very low.

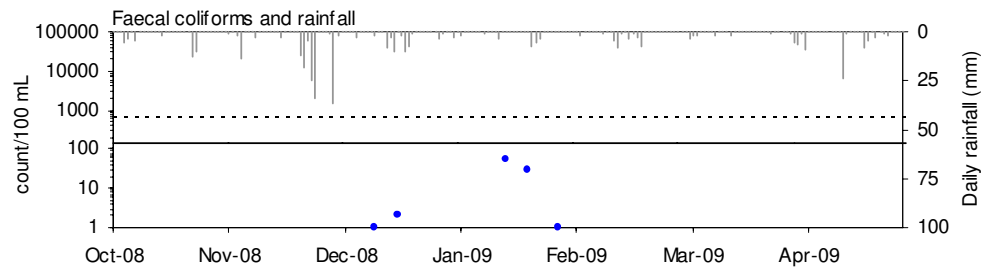
Although only five samples were collected from this site, levels of faecal coliforms were low.

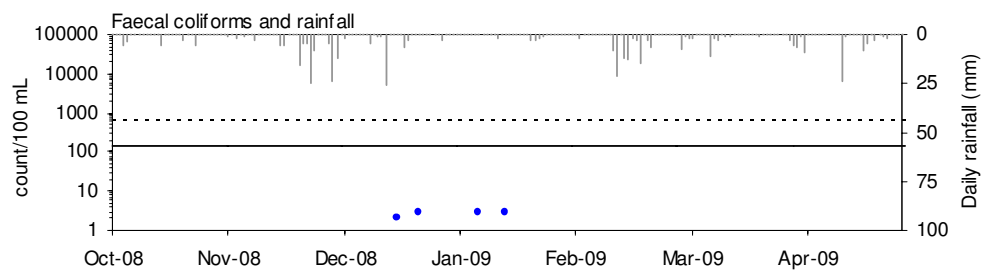
Although only four samples were collected from this site, levels of faecal coliforms were very low.

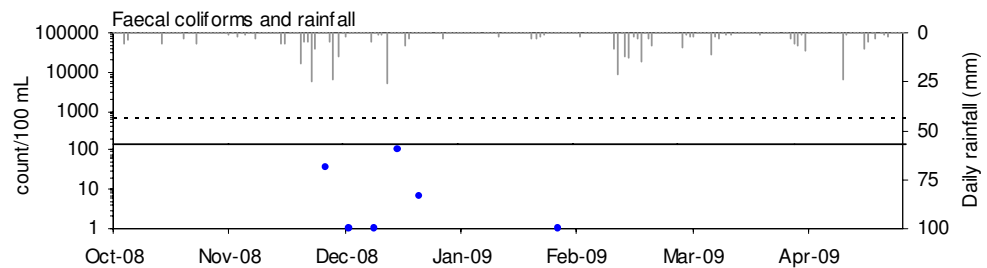
Although only six samples were collected, levels of faecal coliforms were low, remaining below the median guideline limit.

Faecal coliform levels at Cuttagee Inlet complied with NHMRC (1990) swimming guidelines in December 2008.

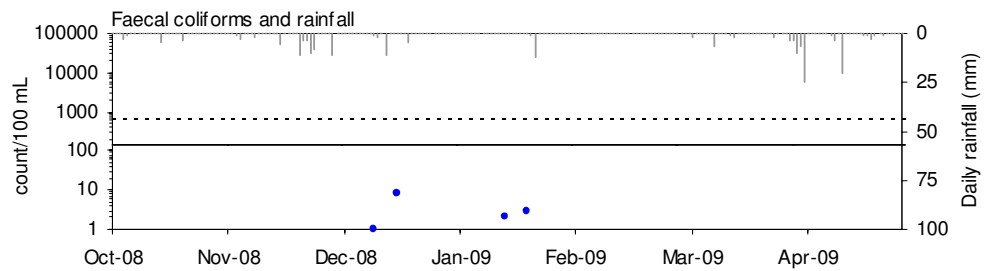
Although only four samples were collected, levels of faecal coliforms were very low.

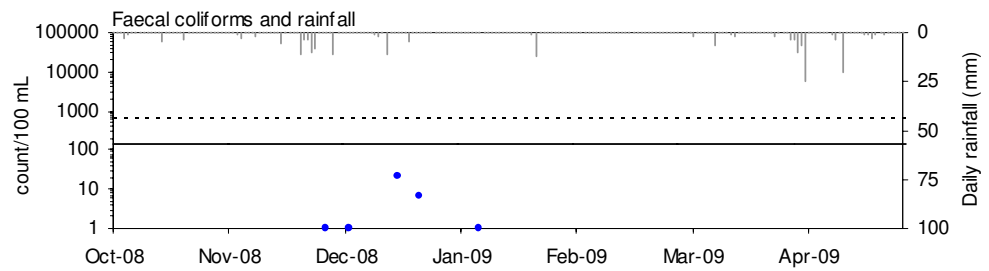
Although only five samples were collected, levels of faecal coliforms were low.

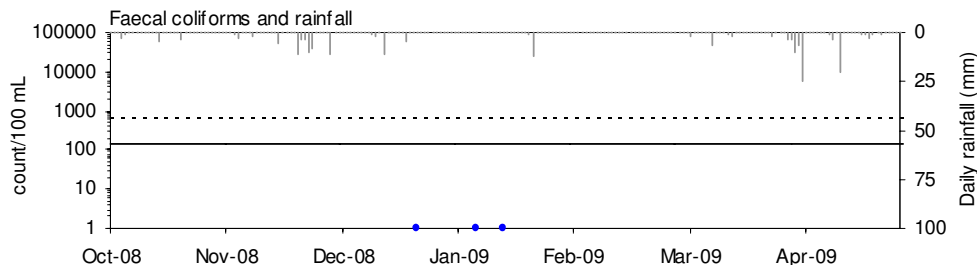
Although only three samples were collected, levels of faecal coliforms were very low.

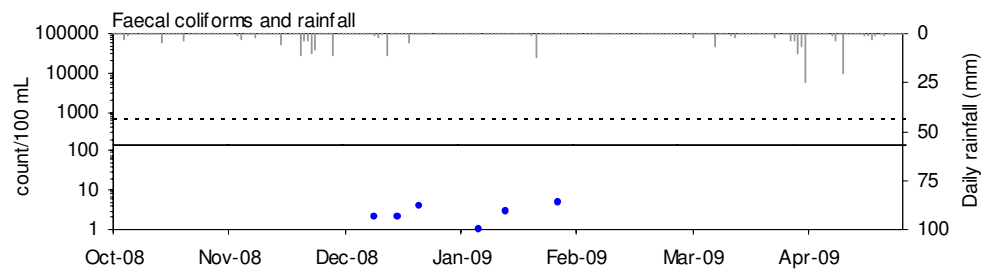
Although only six samples were collected, levels of faecal coliforms were very low.

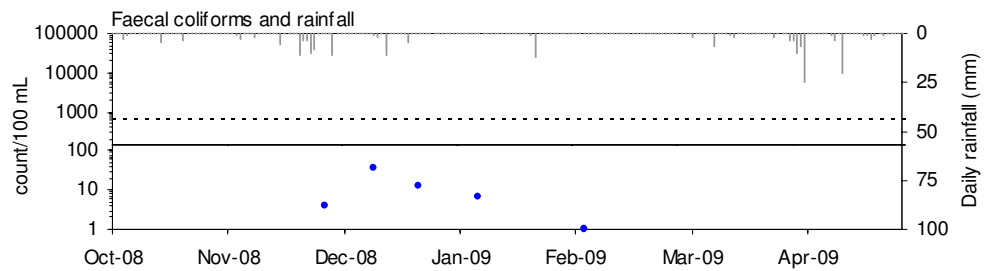
**Timeseries plots** Although only five samples were collected, levels of faecal coliforms were low.

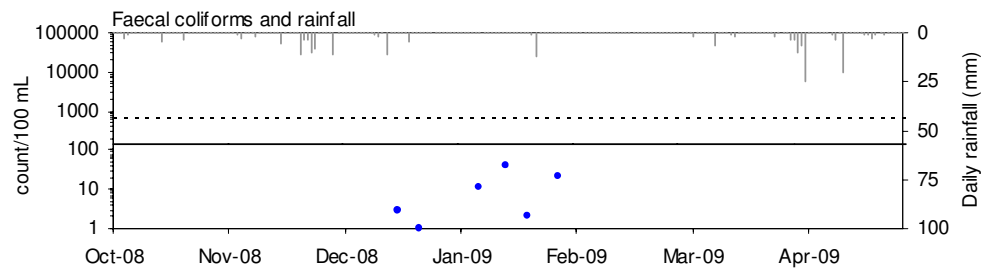
Although only six samples were collected, levels of faecal coliforms were low.

Bar Beach complied with NHMRC (1990) swimming guidelines in January 2009.

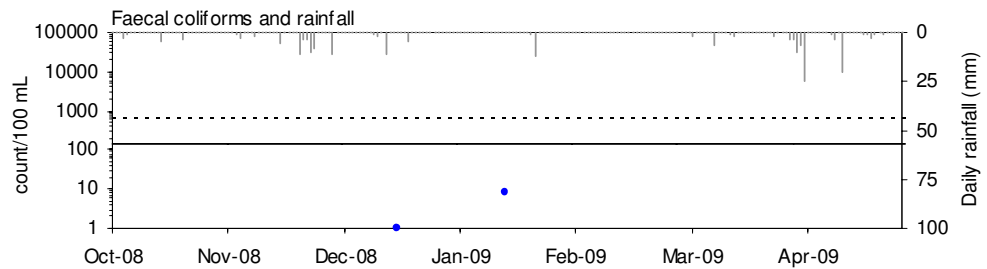
**Timeseries plots** Although only two samples were collected, levels of faecal coliforms were very low.

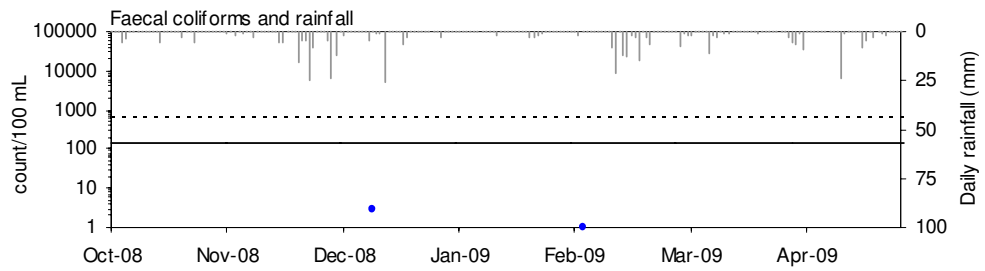
Although only two samples were collected, levels of faecal coliforms were very low.

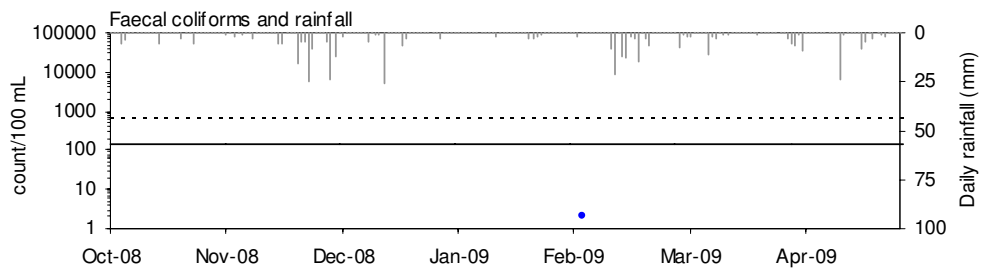
**Timeseries plots** Although only one sample was collected, the level of faecal coliforms was very low.
