# Coffs Harbour City Council

**Ocean beaches:** Woolgoolga Main, Emerald, Diggers, Park, Jetty, Mid Sawtell.  
**Ocean pools:** Sawtell Rock Pool.

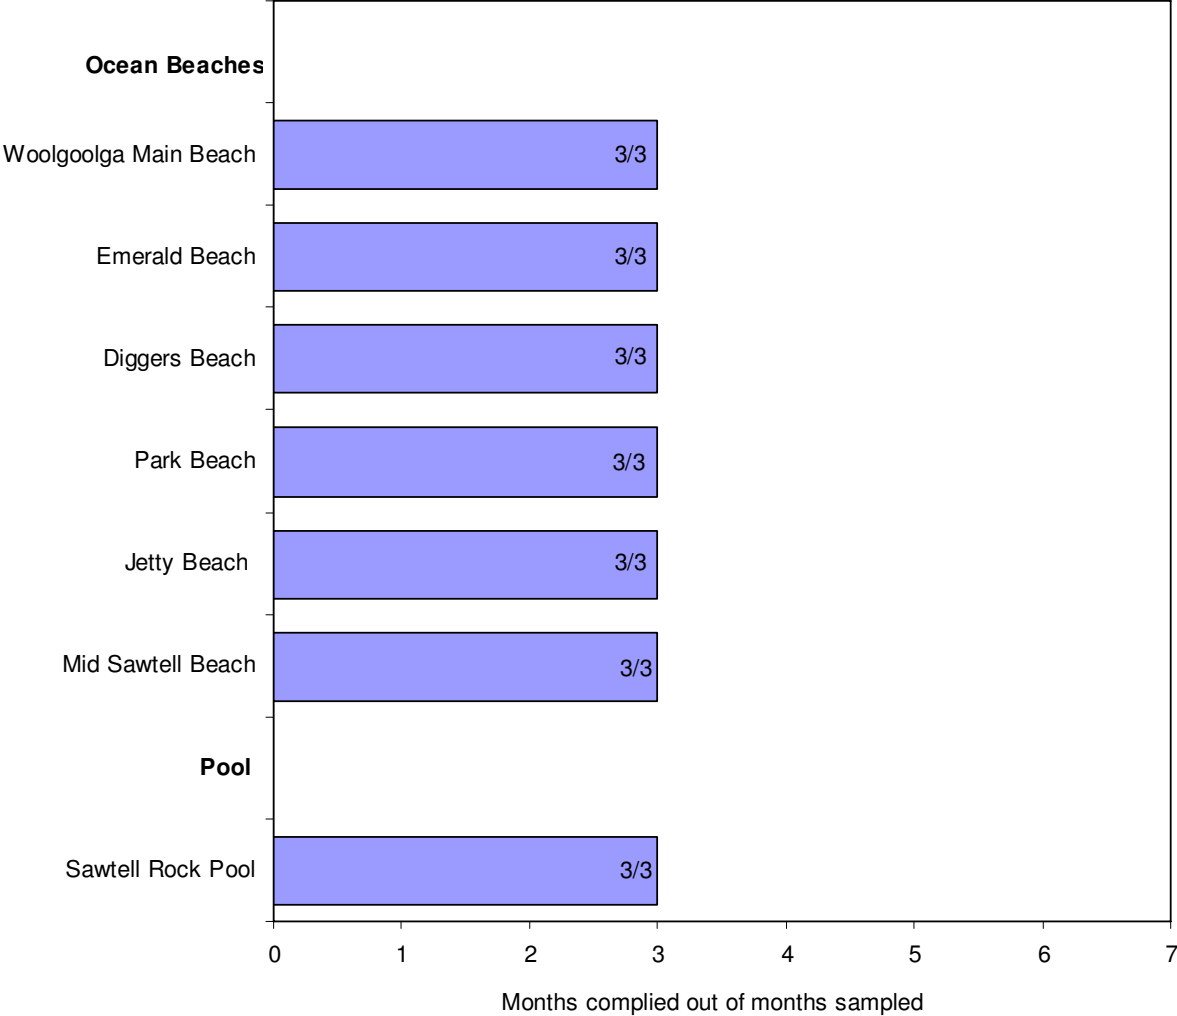
**Figure 5: Summary of compliance with NHMRC (1990) microbiological guidelines for swimming at Coffs Harbour City Council swimming sites during the 2008–2009 summer swimming season**

A high level of compliance with NHMRC (1990) swimming water guidelines was recorded at all ocean beaches. Woolgoolga Main, Emerald, Jetty, Diggers, Park and Mid-Sawtell beaches were suitable for swimming during all three months in which compliance was assessed (Figure 5).

A high level of compliance with NHMRC (1990) swimming water guidelines was recorded at Sawtell Rockpool (Figure 5). The site was suitable for swimming during all three months in which compliance was assessed (Figure 5).

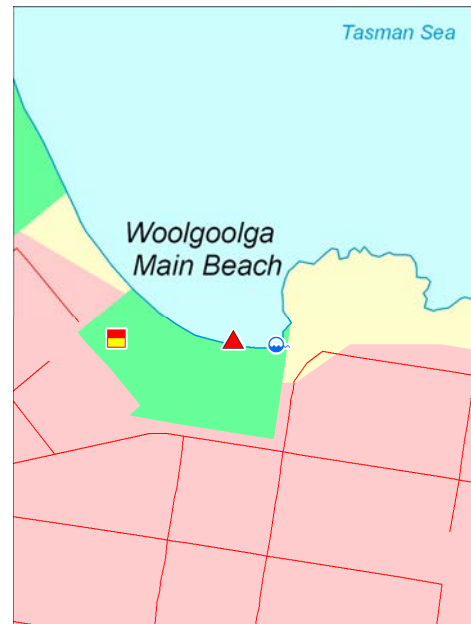
See page 43 for key to map

**Description** Woolgoolga Main Beach is a popular swimming and surfing location. It is patrolled seasonally and a surf club, toilet facilities and a car park are located at the beach. Although the beach is predominantly backed by dune vegetation, urban development surrounds the area with a shopping centre immediately adjacent to the beach.

**Pollution sources** Onsite wastewater management systems situated within the catchment and possible sewage overflows both represent possible pollution sources at this site. The local public toilets are sewered. Domestic animal faecal wastes are another possible source of contamination at this site.

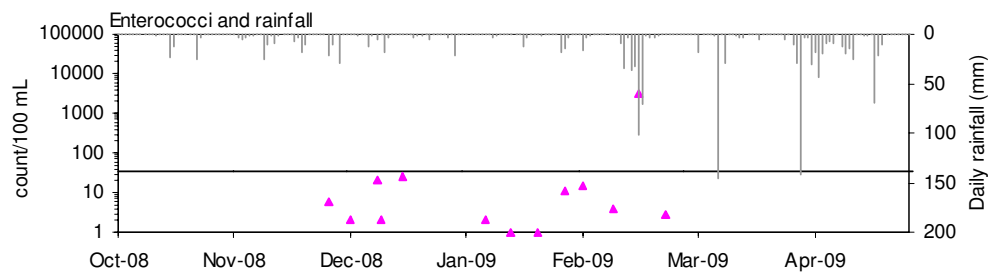
**Timeseries plots** Enterococci levels were generally low throughout the monitoring period. A very high result was measured in February 2009 in response to more than 100 millimetres of rainfall.

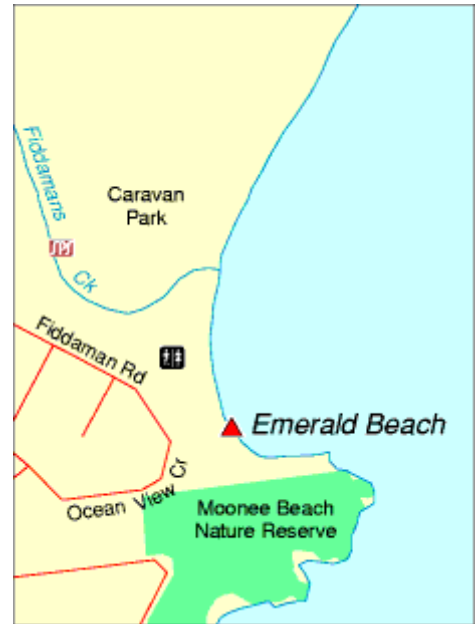
See page 43 for key to map

Emerald Beach lies to the north of Dammerals Head. The beach is accessed at the southern end, where there are amenities, picnic facilities and a park. This is a popular swimming beach that is patrolled during the summer.

Sewage pumping stations and on-site wastewater management systems are potential pollution sources. Elevated bacterial levels have previously been measured in Fiddamans Creek, which discharges to the north of the sampling site. Domestic animal droppings may also be a potential pollution source.

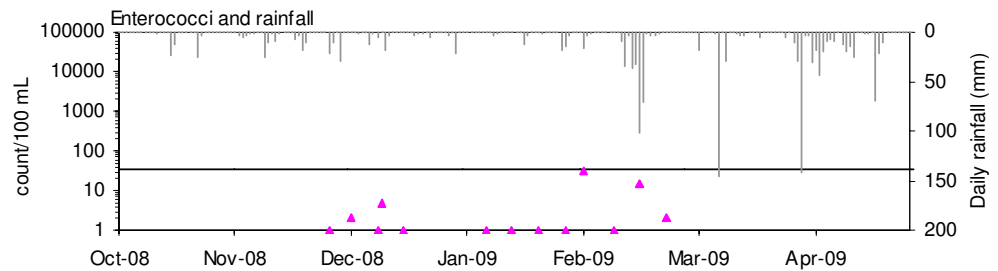
Enterococci levels were generally low, remaining below the geometric mean guideline throughout the monitoring period.

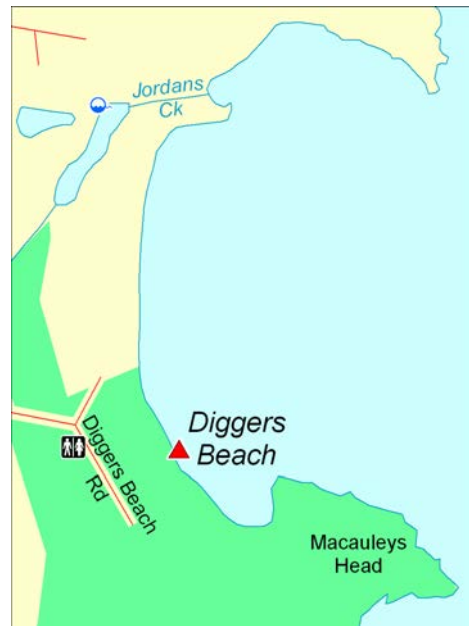
See page 43 for key to map

**Description** Diggers Beach is positioned between Diggers and Macauleys headlands. It is 1 kilometre long and divided by a small rocky outcrop at the northern end of the beach. Jordans Creek drains across this end of the beach. There are carparks at the southern end of the beach which is a popular swimming and surfing location. Above the sampling location there is a public toilet and resort development behind sand dunes.

**Pollution sources** Stormwater runoff from Jordans Creek and the outlet at the northern end of the beach are potential pollution sources. Sewage pumping stations are located in the catchment and a seweried public toilet is located directly behind the sampling site.

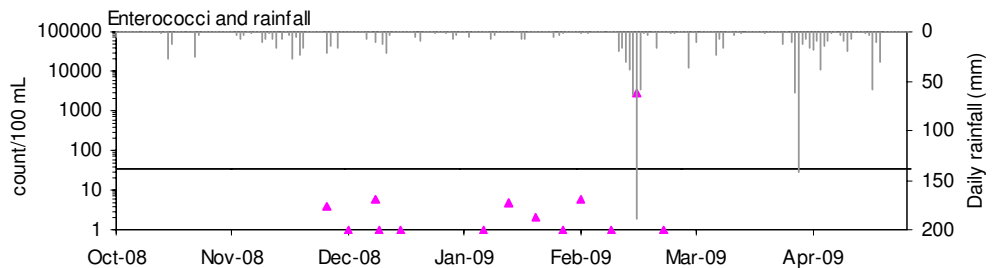
**Timeseries plots** Enterococci levels were generally low throughout the monitoring period. A very high result was measured in February 2009 in response to more than 100 millimetres of rainfall.

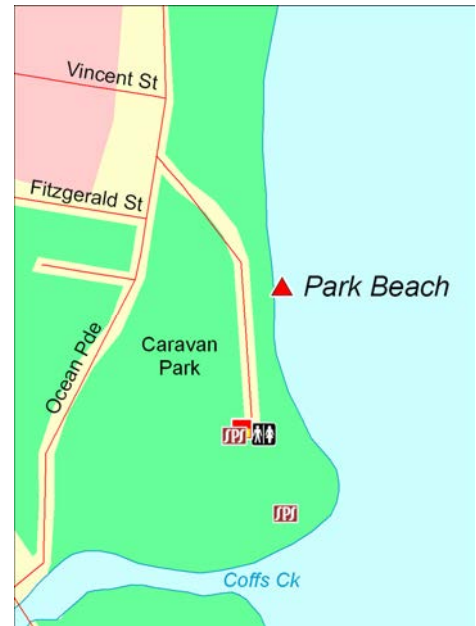
See page 43 for key to map

Park Beach is the central beach for Coffs Harbour. The southern end is patrolled, popular for swimming and surfing and has numerous facilities. The beach is backed by a fenced and vegetated foredune and the catchment contains dense urban and commercial development.

Sewage pumping stations and a sewer public toilet are located behind the sampling site. Domestic animal droppings are also potential sources of pollution.

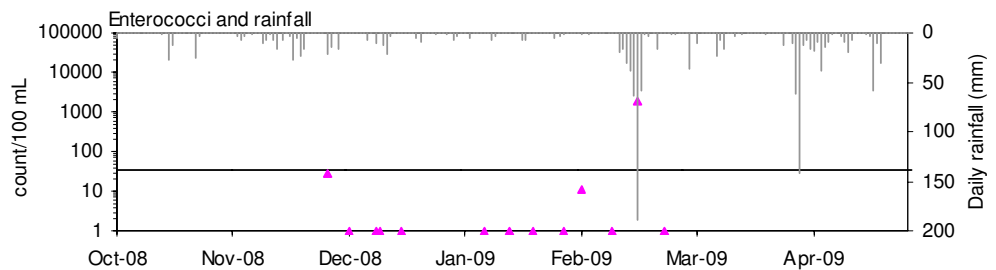
Enterococci levels were generally low throughout the monitoring period. A very high result was measured in February 2009 in response to more than 100 millimetres of rainfall.

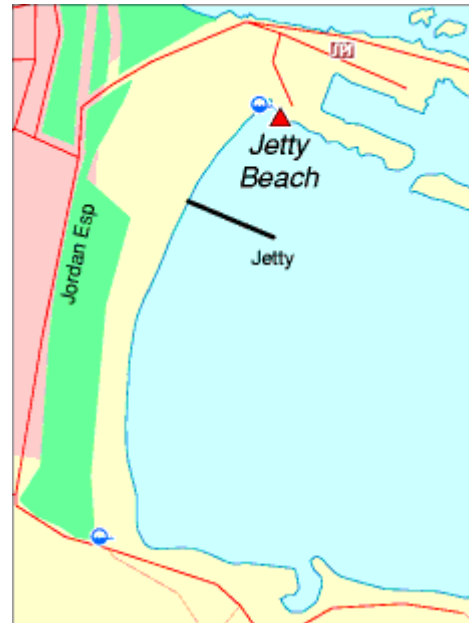
See page 43 for key to map

**Description** Jetty Beach is approximately 1.4 kilometres long and extends south from a marina to Corambirra Point. There is no surf at the beach and it is a popular swimming location during summer. The beach is backed by a line of vegetation, behind which there is urban development. The sampling site is located at the northern end of the beach, between Coffs Harbour Jetty and the marina.

**Pollution sources** Urban stormwater is discharged from drains at the northern and southern ends of the beach. Boat effluent and contamination from the marina and domestic animal droppings are also potential sources of pollution.

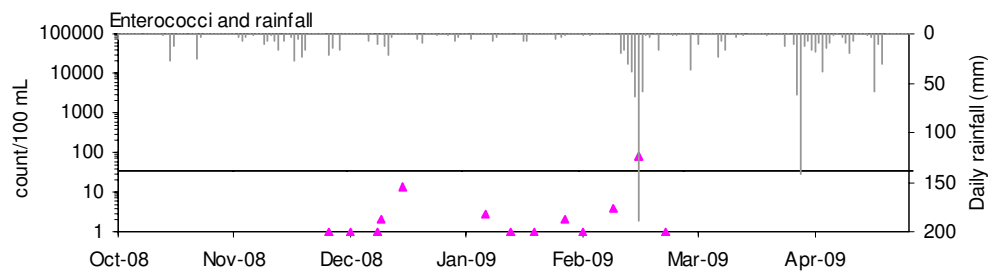
**Timeseries plots** Enterococci levels were generally low throughout the monitoring period. A slightly elevated result was measured in February 2009 in response to more than 100 millimetres of rainfall.

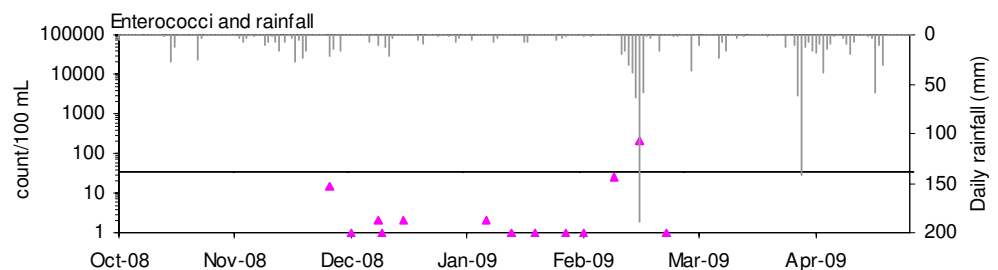
Enterococci levels were generally low throughout the monitoring period. A slightly elevated result was measured in February 2009 in response to more than 100 millimetres of rainfall.

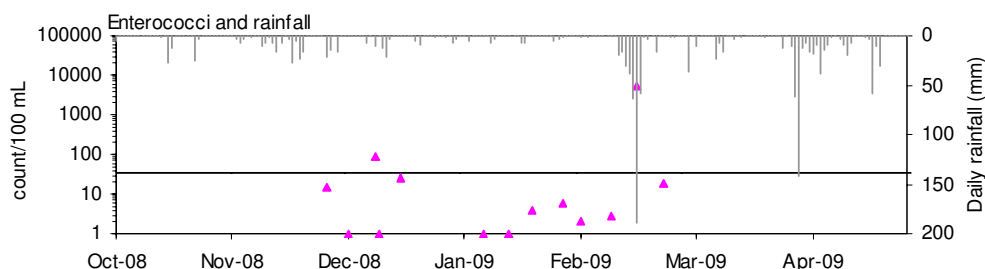
Levels of enterococci remained generally low over the monitoring period. A very high result was recorded in February 2009 in response to more than 100 millimetres of rainfall.
