Kempsey Shire Council

Local government area description

Program outline

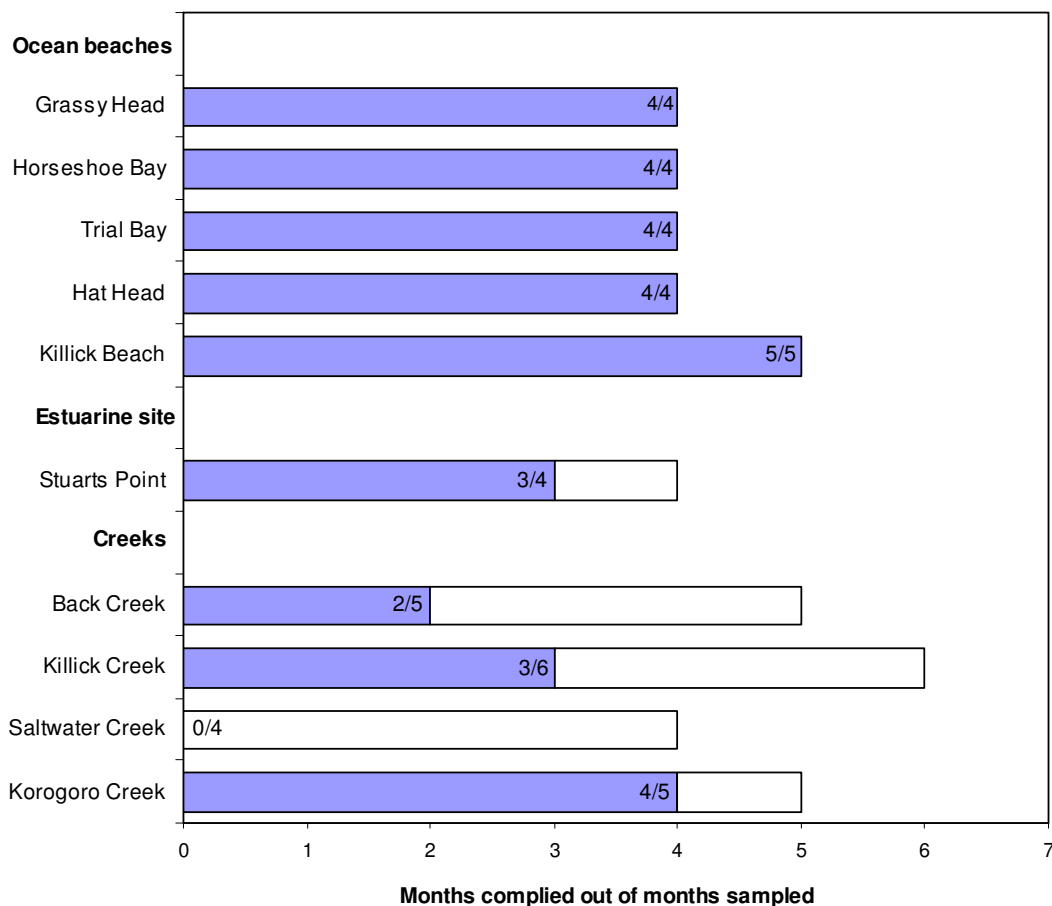
Figure 6: Summary of compliance with NHMRC (1990) microbiological guidelines for swimming at Kempsey Shire Council swimming sites during the 2008–2009 summer swimming season

A high level of compliance with NHMRC (1990) swimming guidelines was recorded at the ocean beaches during the 2008–2009 summer swimming season (Figure 6). Grassy Head, Horseshoe Bay, Trial Bay and Hat Head beaches complied with the swimming guidelines in all four months in which sufficient samples were collected. Killick Beach complied with the guidelines in all five months in which sufficient samples were collected.

Stuarts Point complied with the NHMRC (1990) swimming water quality guidelines in three of the four months in which sufficient samples were collected (Figure 6). The site failed the guidelines in March 2009.

Compliance with the NHMRC (1990) swimming water quality guidelines varied substantially among the creek locations (Figure 6). The highest level of compliance was recorded at Korogoro Creek, which complied in four of the five months in which sufficient samples were collected to calculate compliance.

Killick Creek complied with the swimming guidelines in three of the six months and Back Creek complied in two of the five months in which sufficient samples were collected.

The lowest level of compliance was recorded at Saltwater Creek which failed to comply with the swimming guidelines in all four months in which sufficient samples were collected. Similar results were recorded during the 2007–2008 summer season (DECC, 2008).

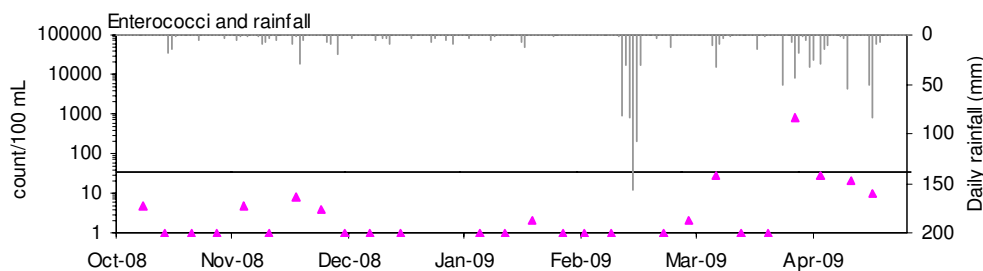
Timeseries plots Enterococci levels generally remained low and below the geometric mean guideline throughout the monitoring period. A single elevated enterococci result was recorded in March 2009 in response to heavy rainfall.

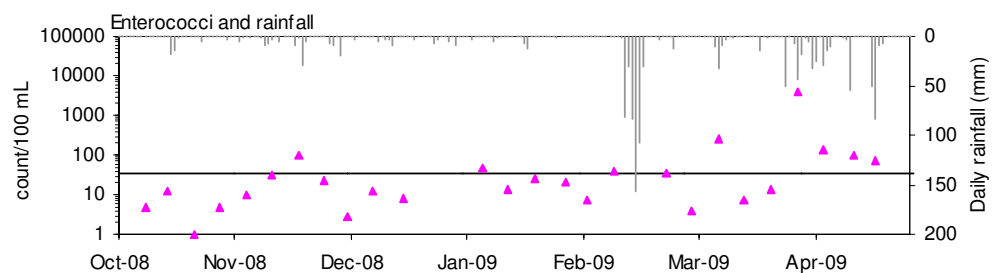
Levels of enterococci remained below the geometric mean guideline for most of the monitoring period, with some elevated values recorded in March 2009 and April 2009 in response to heavy rainfall.

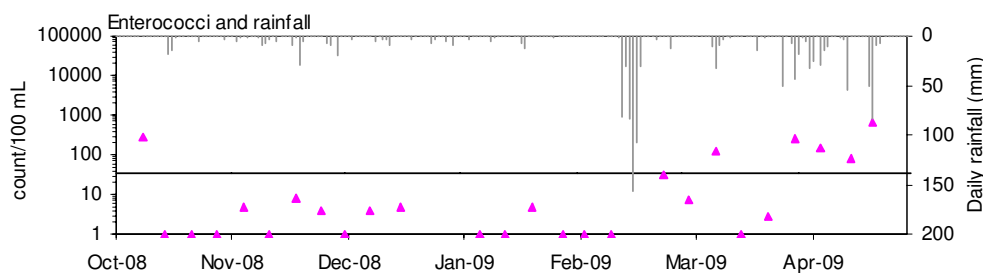
Levels of enterococci remained low over most of the monitoring period. The geometric mean guideline was exceeded on a number of occasions, generally in response to rainfall.

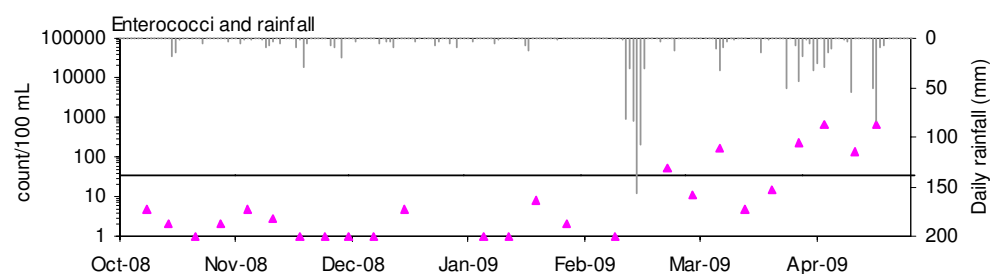
Levels of enterococci remained below the geometric mean guideline for most of the monitoring period, with some elevated values recorded in March 2009 and April 2009 in response to heavy rainfall.

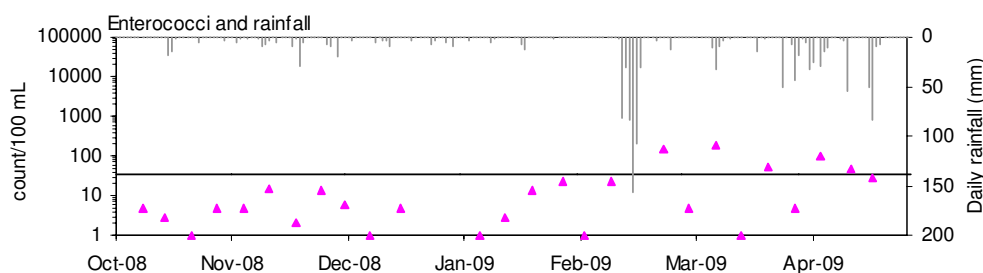
Timeseries plots Enterococci levels remained generally low over the monitoring period, exceeding the geometric mean guideline on a number of occasions in March 2009 and April 2009 in response to heavy rainfall.

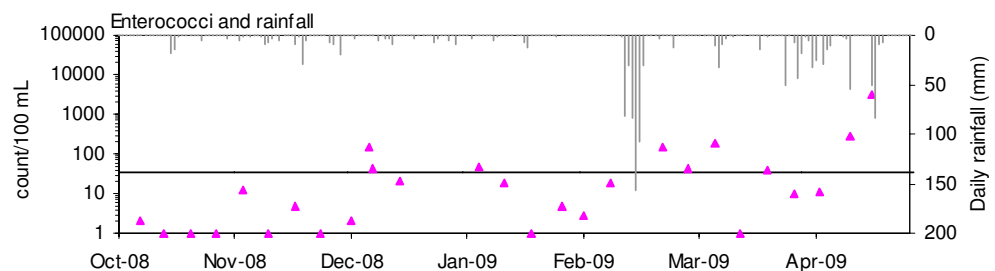
Enterococci levels were mostly low throughout the monitoring period but exceeded the geometric mean guideline on a number of occasions in response to heavy rainfall.

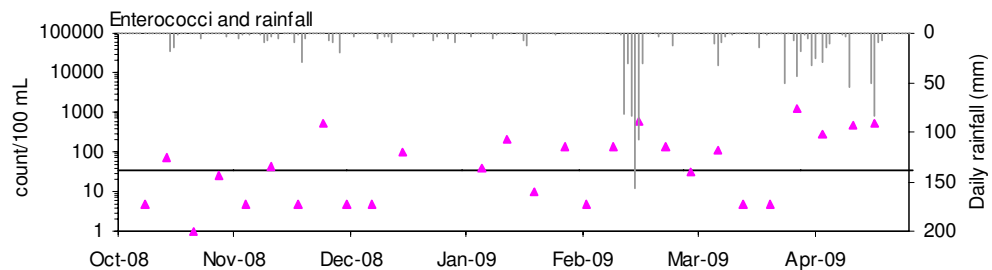
Enterococci levels were slightly elevated throughout the monitoring period and exceeded the guidelines limit on several occasions in both wet and dry weather conditions.

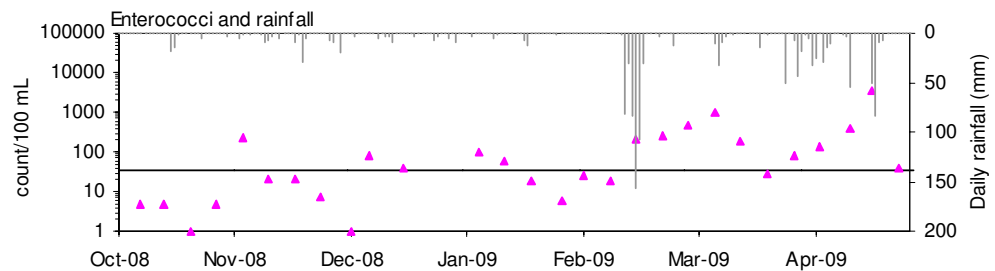
Elevated enterococci levels were recorded in the last three months of the monitoring period, with very high values recorded in both dry and wet weather conditions.

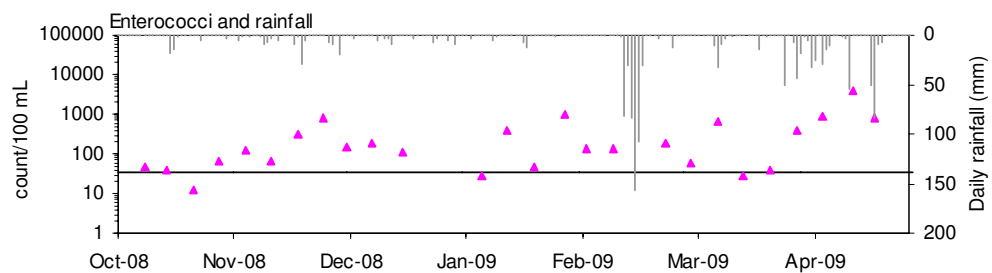
Timeseries plots Elevated levels of enterococci were measured throughout the monitoring period, in both wet and dry weather conditions.

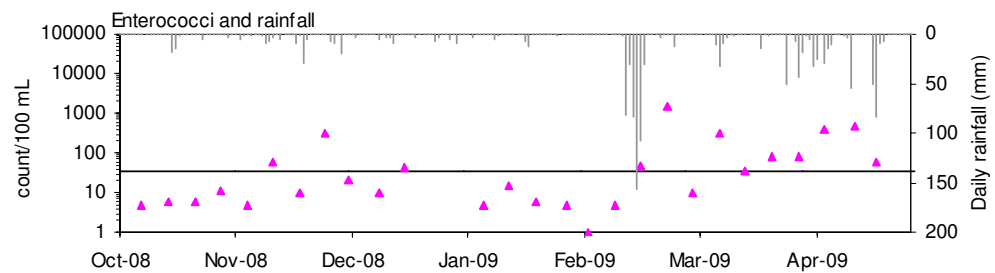
Elevated enterococci levels were recorded in the last three months of the monitoring period, with very high values recorded in response to heavy rainfall.
