Shoalhaven City Council

Ocean beaches: Shoalhaven Heads, Tilbury Cove, Warrain, Collingwood, Cudmirrah, Mollymook, Rennies, Racecourse, Bawley Point, Merry.

Local government area description

Program outline

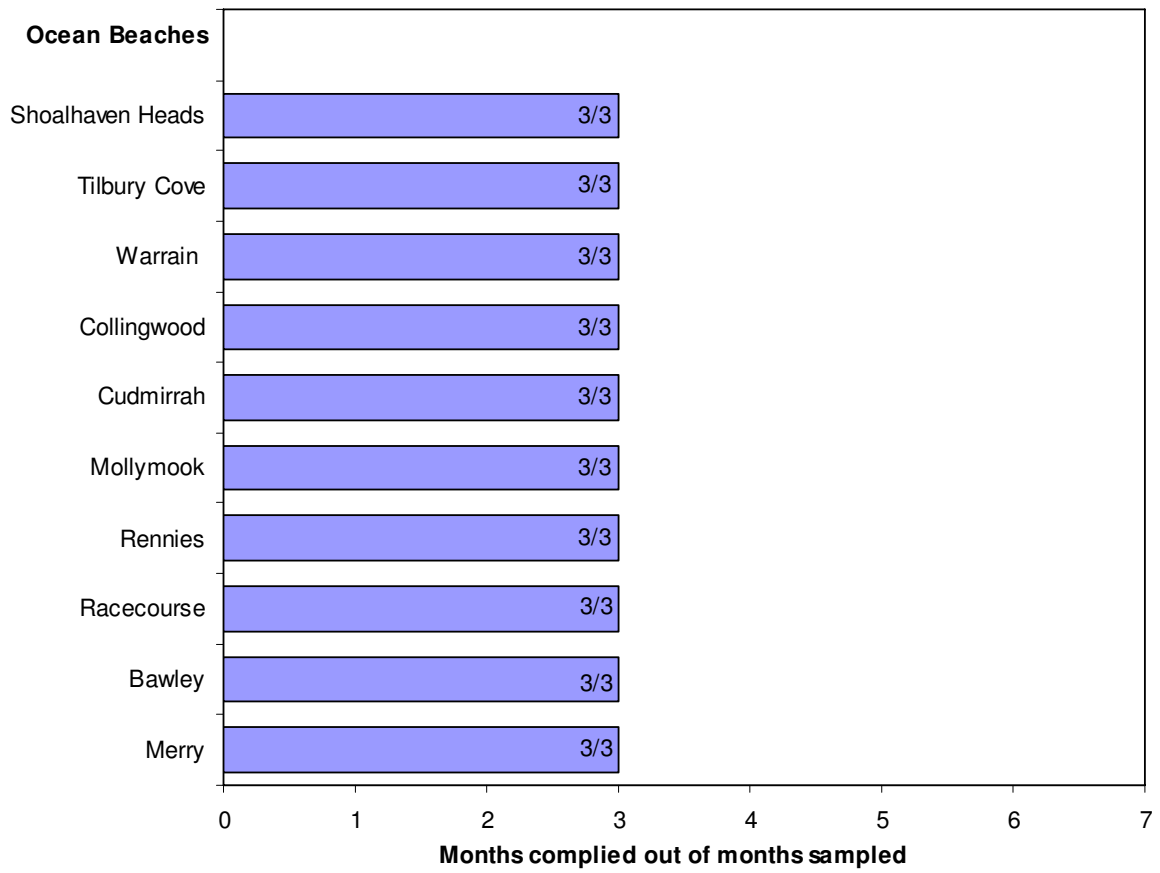
Figure 11: Summary of compliance with NHMRC (1990) microbiological guidelines for swimming at Shoalhaven City Council swimming sites over the 2008–2009 summer season

A high level of compliance with the NHMRC (1990) swimming water quality guidelines was recorded at ocean beaches in the Shoalhaven, with all ten locations passing in all three months (Figure 11).

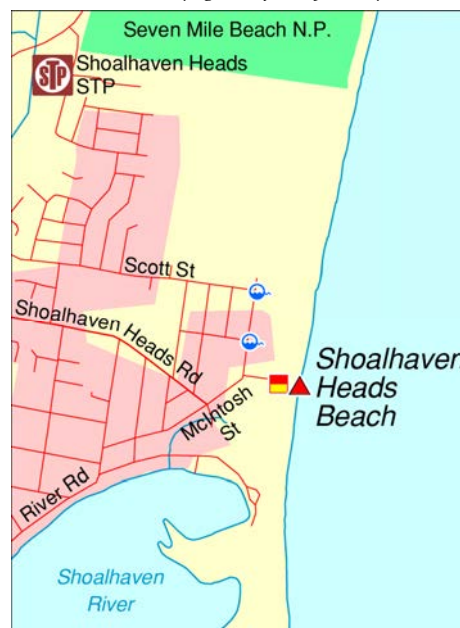
Shoalhaven Heads Beach is located towards the southern end of Seven Mile Beach, at the township of Shoalhaven Heads. The sampling site is located in front of the surf club. The beach is popular with the local community and tourists.

Tertiary treated effluent from the Shoalhaven Heads STP is pumped into sand dunes behind the beach. Stormwater and sewage overflows from a pumping station may also affect beach water quality during periods of wet weather. The Shoalhaven River periodically opens to the south of the main swimming area during flood.

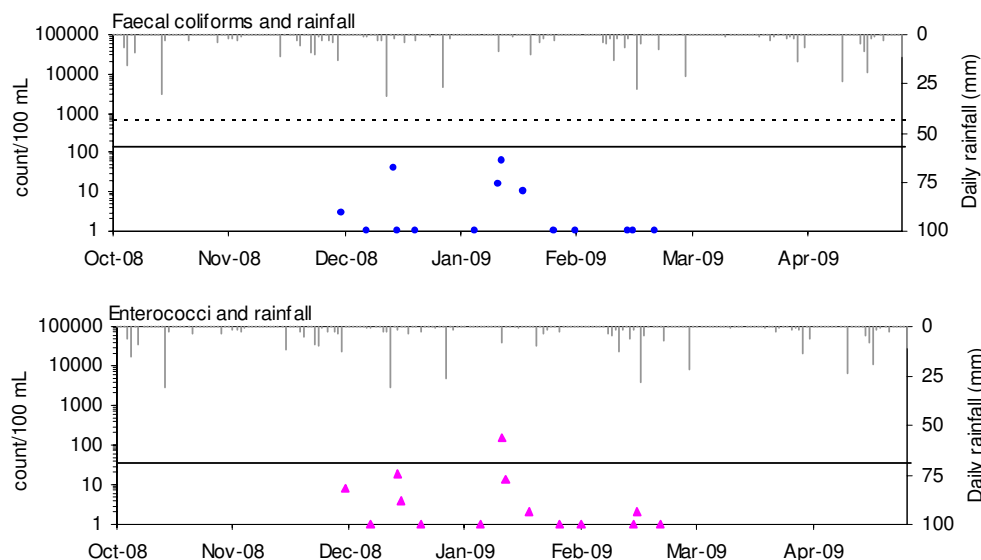
Levels of faecal coliforms and enterococci were generally very low over the monitoring period. A single enterococci result exceeded the geometric mean guideline in mid January 2009 in response to rainfall.

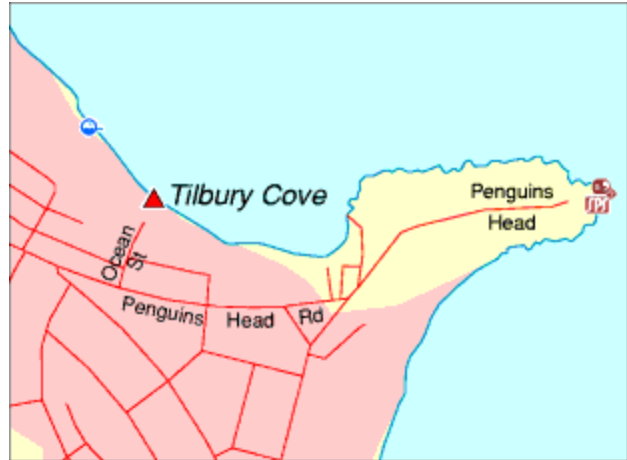
Tilbury Cove is located in the south-eastern corner of Culburra Beach, adjacent to the township of Culburra. The waters are sheltered by Penguin Head and offer generally calmer swimming conditions than the patrolled northern end of the beach. The sampling site is located in front of the Ocean Street car park. Amenities and a boat ramp are also located at the site.

Urban stormwater is discharged to the north of the sampling site. Treated sewage effluent is sometimes discharged via an ocean outfall at Penguin Head when extended wet weather events occur. Beach water quality may also be affected by possible sewage overflows from a nearby sewage pumping station and illegal disposal of effluent from boats.

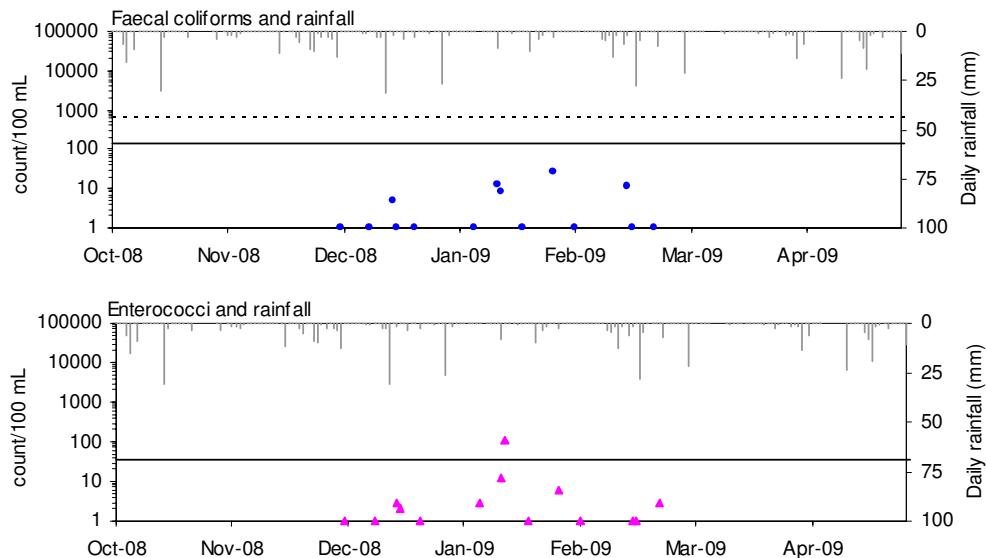
Levels of faecal coliforms and enterococci were generally low over the monitoring period. A single, slightly elevated enterococci value was recorded in mid January 2009 following rainfall.

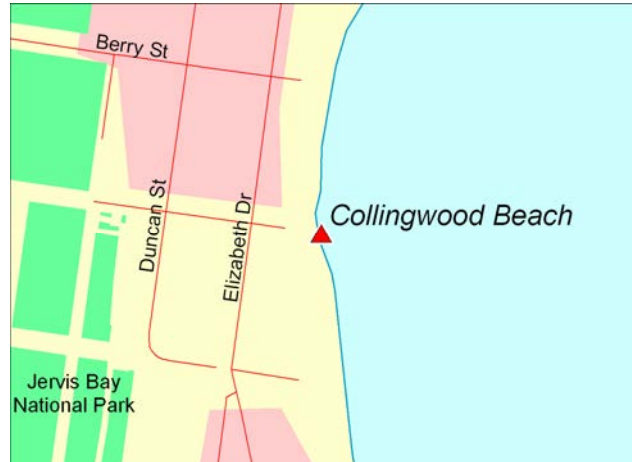
Collingwood Beach is located in Jervis Bay, adjacent to the town of Vincentia. The beach is approximately two kilometres long and faces the entrance to Jervis Bay. Moona Moona Creek discharges at the northern end of the beach. The sampling site is located off Montague Street.

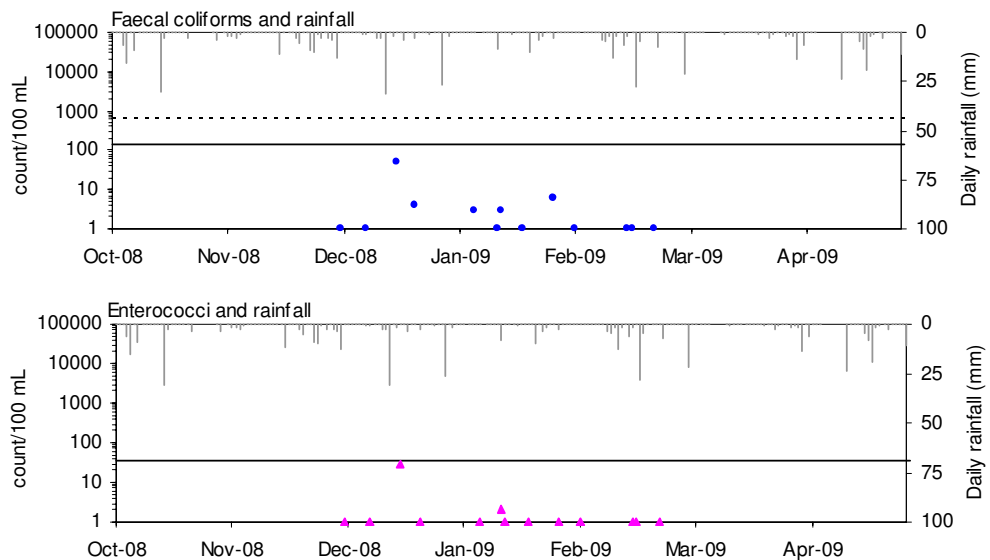
Levels of faecal coliforms and enterococci were generally low over the monitoring period, remaining below the guideline limits.

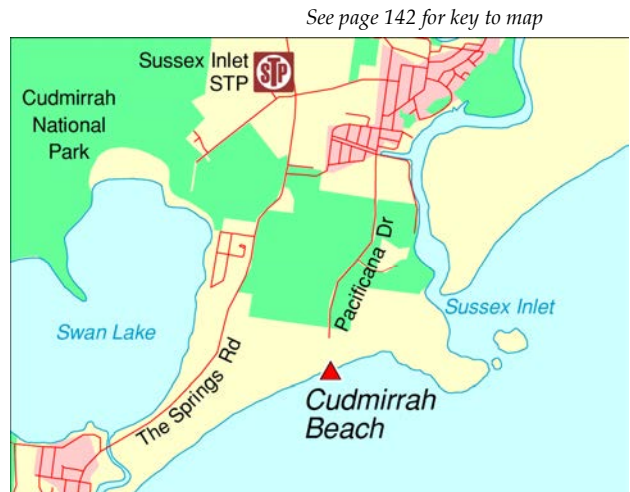
Cudmirrah Beach is the main surf beach for the township of Sussex Inlet. The beach is approximately three kilometres long and extends from the mouth of Sussex Inlet in the north to the mouth of Swan Lake in the south. A surf club and car park are located behind the northern end of the beach. The sampling site is located at the end of Pacificana Drive.

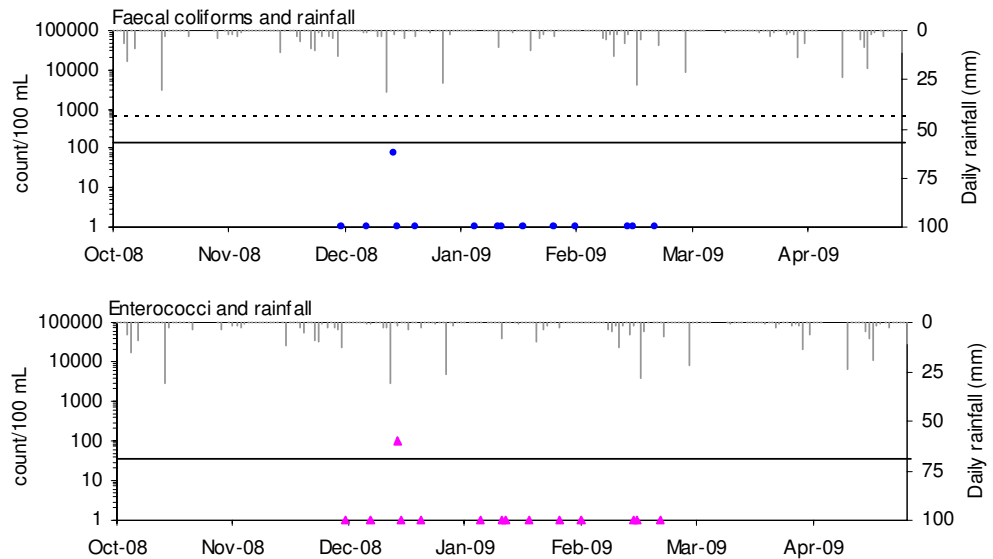
Levels of faecal coliforms and enterococci were generally very low over the monitoring period, with a single, slightly elevated result recorded for both bacterial indicators following heavy rainfall in December 2008.

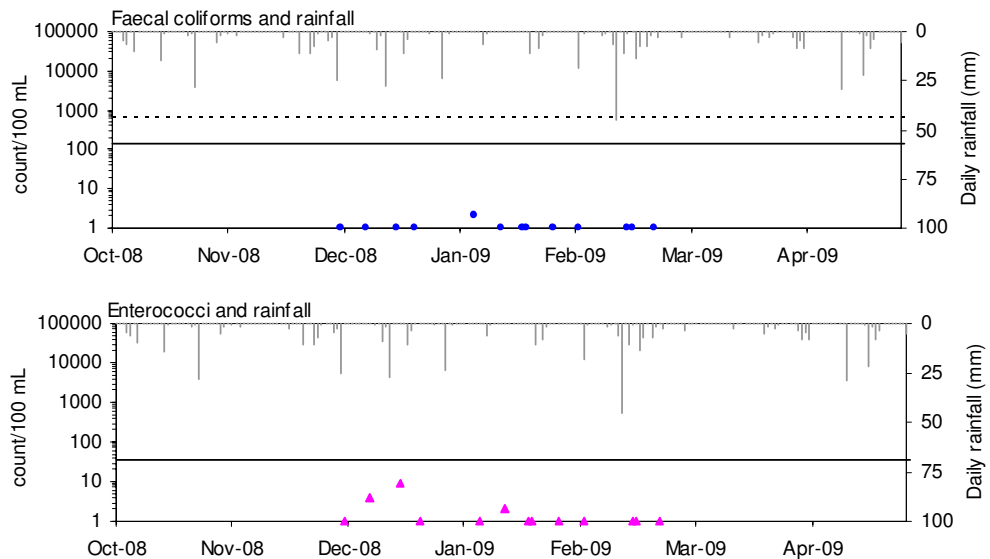
Timeseries plots Levels of faecal coliforms and enterococci were very low over the monitoring period.

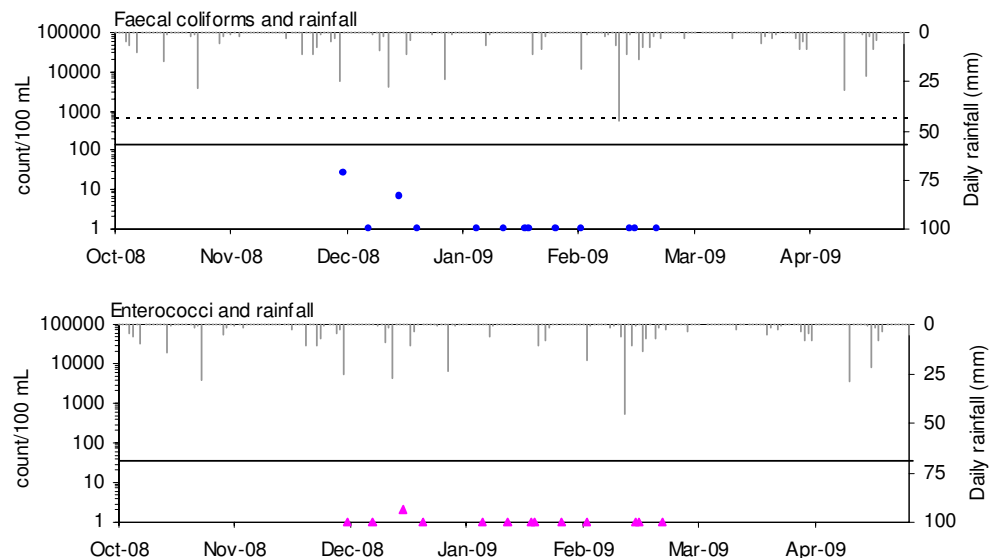
Levels of faecal coliforms and enterococci were generally very low over the monitoring period.

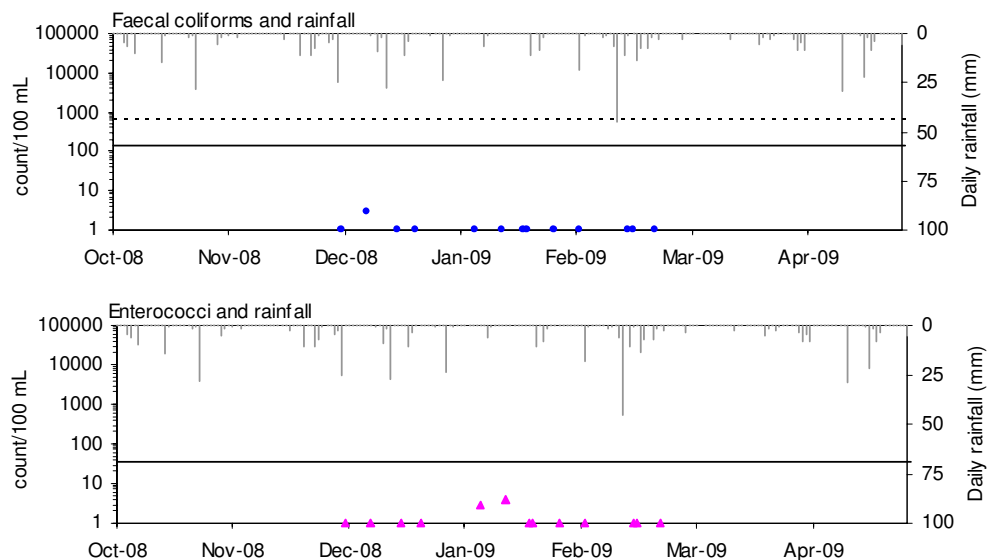
Levels of faecal coliforms and enterococci were consistently low over the monitoring period.
