Wyong Shire Council

Local government area description

Program outline

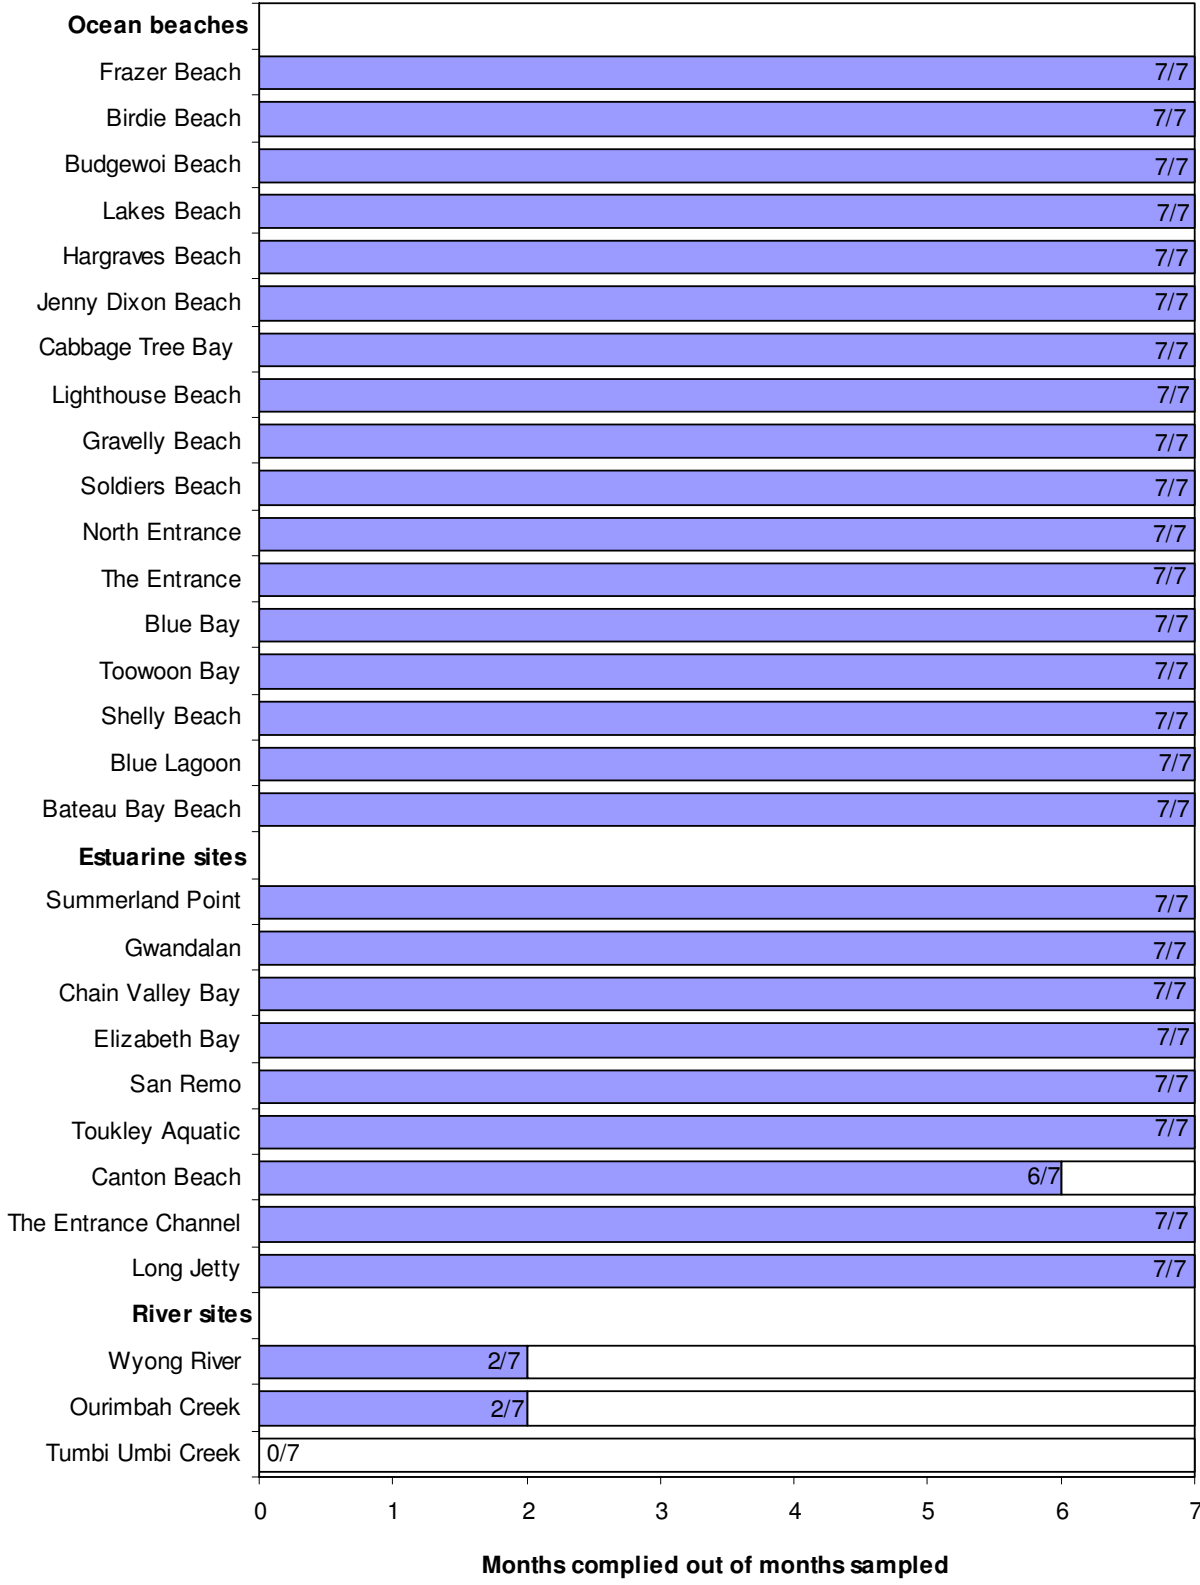
Figure 9: Summary of compliance with NHMRC (1990) microbiological guidelines for swimming at Wyong Shire Council swimming sites over the 2008–2009 summer season

A high level of compliance with NHMRC (1990) swimming water quality guidelines was recorded at the 17 ocean beaches (Figure 9). All beaches were suitable for swimming in all seven months of the 2008–2009 summer swimming season.

The three swimming locations monitored in Lake Macquarie (Summerland Point, Gwandalan and Chain Valley Bay) were suitable for swimming in all seven months of the 2008–2009 summer swimming season (Figure 9).

Long Jetty and The Entrance Channel complied with the NHMRC (1990) swimming water quality guidelines in all seven months of the 2008–2009 summer swimming season (Figure 9). A high level of compliance was also recorded at Canton Beach, which complied six of the seven months. The site failed the guidelines in March 2009.

Very low levels of compliance with the NHMRC (1990) swimming water quality guidelines were recorded at all three locations. Ourimbah Creek and Wyong River failed the guidelines in five of the seven months of the 2008–2009 summer swimming season, and Tumbi Umbi Creek failed the guidelines in all seven months (Figure 9).

The two swimming locations monitored in Lake Budgewoi were San Remo in the north and Toukley Aquatic in the south. Both sites complied with NHMRC (1990) swimming water quality guidelines in all seven months of the 2008–2009 summer swimming season (Figure 9).

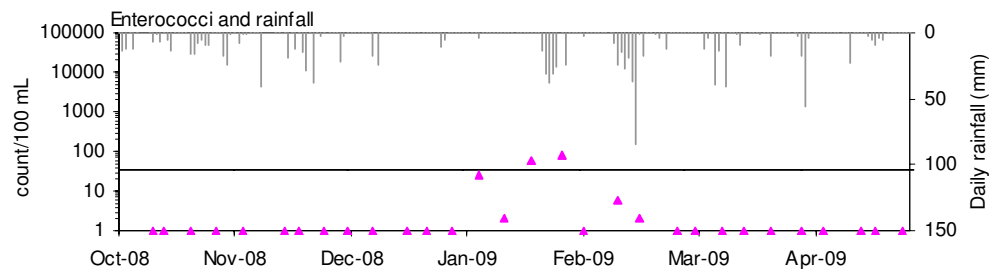
See page 5 for key to graph

Levels of enterococci generally remained low throughout the monitoring period, just exceeding the geometric mean guideline limit on two occasions.

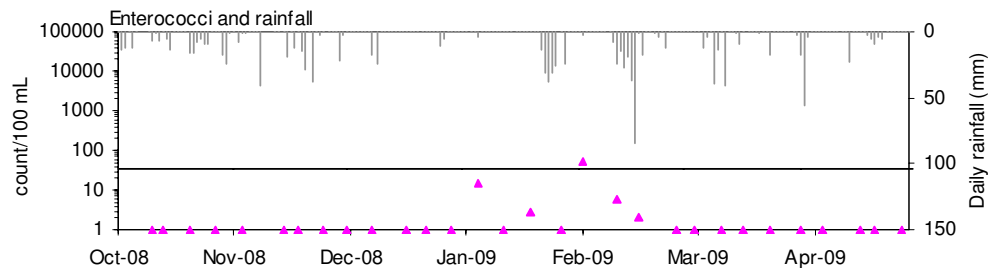
See page 5 for key to graph

Levels of enterococci remained low throughout the monitoring period, just exceeding the geometric mean guideline limit on one occasion.

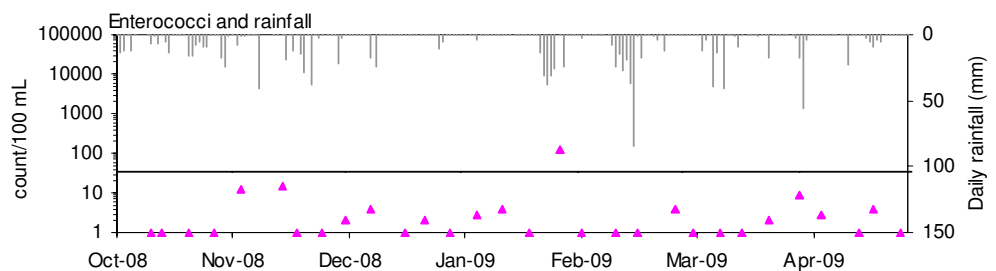
See page 5 for key to graph

Levels of enterococci remained low throughout the monitoring period, just exceeding the geometric mean guideline limit on one occasion in response to rainfall.

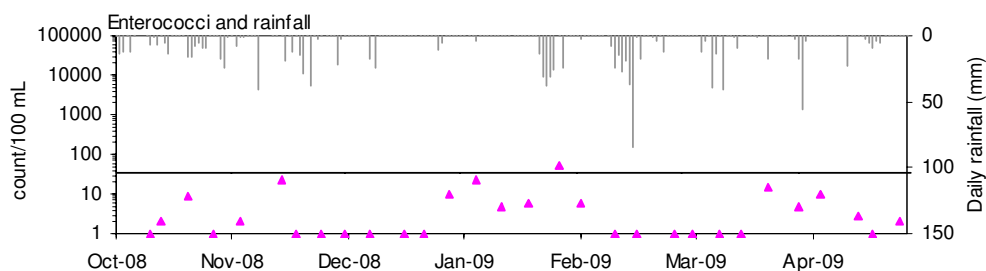
See page 5 for key to graph

Levels of enterococci were generally low throughout the monitoring period, just exceeding the geometric mean guideline limit on one occasion in response to rainfall.

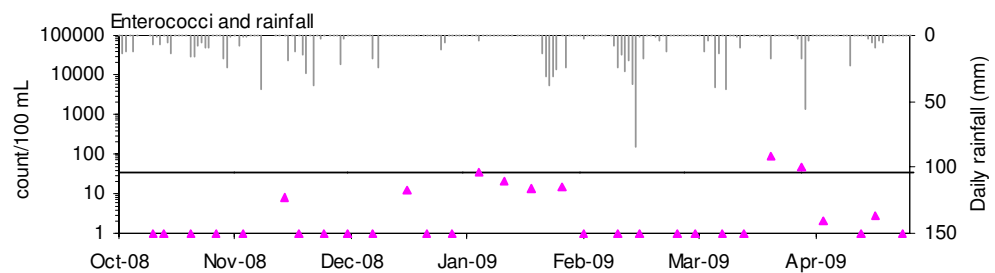
See page 5 for key to graph

Enterococci levels generally remained low throughout the monitoring period, just exceeding the geometric mean guideline limit on two occasions in response to rainfall.

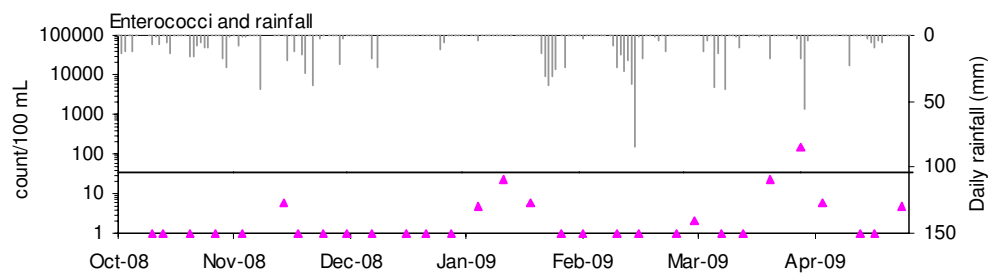
See page 5 for key to graph

Timeseries plots Enterococci levels generally remained very low throughout the monitoring period, just exceeding the geometric mean guideline limit on one occasion in response to rainfall.

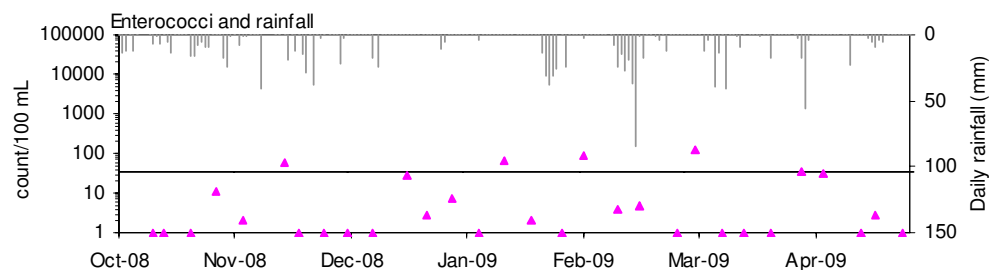
See page 5 for key to graph

Enterococci levels were generally low throughout the monitoring period. Several results just exceeded the geometric mean guideline during dry and wet weather conditions.

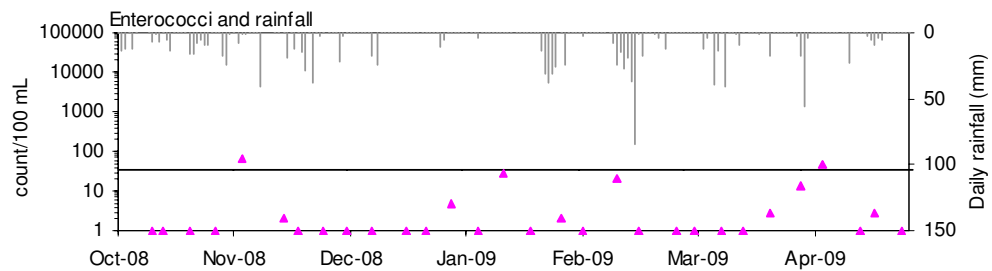
See page 5 for key to graph

Timeseries plots Levels of enterococci were generally very low throughout the monitoring period, just exceeding the geometric mean guideline on two occasions.

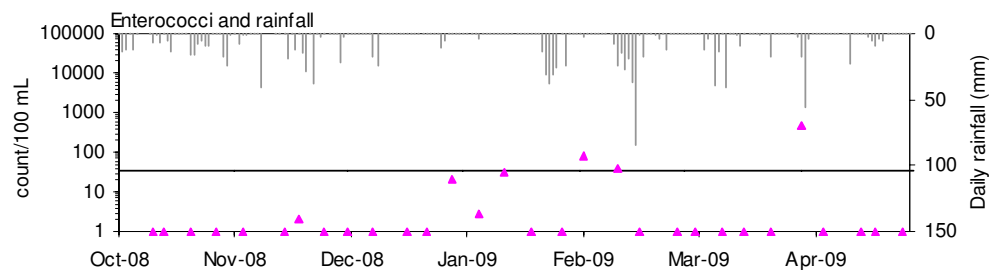
See page 5 for key to graph

Levels of enterococci were generally low throughout the monitoring period. A single very high result was recorded in early April 2009 in response to heavy rainfall.

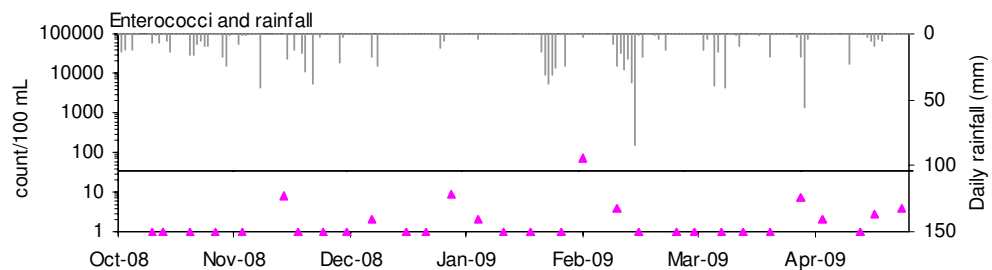
See page 5 for key to graph

Levels of enterococci were generally low throughout the monitoring period, with a single slightly elevated result exceeding the geometric mean guideline.

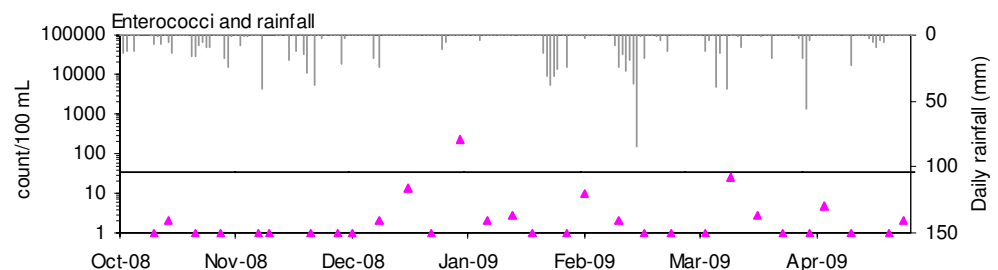
See page 5 for key to graph

Levels of enterococci were generally low throughout the monitoring period, with a single elevated result exceeding the geometric mean guideline.

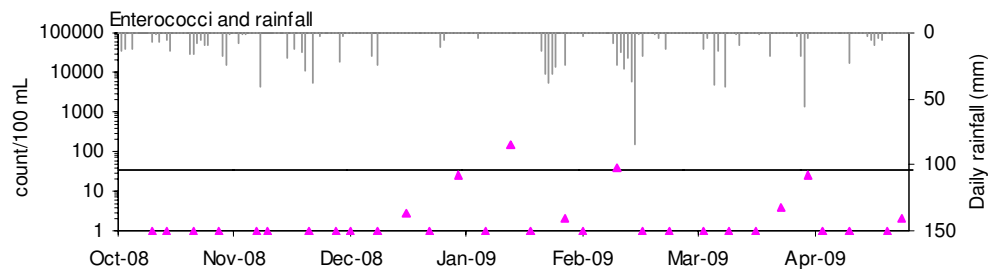
See page 5 for key to graph

Timeseries plots Levels of enterococci were generally low throughout the monitoring period, with a single slightly elevated result exceeding the geometric mean guideline.

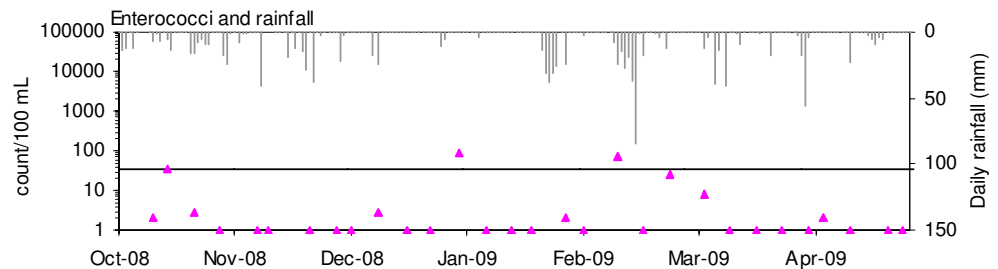
See page 5 for key to graph

Levels of enterococci remained generally low over the monitoring period, just exceeding the geometric mean guideline on two occasions.

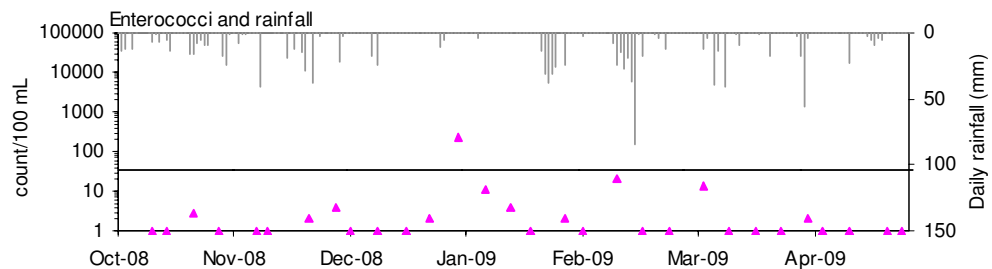
See page 5 for key to graph

Timeseries plots Levels of enterococci remained generally low over the monitoring period, just exceeding the geometric mean guideline on one occasion.

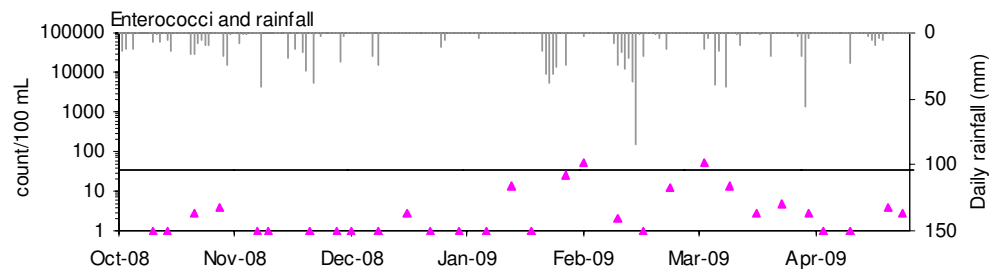
See page 5 for key to graph

Levels of enterococci remained generally low over the monitoring period, just exceeding the geometric mean guideline on two occasions.

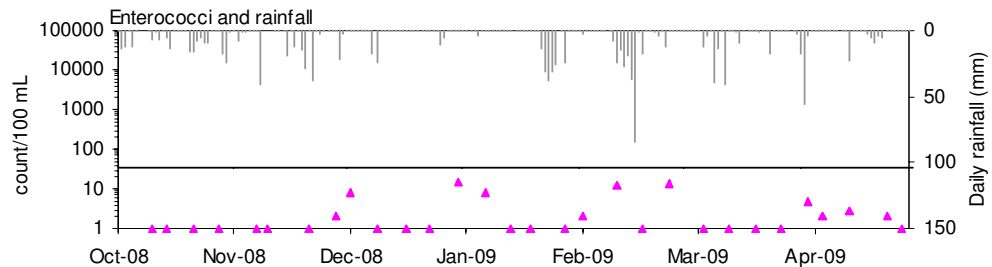
See page 5 for key to graph

Timeseries plots Levels of enterococci remained low over the monitoring period.

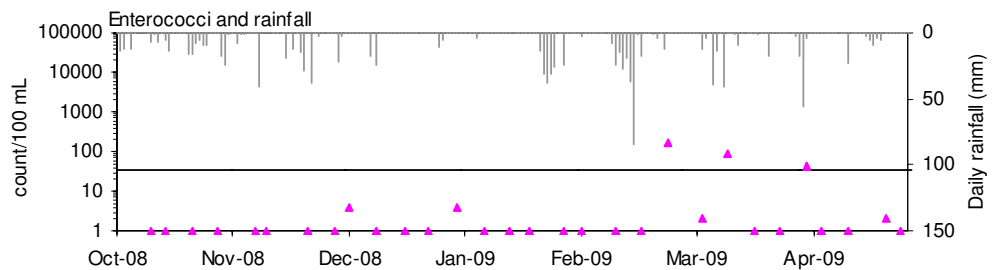
See page 5 for key to graph

Levels of enterococci remained generally low over the monitoring period, just exceeding the geometric mean guideline on three occasions in response to rainfall.

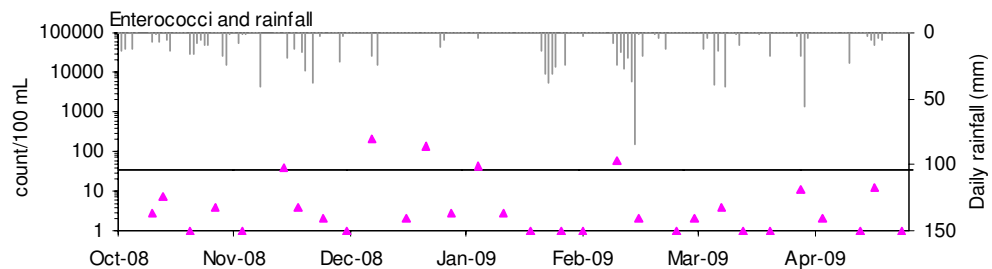
See page 5 for key to graph

Timeseries plots Levels of enterococci remained low over most of the monitoring period, just exceeding the geometric mean guideline on a number of occasions.

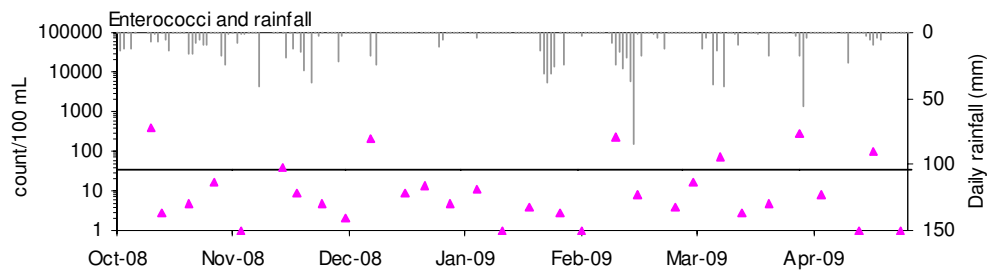
See page 5 for key to graph

Levels of enterococci were generally low throughout the monitoring period, with elevated levels recorded on a number of occasions in response to rainfall.

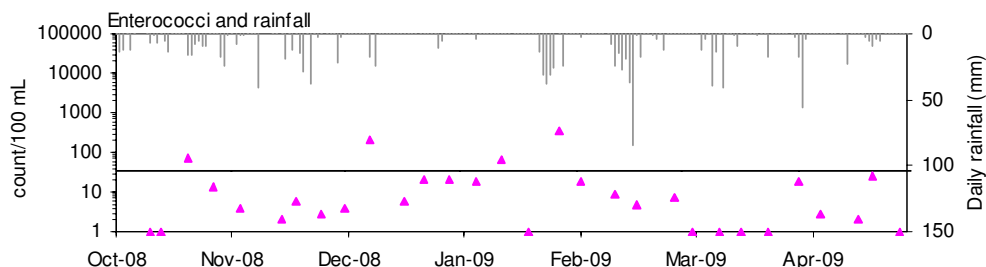
See page 5 for key to graph

Levels of enterococci were generally low throughout the monitoring period, with elevated levels recorded on a number of occasions in response to rainfall.

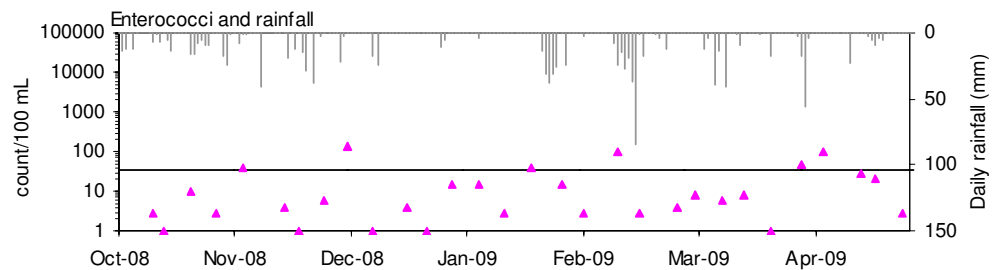
See page 5 for key to graph

Levels of enterococci were mostly low throughout the monitoring period. Levels exceeded the geometric mean guideline on a number of occasions, generally in response to rainfall.

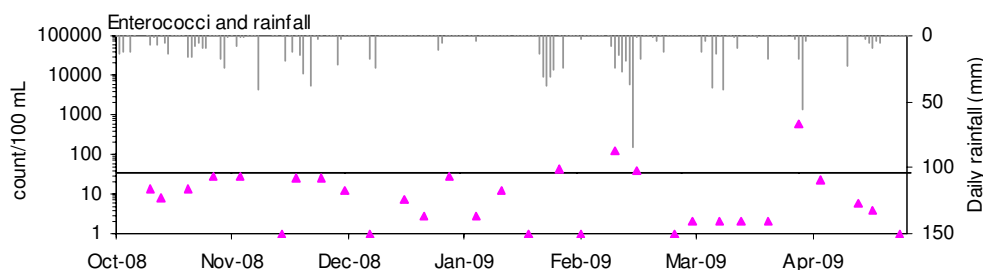
See page 5 for key to graph

Timeseries plots Enterococci levels generally remained generally low throughout the monitoring period, occasionally exceeding the geometric mean guideline limit in response to heavy rainfall.

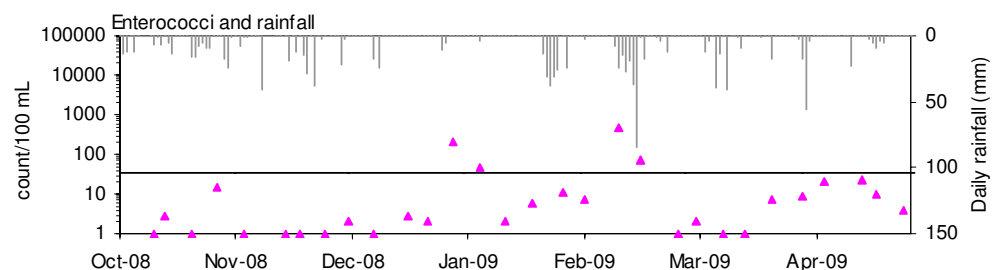
See page 5 for key to graph

Levels of enterococci were generally low throughout the monitoring period, exceeding the geometric mean guideline limit on four occasions.

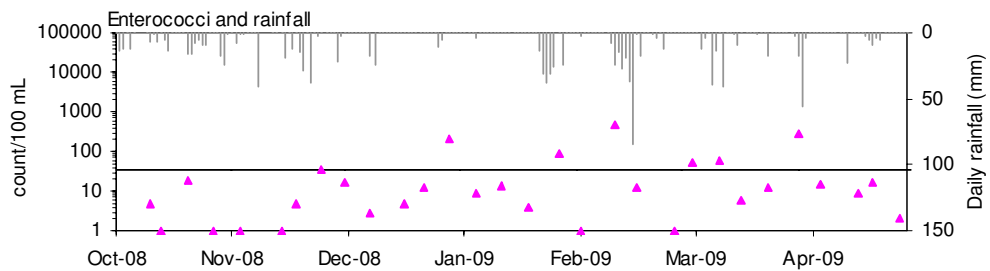
See page 5 for key to graph

Timeseries plots Levels of enterococci mostly remained below the geometric mean guideline limit throughout the monitoring period. Elevated levels were recorded on several occasions, generally in response to rainfall.

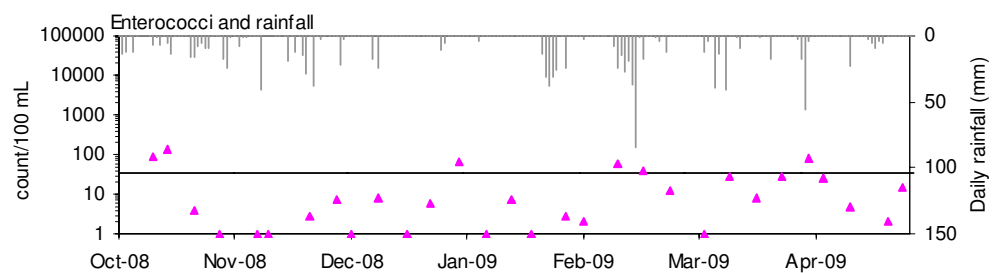
See page 5 for key to graph

Levels of enterococci were mostly below the geometric mean guideline limit throughout the monitoring period, with slightly elevated results recorded on a number of occasions, generally in response to rainfall.

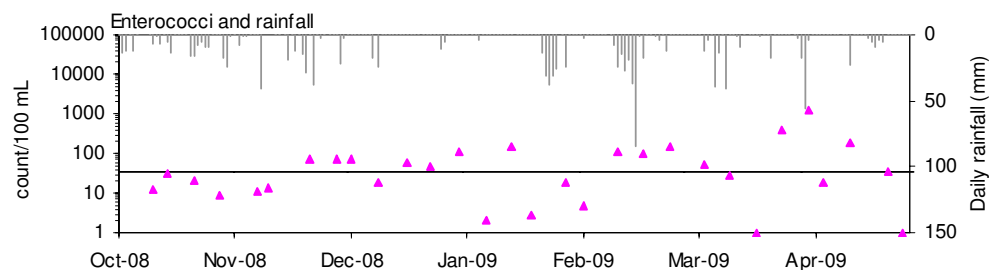
See page 5 for key to graph

Enterococci levels exceeded the geometric mean guideline level throughout much of the monitoring period, indicating that the site is affected by faecal contamination in dry and wet weather conditions.

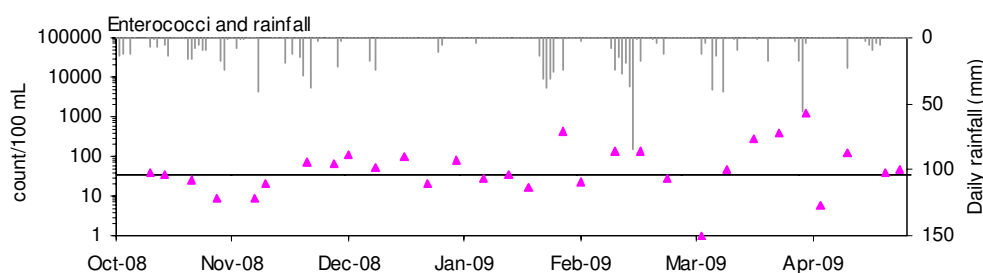
See page 5 for key to graph

Enterococci levels exceeded the geometric mean guideline level throughout much of the monitoring period, indicating that the site is affected by faecal contamination in dry and wet weather conditions.

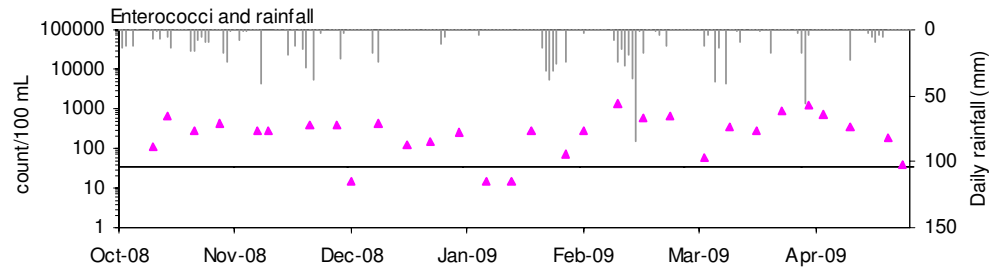
See page 5 for key to graph

High levels of bacteria were measured throughout the monitoring period, indicating that the site is affected by faecal contamination in dry and wet weather conditions.
