State of the beaches 2019–2020

Hunter region

Beachwatch

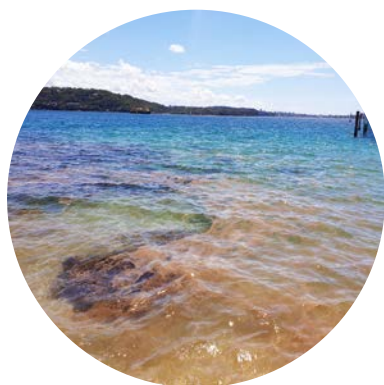
Marine algal bloom present in the water
Photo: Chad Weston/NPWS, DPIE

The appearance of **marine algae** is sometimes mistaken for **sewage contamination** or **oil slicks**, due to a strong odour and red or brown discolouration in the water caused by the blooms.

As a precaution, direct contact with algae should be avoided as it can cause skin and eye irritations. The marine algal blooms dissipated with changes in tide and wind conditions.

Water NSW reported an occurrence of marine algal bloom at Hunter beaches in 2019–2020. An algal bloom of the genus *Trichodesmium* was reported at some Newcastle ocean beaches in February 2020. Marine algae advisories were issued on the Beachwatch and Water NSW websites.

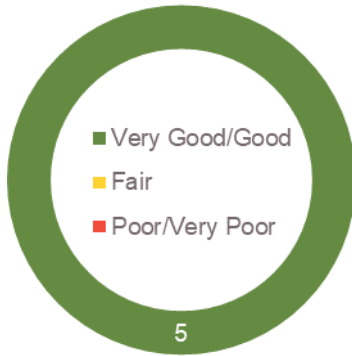
Beach Suitability Grades for Port Stephens Council ocean beaches

All five ocean beaches were graded as Very Good in 2019–2020: Zenith Beach, Box Beach, Fingal Beach, One Mile Beach and Birubi Beach. Water quality at these sites was suitable for swimming almost all of the time.

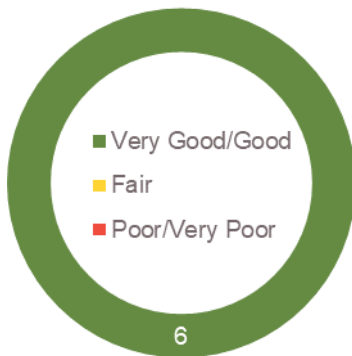
Beach Suitability Grades for Port Stephens Council estuarine beaches

All six estuarine beaches in Port Stephens were graded as Good: Little Beach, Dutchmans Beach, Bagnalls Beach, Georges Reserve, Lemon Tree Passage Tidal Pool and Karuah Tidal Pool. Water quality at these sites is mostly suitable for swimming during dry weather conditions but may be susceptible to pollution for up to three days after rainfall.

Bagnalls Beach improved to Good from a Poor grade in 2018–2019. While microbial water quality at this site has improved over the past five years, it remains close to the threshold between Good and Poor grades. Enterococci levels often exceeded the safe swimming limit in dry weather conditions and after low levels of rainfall. Swimming should be avoided at this site during and for at least three days following rainfall, or if signs of pollution are present such as discoloured water or flowing stormwater drains.

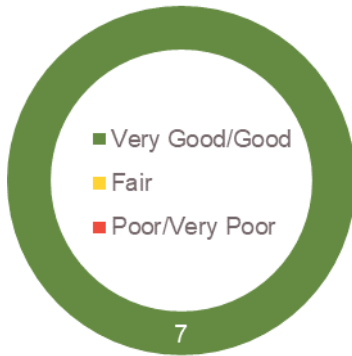
Beach Suitability Grades for City of Newcastle Council ocean beaches

All seven ocean beaches were graded as Very Good: South Stockton Beach, Nobbys Beach, Newcastle Beach, Bar Beach, Merewether Beach, Burwood North Beach and Burwood South Beach. Water quality at these sites has been consistently excellent for many years and is suitable for swimming almost all of the time.

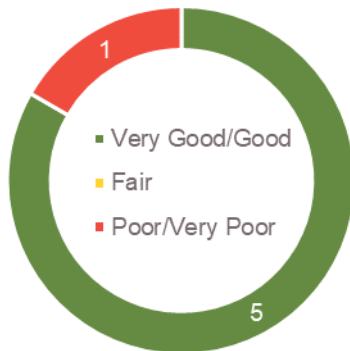
Beach Suitability Grades for Lake Macquarie City Council ocean beaches

Five of the six ocean beaches were graded as Very Good in 2019–2020: Glenrock Lagoon Beach, Dudley Beach, Redhead Beach, Blacksmiths Beach and Caves Beach. The water quality at these beaches is suitable for swimming almost all of the time.

Swansea Heads Little Beach was graded Poor, a decline from Good in the previous year. Microbial water quality has declined over recent years and crossed the threshold between Good and Poor. The decline in water quality reflects a slightly higher proportion of samples collected during wet weather compared to the 2018–2019 assessment period. Enterococci levels occasionally exceeded the safe swimming limit in dry weather conditions and often following light rainfall.

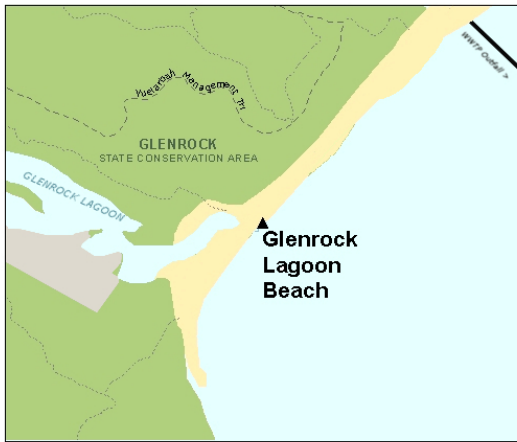
Glenrock Lagoon Beach is 300 metres long and is located at the southern end of Burwood Beach. The beach is not patrolled by lifeguards.

The Beach Suitability Grade of Very Good indicates microbial water quality is considered suitable for swimming almost all of the time with few potential sources of faecal contamination.

Although water quality was of a high standard at Glenrock Lagoon Beach, a health risk assessment completed by Hunter Water in 2010 indicated there was a small risk that the effluent plume from Burwood Beach WWTP could be driven back to the coast under certain combinations of wind and current. In March 2017 Hunter Water upgraded the WWTP with a UV disinfection system, at a cost of \$13 million, to address the small health risk identified in the study. Since its commissioning, monitoring of the UV system has shown a reduction in pathogen concentrations in the effluent, meeting EPA requirements. The risk from the WWTP has been lowered in the sanitary inspection for Glenrock Lagoon Beach as a result of the upgrade.

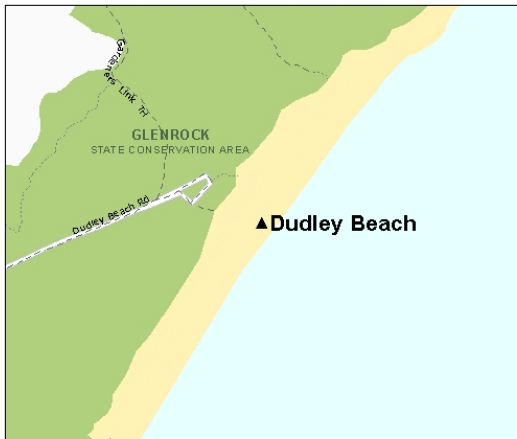
Dudley Beach is one kilometre long and is not patrolled by lifeguards.

The Beach Suitability Grade of Very Good indicates microbial water quality is considered safe for swimming almost all of the time, with few potential sources of faecal contamination.

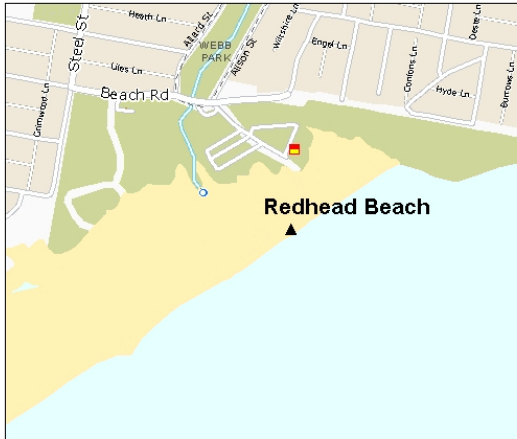
Redhead Beach is located at the northern end of a 10 kilometre stretch of beach and is patrolled between September and April.

The Beach Suitability Grade of Very Good indicates microbial water quality is considered suitable for swimming almost all of the time, with few potential sources of faecal contamination.

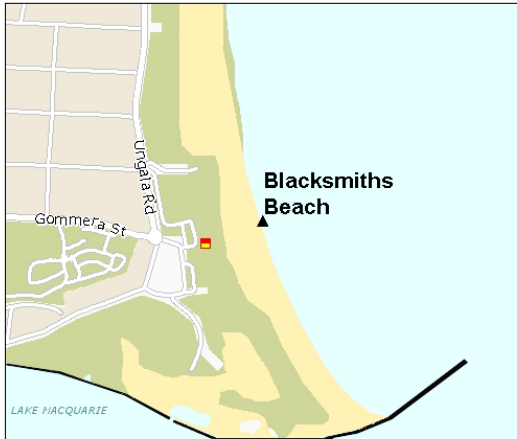
Blacksmiths Beach is at the southern end of a 10 kilometre stretch of beach and is patrolled between September and April.

The Beach Suitability Grade of Very Good indicates microbial water quality is considered suitable for swimming almost all of the time, with few potential sources of faecal contamination.
