Illawarra region

The programs

The Beachwatch Program was extended to the Illawarra region in 1996. The program currently covers 19 ocean beaches and one lagoon site (Table 23).

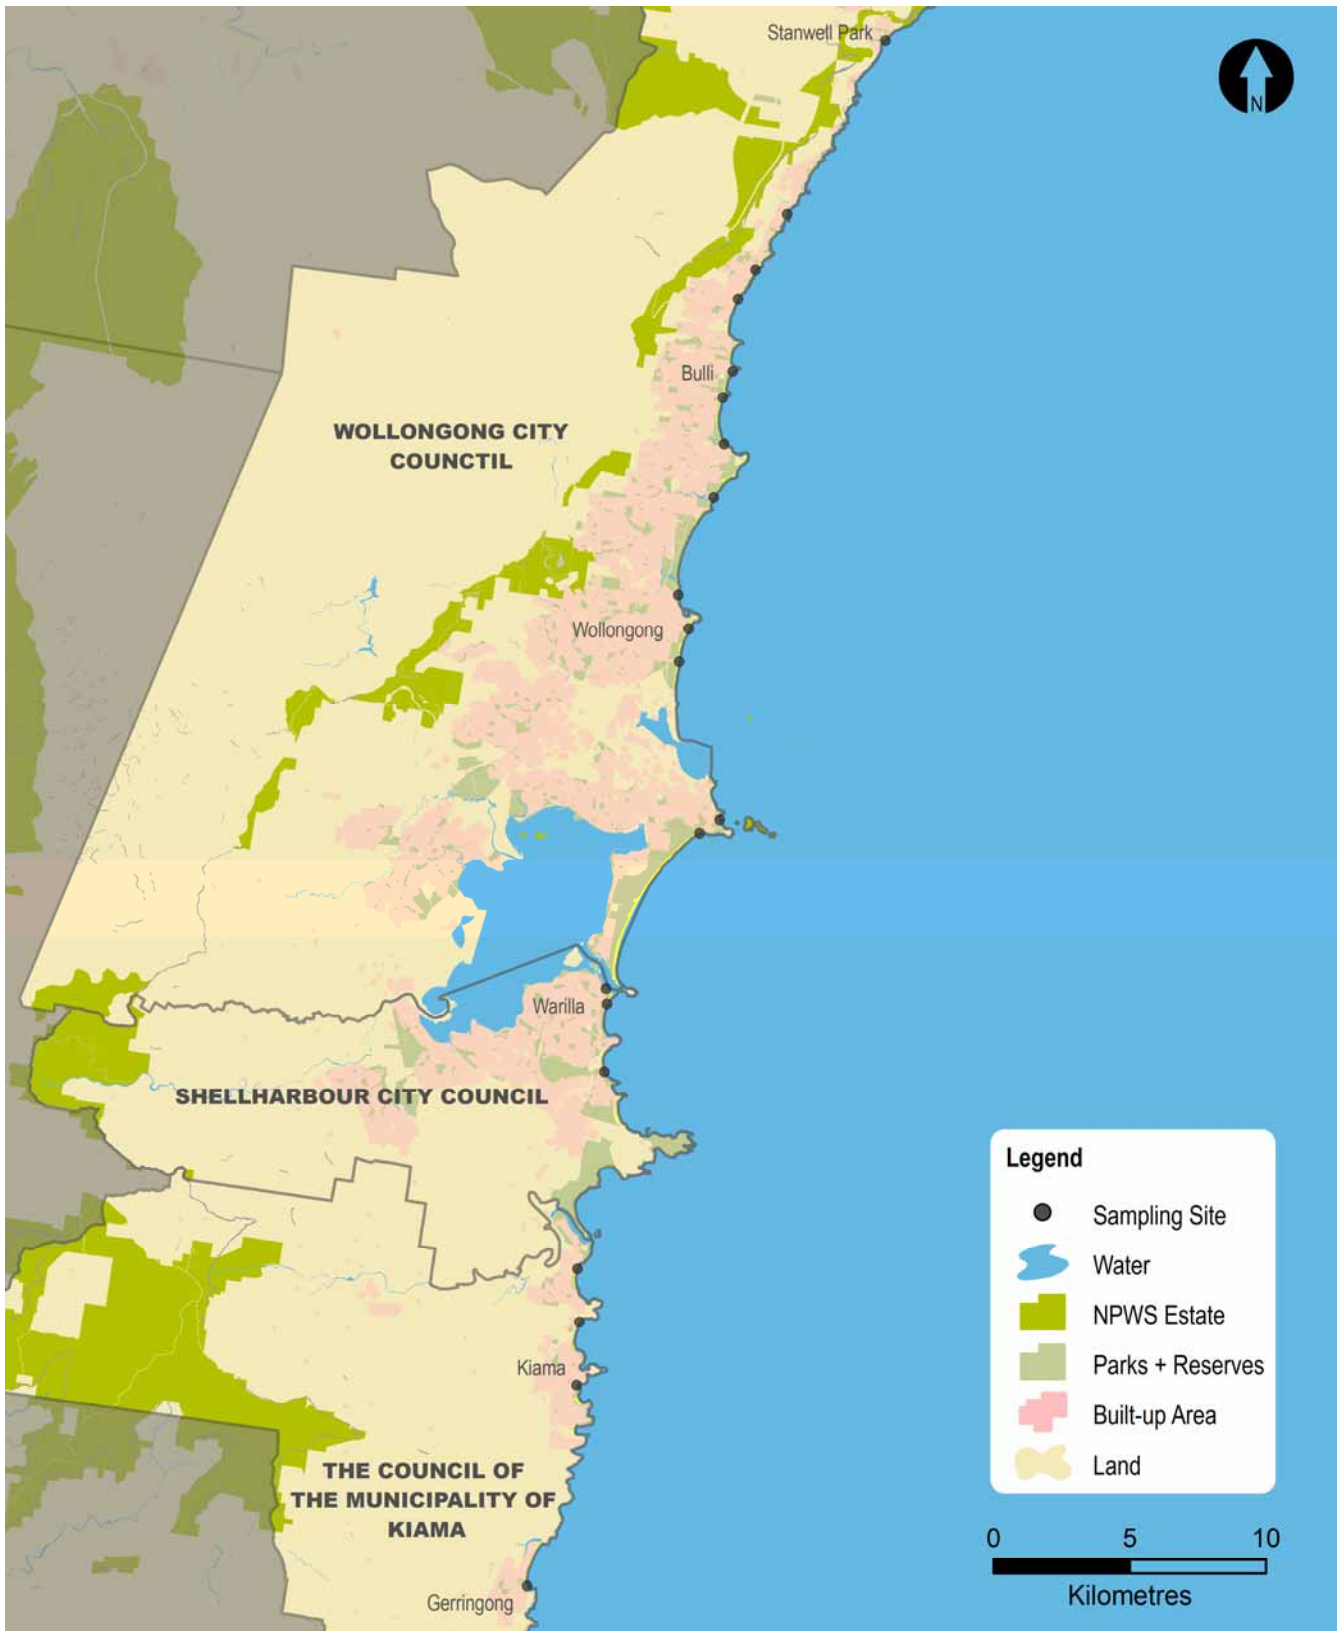
Figure 31: Councils and sampling locations in the Illawarra region

The Illawarra region of New South Wales extends from the southern border of the Royal National Park to Gerroa. Swimming locations are monitored in all three local council areas (Figure 30):

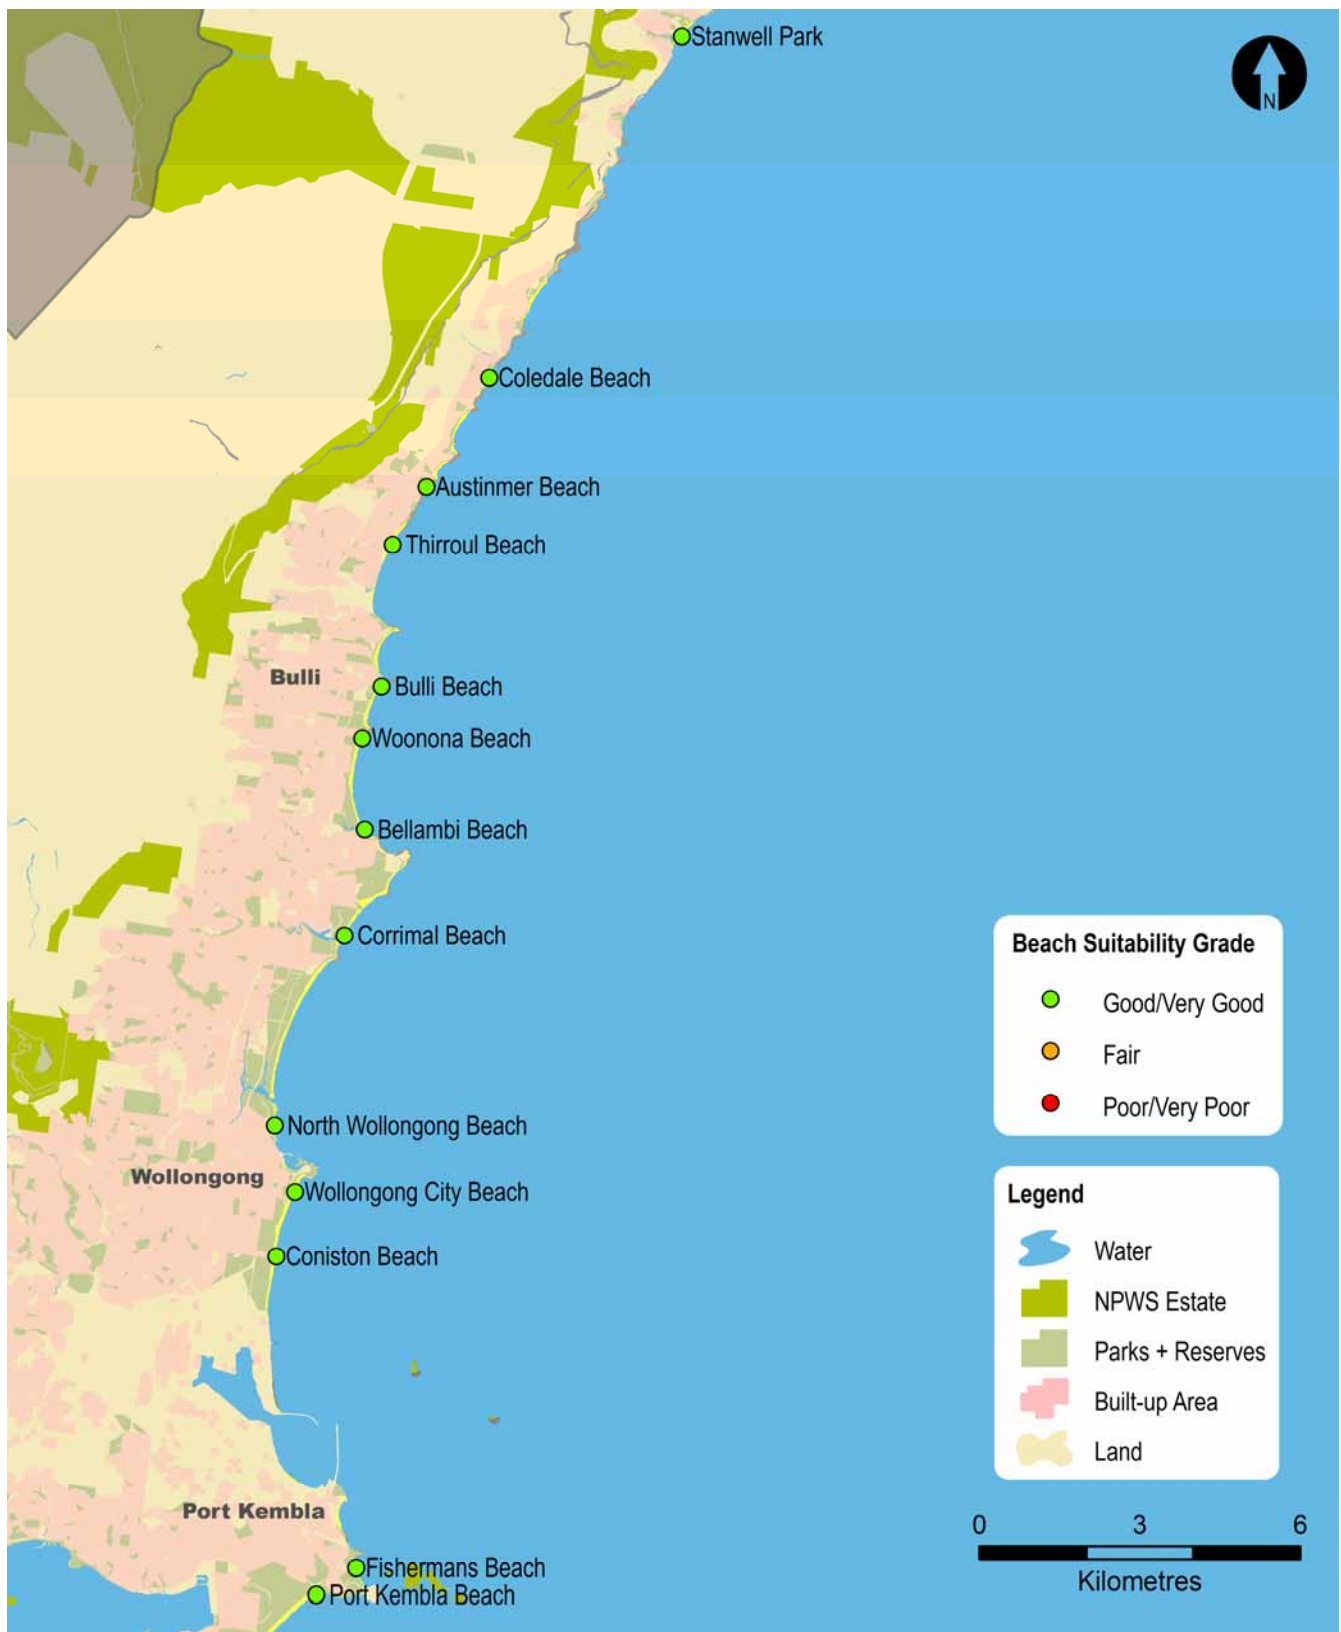
Figure 31: Sampling locations and Beach Suitability Grades in the Wollongong City Council area

All 13 ocean beaches monitored in the Wollongong City Council area were graded as Good or Very Good during 2010–2011 (Figure 31).

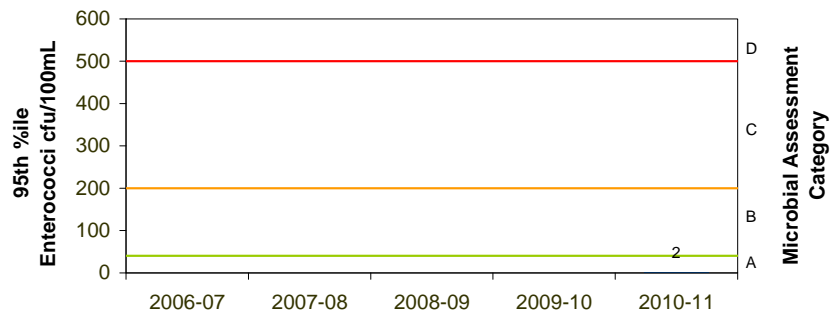
Microbial Assessment: **A**

Monitoring period for 2010–11 result is February 2011 to April 2011.

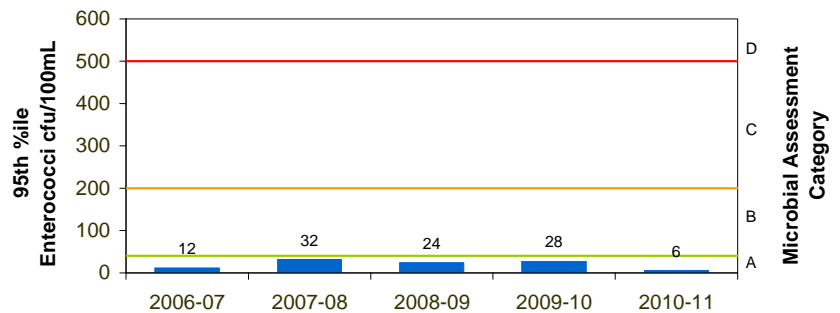
Microbial Assessment: **A**

Monitoring period for 2010–11 result is November 2008 to April 2011.
