# North Coast region

# Kempsey Shire Council

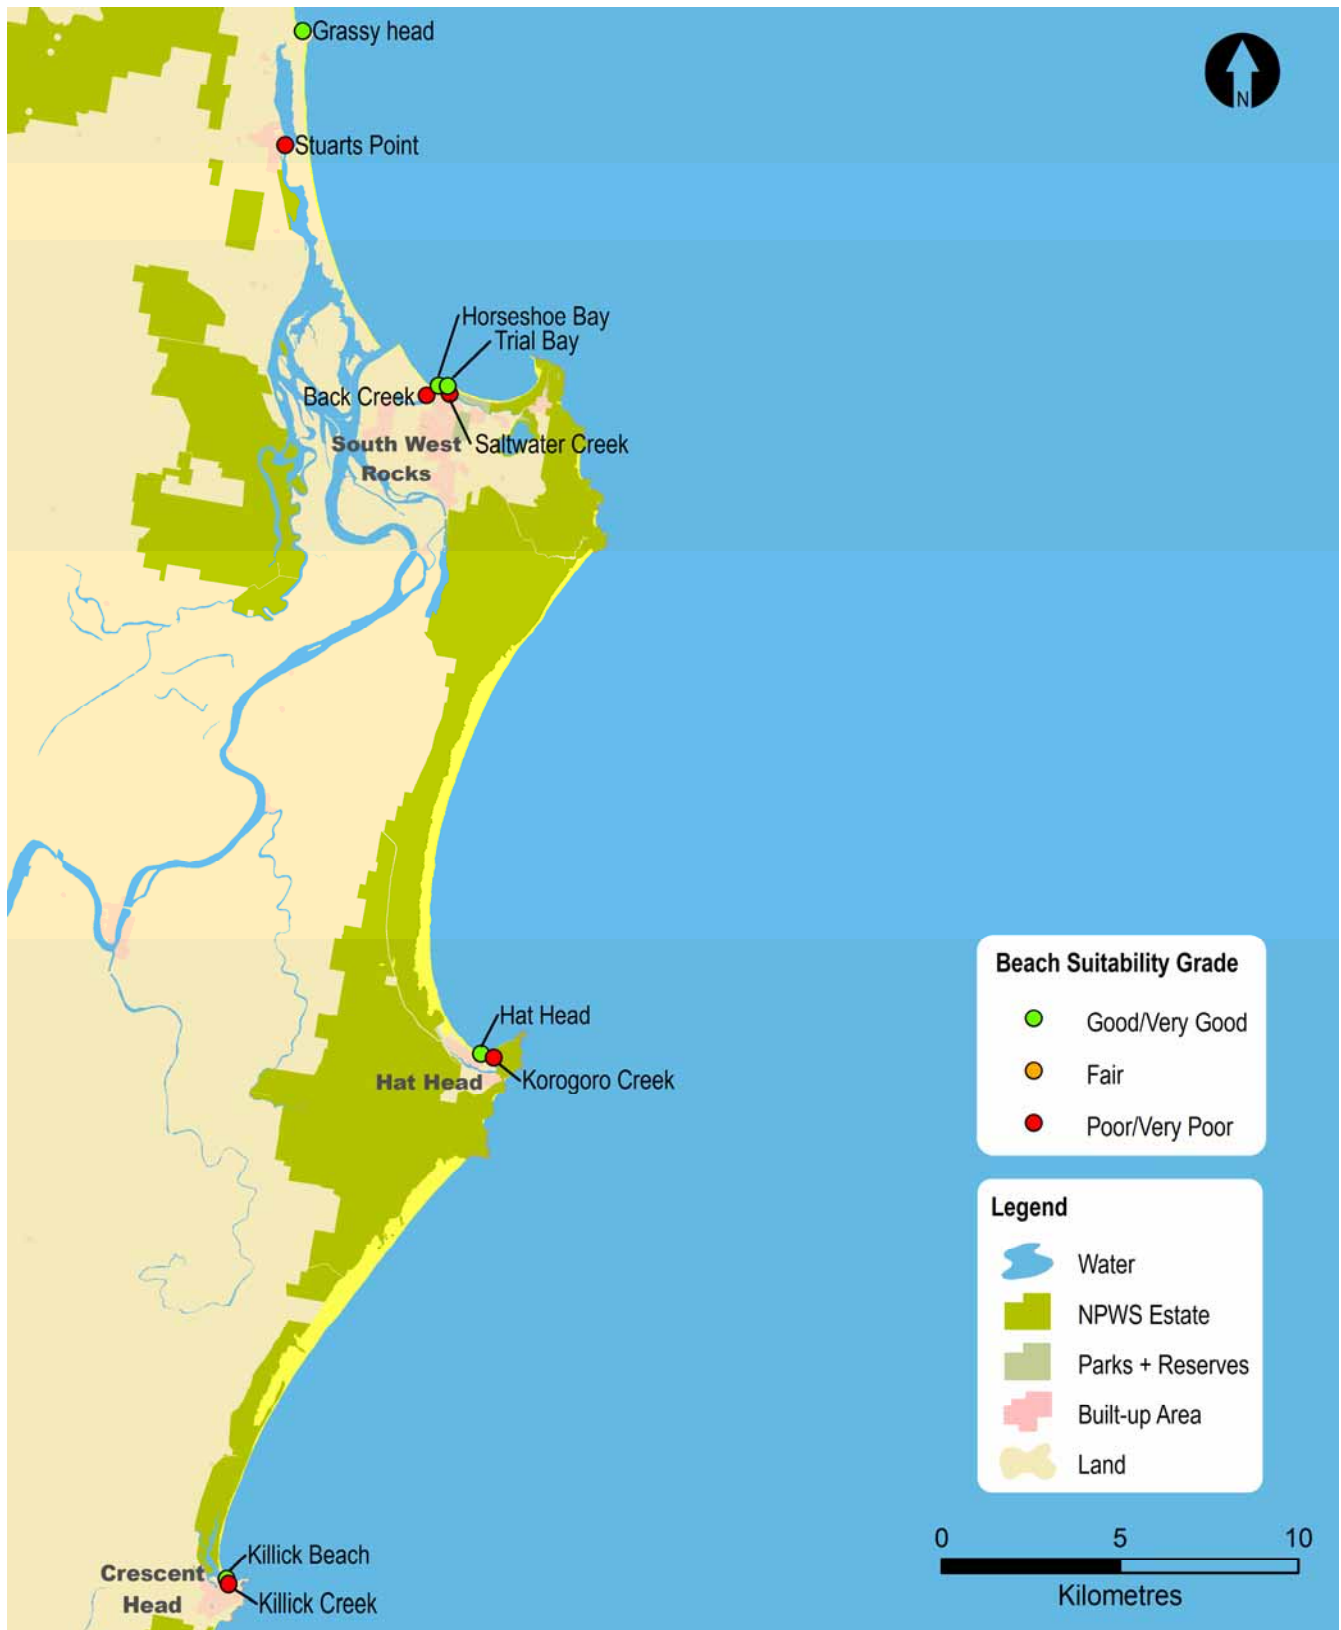
Figure 12: Sampling locations and Beach Suitability Grades in the Kempsey Shire Council area

Five of the ten swimming locations monitored in Kempsey Shire Council area were graded as Very Good or Good during 2010–2011 (Figure 13).
