## Beachwatch

# State of the beaches 2023–24

Illawarra region

Department of Climate Change,  
Energy, the Environment and Water

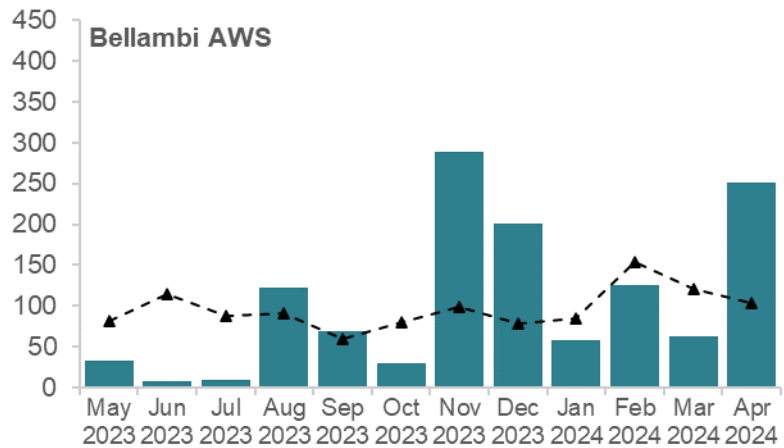
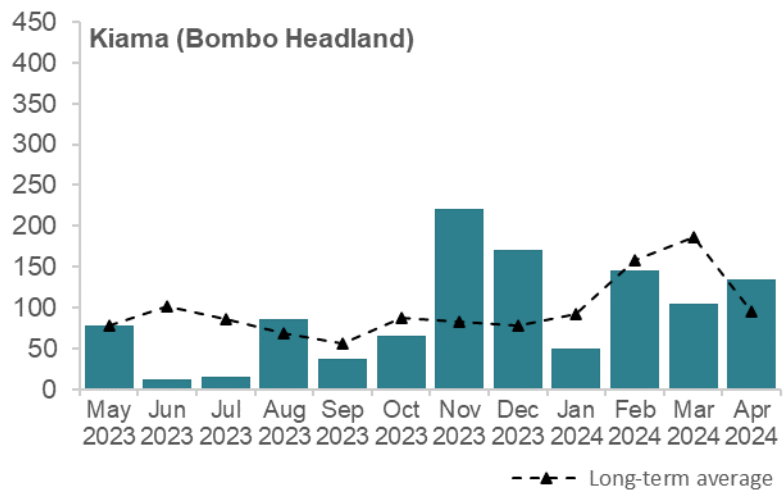
### Illawarra region rainfall

Rainfall on the Illawarra Coast was mostly average to below average for the 2023–2024 reporting year, except for some isolated wet months. Well above average rainfall fell in November and December 2023 and April 2024 across the region.

November and December 2023 were notably wet. Bellambi recorded its highest November daily rainfall of 154.8 mm on 5 November, its record highest November total rainfall of 289.2 mm, and its record highest December total rainfall of 200.8 mm. Similarly, Bellambi recorded its highest April daily rainfall of 194.8 mm on 6 April.

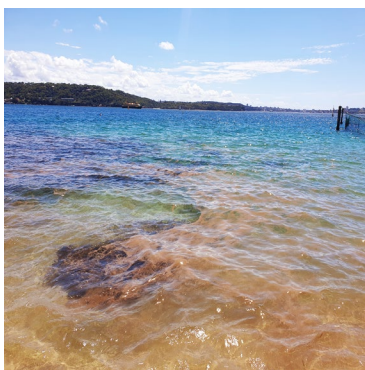
Marine algal bloom present in the water

Water NSW reported a caution alert for a marine algae bloom, *Trichodesmium* sp., in December 2023 at Belmore Basin in Wollongong. Marine algae advisories were issued on the Water NSW website.

The appearance of **marine algae** is sometimes mistaken for **sewage contamination** or **oil slicks**, due to a strong odour and red or brown discolouration in the water caused by the blooms.

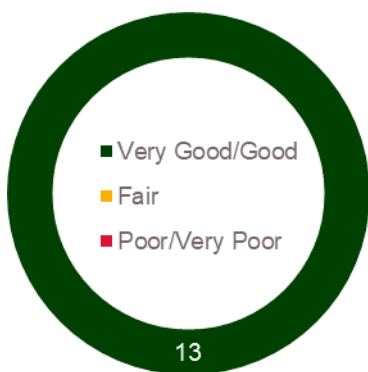
**Beach Suitability Grades for Wollongong City Council ocean beaches**

All 13 ocean beaches continued to be graded as Very Good or Good in 2023–2024.

Seven beaches were graded as Very Good: Stanwell Park Beach, Coledale Beach, Austinmer Beach, Woonona Beach, Coniston Beach, Wollongong City Beach and Fishermans Beach. Water quality at these beaches is suitable for swimming almost all of the time. Coniston Beach improved to Very Good from Good in the previous year due to improved microbial water quality.

Thirroul Beach, Bulli Beach, Bellambi Beach, Corrimal Beach, North Wollongong Beach and Port Kembla Beach continued to be graded as Good in 2023–2024. Water quality at these sites was frequently suitable for swimming during dry weather conditions. However, enterococci levels generally increased with increasing rainfall, often exceeding the safe swimming limit after moderate to heavy rainfall.

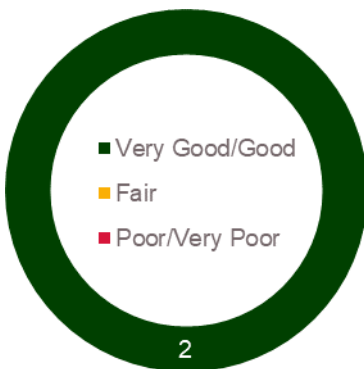
Beach Suitability Grades for Shellharbour City Council ocean beaches

Warilla Beach and Shellharbour Beach were graded as Very Good in 2023–2024. These sites had excellent water quality and were suitable for swimming almost all of the time. Warilla Beach was upgraded to Very Good from Good due to improved microbial water quality.

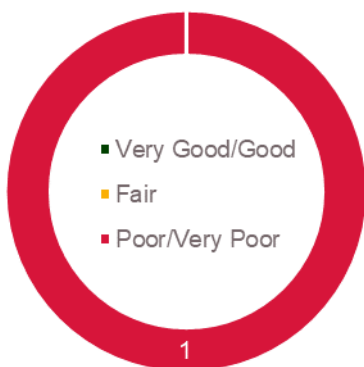
Beach Suitability Grades for Shellharbour City Council lake/lagoon swimming sites

Entrance Lagoon Beach continued to be graded as Poor in 2023–2024, consistent with the previous year. Water quality at this site was mostly suitable for swimming during dry weather conditions, with 79% of dry weather samples within the safe swimming limit when there had been no rain in the previous 24 hours. Enterococci levels increased with increasing rainfall and were often recorded after light rain.
