#### **RE: DEVELOPMENT APPLICATION CP17-004**

# RESPONSES TO QUESTIONS BY NSW COASTAL PANEL DATED 26/4/17 Ref DOC17/237550

# Belongil Seawall Repairs 28, 28A CHILDE STREET AND 8 THE ESPLANADE

# DRAWING REGISTER

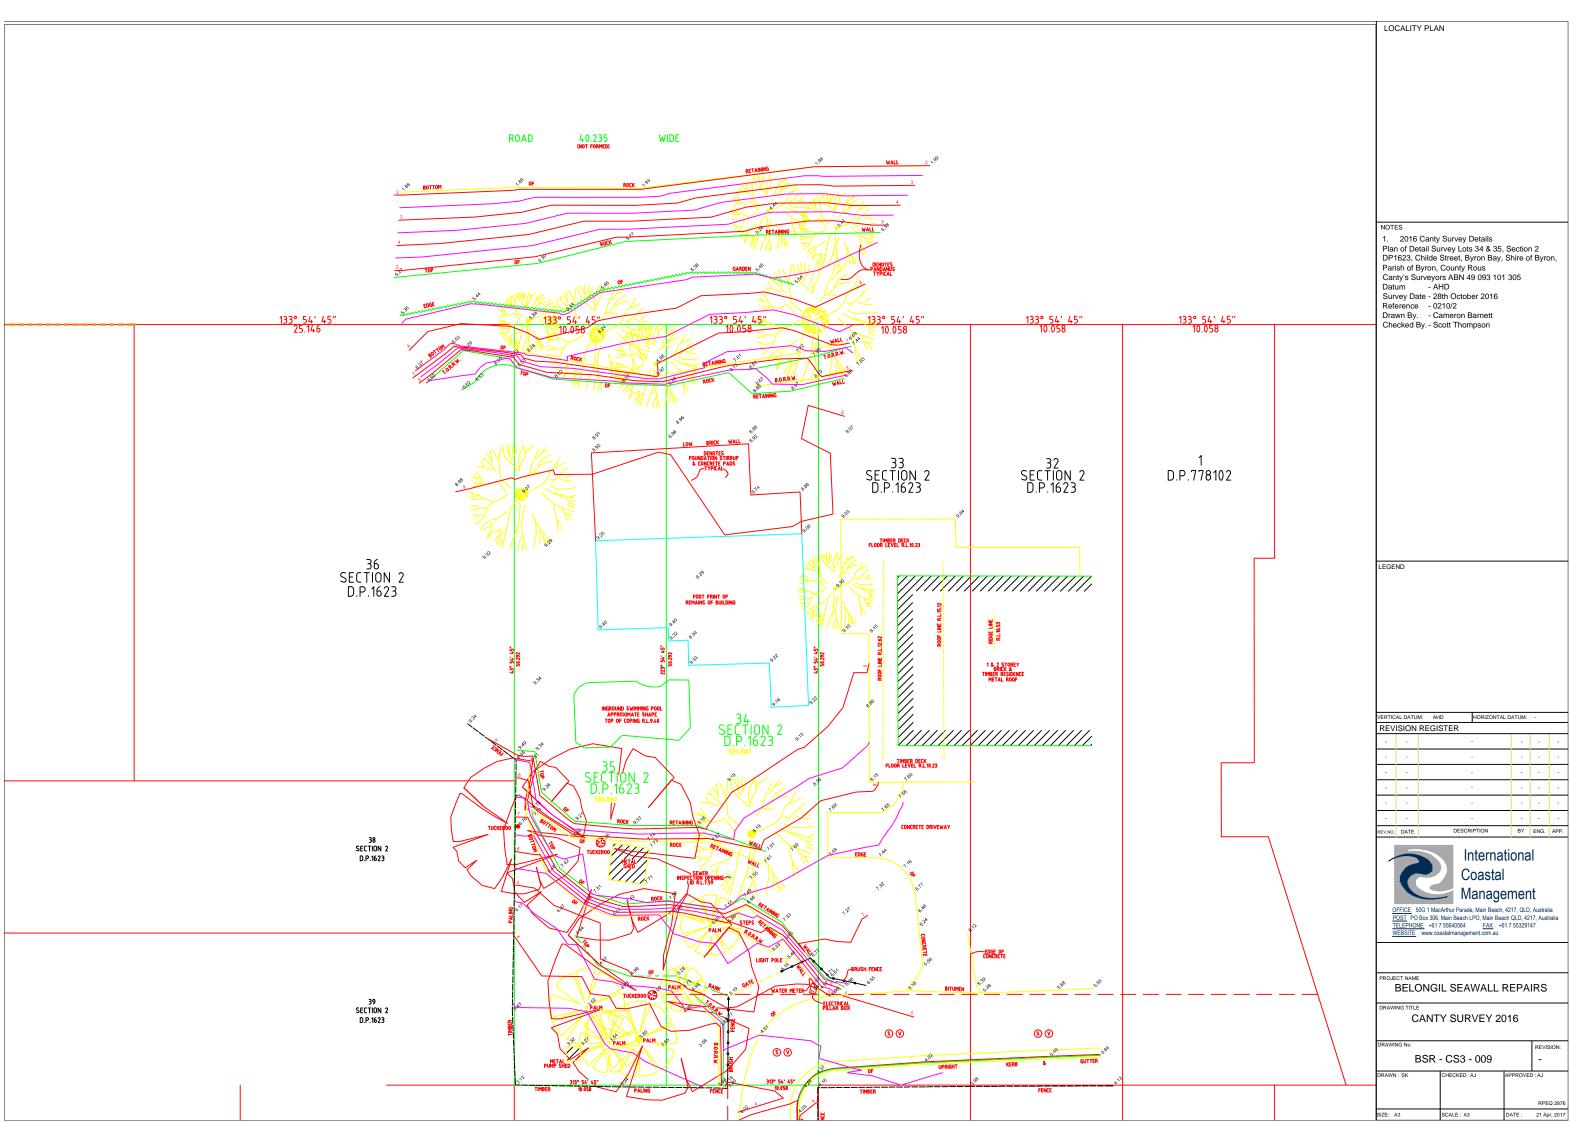
BSR - CS3 - 008 В

## **REPAIR DESIGN**

To determine the extent of repair works:

- An inspection of the walls covered under the consent orders was carried out by ICM engineers on 13/10/16 to ascertain the present condition.
- Historical photos and surveys held by ICM were reviewed to ascertain the previous condition.

## REPAIR CONSTRUCTION METHOD STATEMENT

Works to repair the seawall structures are to be carried out as anticipated by the recent Supreme Court of NSW consent orders made 12/8/16. The proposed method of carrying out the works is as follows:

- The works shall be carried out in 10 -15m sections starting from the NW end.
  - Loose rocks above about -1m AHD that have been displaced from the wall face onto the beach to 0 seaward of the wall will be restacked to the original stable slope of 1V:1.5H with the repaired crest at +5m AHD with a 20-30t hydraulic excavator.

- The crest and toe of the works shall be tapered smoothly into the adjacent crest and toe without interference with the existing structures.
  - The existing access to the beach shall be repaired and safe access provided at each end of the works to 0 provide public access along the top of the wall.

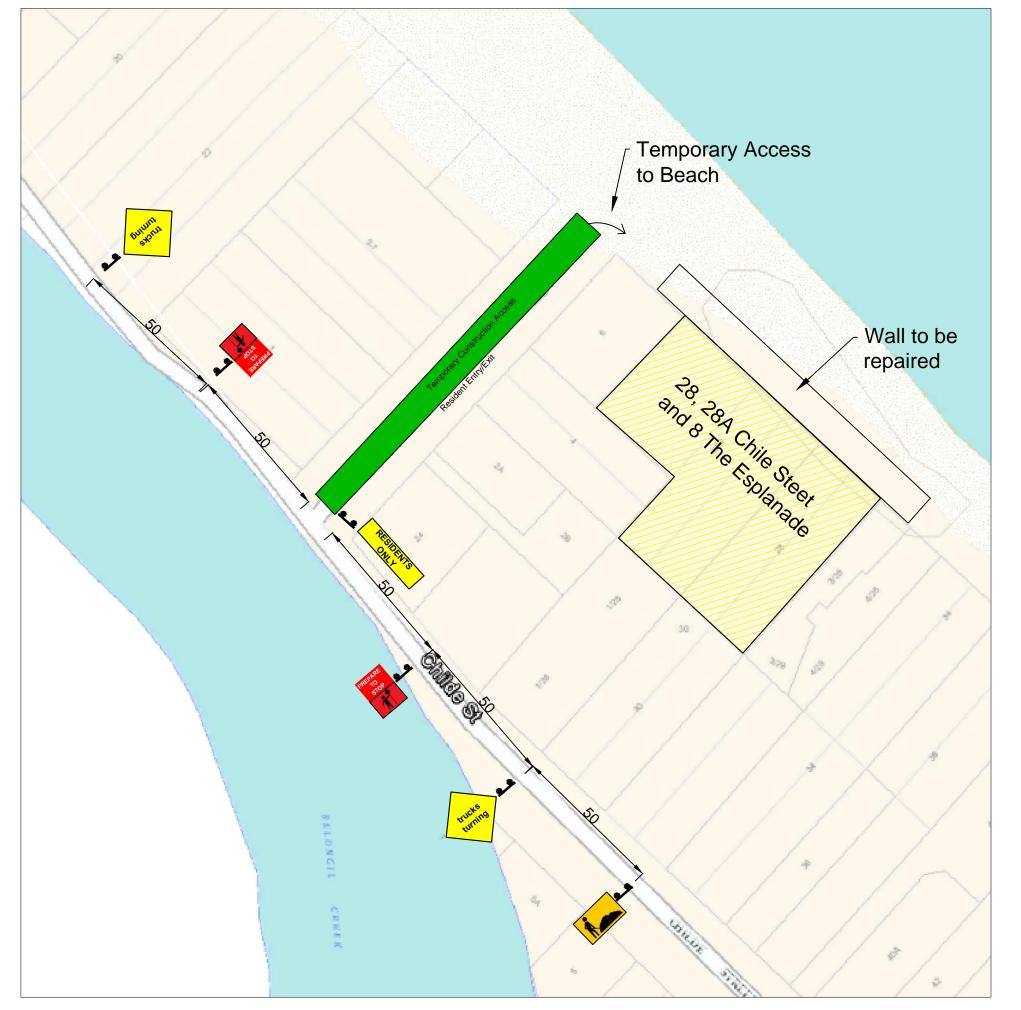
TRAFFIC CONTROL PLAN

- 1. Work hours; 7am 6pm Monday to Friday excepting public holidays
- 2. Construction Time; Approx 10 working days.
- 3. Truck volumes; It is estimated that 60 trucks @ 12t/truck over the 10 days will be required.

- Traffic Control and Signage; All traffic control and signage is to comply with Roads & Maritime Services Guide to Traffic Control at Worksites Manual. All signage is to be removed when works are not in progress and are to be removed immediately following the completion of works.

- Sign distances may be shortened to 25m so not to be obscured by vegetation if necessary.
- Traffic controller to hold North bound traffic for truck to reverse into sight

- Contractor to provide a spotter for vehicles and pedestrians in Manfred St.
- 5. Road Hazards; Trucking operations to be implemented in a safe manner so as to not cause a hazard for motorists or pedestrians.

- Covering of Loads; All loads are to be covered with taut heavy duty purpose fitted tarpaulins to ensure no loss of load or dust.
- 7. Mud; Contractor to ensure that the wheels, tracks and body surfaces of all vehicles and plant leaving the site are free of mud and that mud is not carried on to adjaced paved streets or other areas.
