Requests for information – Minor Applications

1.3 Watson, 44-48 Childe St. CP17-007

PROJECT NAME: BELONGIL SEAWALL REPAIRS

DRAWING TITLE: PLAN VIEW (PRESENT) 44 AND 48 CHILDE STREET

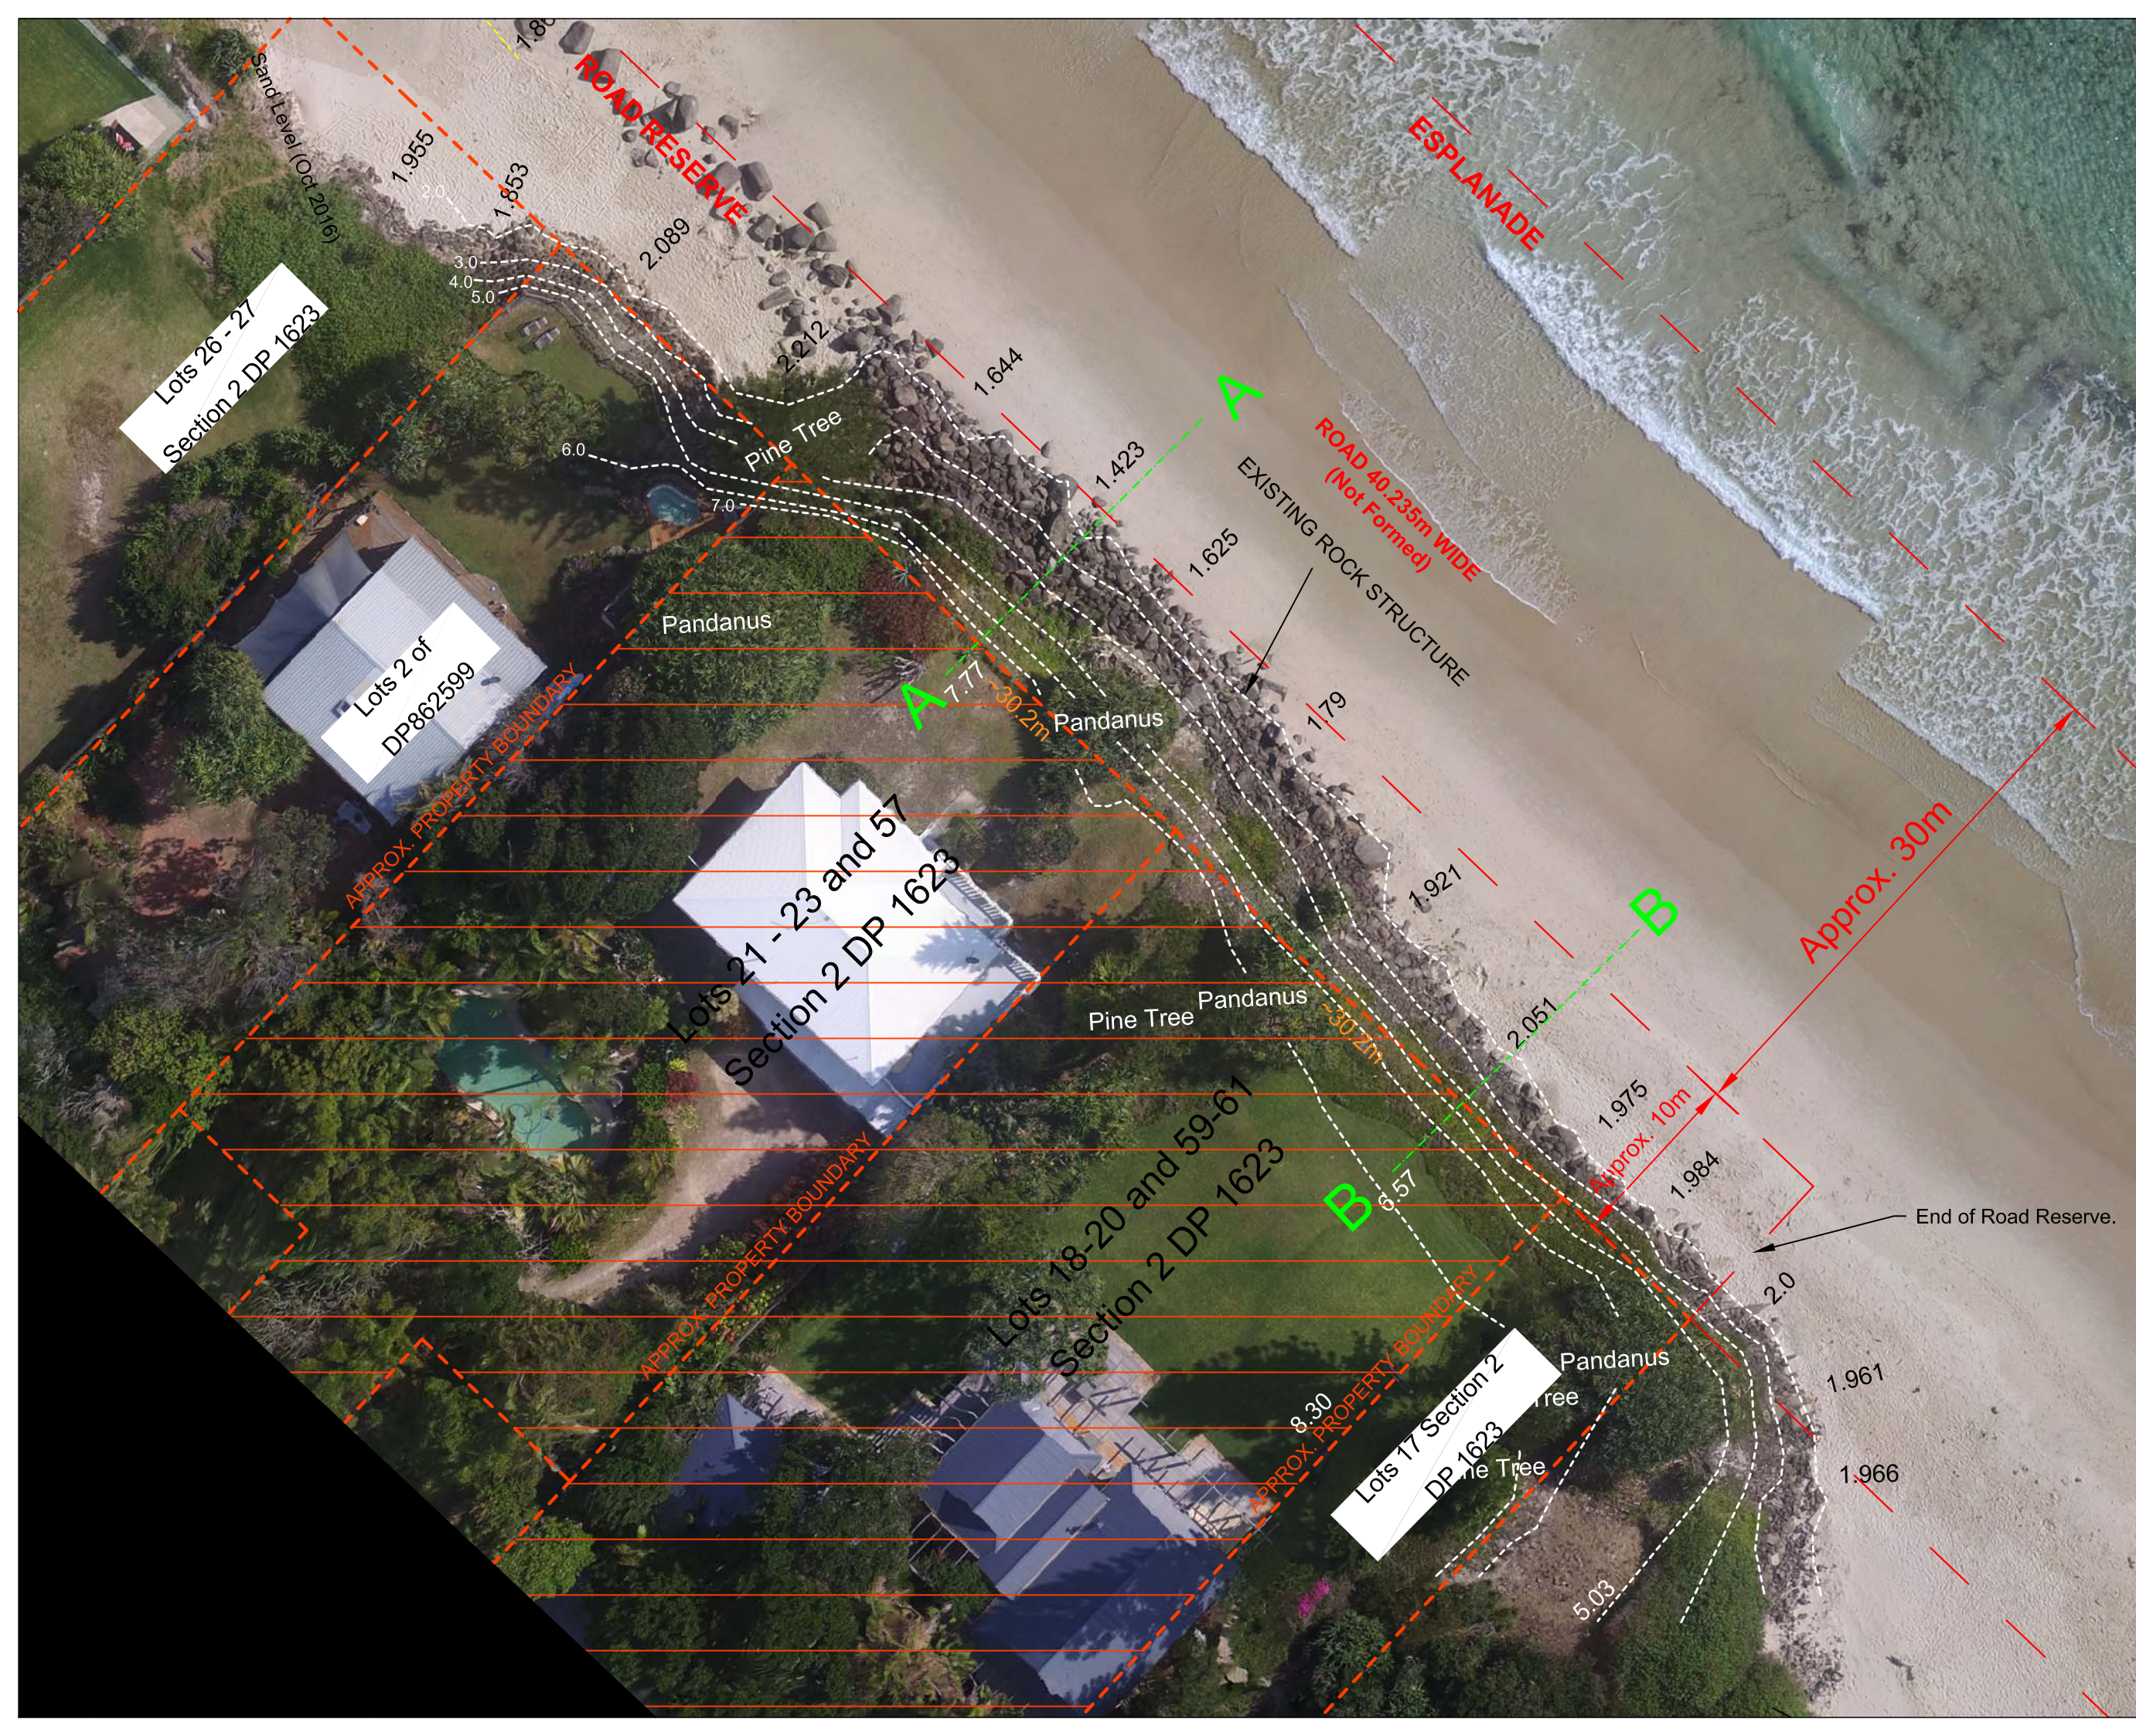
DRAWING No. BSR - CS1 - 002	REVISION: C	
DRAWN: SK	CHECKED: AJ	APPROVED: AJ
SIZE: A3	SCALE: A3	DATE: 18 Jan, 2018

- NOTES
1. Aerial Imagery and levels from 13th October 2016 Survey
 2. Cadastral Data from NSW Globe KML for Google Earth, NSW Land & Property Information
 3. Contours from 13th October 2016 Survey 1m contour intervals
- NOTE: Caution must be taken when interpreting interpolative contours as they do not reflect the void ratio or roughness factor of the boulder wall, landscaping or vegetation.

#	Request for information	Response
1.	A current survey indicating the heights of the current structure (the face of the wall "as is"), property boundaries, footprint of the proposed works and the current sand level	<p>We have already provided this information. The details requested have been provided in the technical drawings previously provided and there has been little or no change:</p> <ul style="list-style-type: none"> • height of current structure and face of wall: Drawings BSR-CS1-UW-002, 003 and 005 show these details. ICM have also added contours of the visible section of the seawall face of the wall in drawing BSR-CS1-UW-002 (Rev a - Attachment 1.3 A) but it needs to be noted that these contours are smoothed as the wall face is very rough with 20-30% voids between large boulders. • property boundaries: Drawing BSR-CS1-UW-002, 003 and 005 show these details. The seaward boundary and corners will be pegged before repairs are commenced. • footprint of the proposed works: BSR-CS1-UW-004, 006 and 007 show the footprint. • existing sand level: BSR-CS1-UW-002, 003 and 005 show beach sand levels at the wall as at 13/10/16 (post June 2016 storms) and there has been a slight increase in sand (about 0.3m) since that date to 17/1/18.

2.	Any photographic and other information used to identify the nature and location of the existing structure(s)	<p>We have already provided this information. In particular, representative photos have been provided in, but not limited to, the following:</p> <ul style="list-style-type: none"> • the August 2017 ICM Report (Figures 5 & 6) provided for this property with the DA submission • the drawings (BSR-CS1-UW-002, 003 & 005)
