**APPENDIX TWO: Munitions Supply Laboratories, Report on Demolition Charge from Japanese Submarine Recovered at Sydney (NAA# 400146 (1942-43))**

DEMOLITION CHARGE FROM JAPANESE SUBMARINE  
RECOVERED AT SYDNEY

**APPENDIX THREE: Sediment Testing Report from ChemCentre,  
Curtin University, February 2017**

**APPENDIX FOUR: Unexploded Ordnance and the *M-24*  
Japanese Submarine Wreck Site: Permit Holder Information  
Sheet**

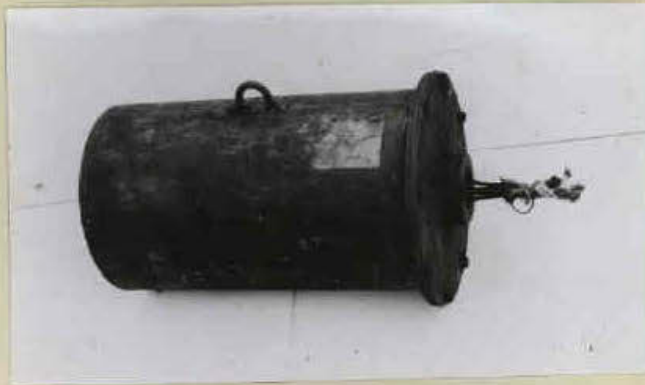
The appearance of the demolition charge as received is seen in Fig.1. The casing of the charge is of welded steel construction and a lug is attached to facilitate handling. At one end of the casing is a flange on to which a steel cover plate is held by eight bolts. A rubber gasket is present between the cover-plate and the flange. A central hole cut in the cover takes a  $2\frac{1}{2}$ " internal diameter collar welded to the outside of the cover. This internal diameter enlarges to 3" at the outer end, leaving a shoulder against which a rubber disc and a steel plate are held firmly by a cap (Fig.1) screwing on to the collar. Three lengths of safety fuse pass through the plate and rubber, and thence through the hole in the cover plate into the interior of the demolition charge. A  $7/16$ " dia. steel rod  $2\frac{3}{8}$ " long is welded centrally to the steel plate and has a small plate welded to the far end. Three slots in this plate take the safety fuse.

SIDE VIEW OF JAPANESE DEMOLITION CHARGE, SHOWING  
COVER PLATE, SAFETY FUZZ AND COLLAR

A label on the outside of the casing (Fig.1) was practically indecipherable.

The translation of the partly effaced label shown on the side wall of the demolition charge in Fig. 1 is: -

EXPLOSIVE CONTAINER.  
30 KILOGRAM EXPLOSIVE HOLDER.

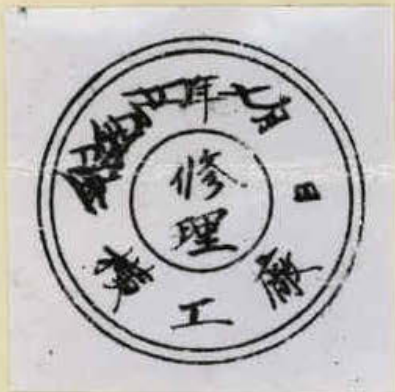
Fig.8 (x 2)

Figure 8.

Repaired July, 1930 (?)

(Name of Laboratory).

- Blocks (a) Fig.7 shows the label present on each in the centre of the side nearest to (d). One block only had, in addition, the label in Fig.9.
- Block (b) A label was present on the top surface but was so discoloured as to make photography impossible.
- Block (c) Fig.4 shows the label on the top surface. In addition, on the side wall, were an anchor and the numbers 98-1914. (Fig.3)
- Block (d) Fig.10 shows the label from this block.
- Block (e) Each block had on its upper surface the label shown in Fig.6, and half of the label shown in Fig.7 on the upper part of the side nearest (f).
- Block (f) Label on upper surface as in Fig.5 and on the side as in Fig.8. (See also Fig.3)

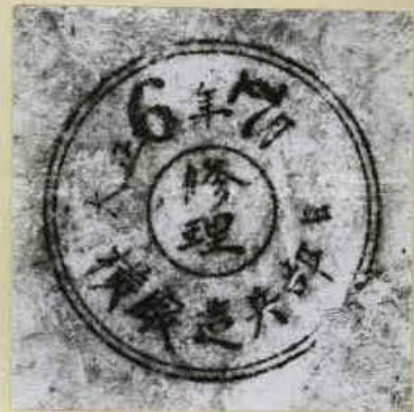
Fig.9 (x 2)

Figure 9.

Repaired - July 1917.

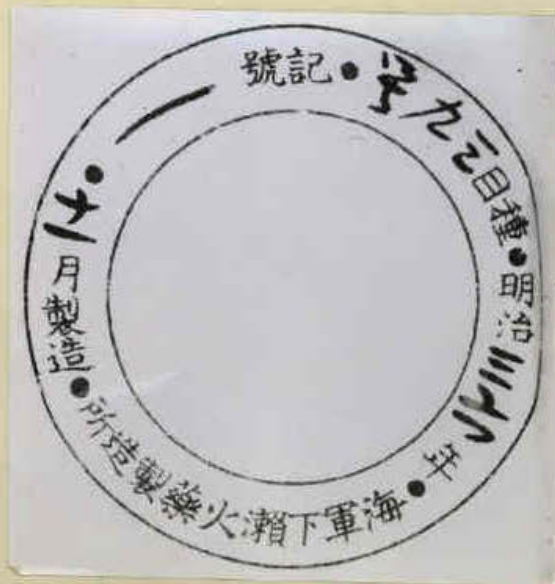
Fig.10  
(x 2)

Figure 10.

Lot No. 39

1904 November.

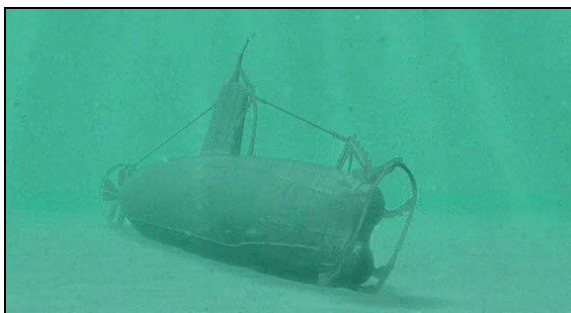
CGI model of M24 on seabed when it first sank (Image: Model Animax Films).

The wreck was found largely intact sitting upright on its keel under a large fishing net (with the exception of a section of the conning tower, stern cage and some of the net-cutter at the bow missing). It has been speculated that these sections became detached after the submarine was possibly rolled after becoming entangled in the net or through being caught by several fishing net hookups.

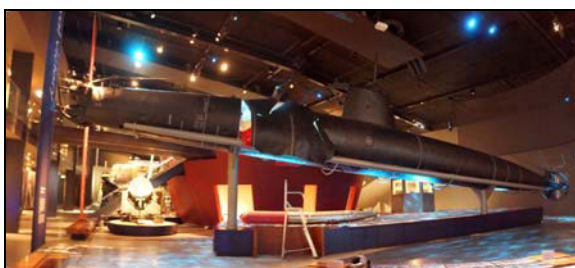
Composite hull reconstruction of *Ha-14* and *Ha-21* pieced together for a display at Australian War Memorial. (Image: B. Duncan, Heritage Division).

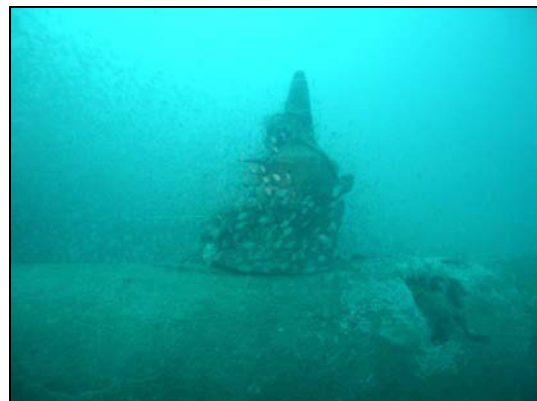
*M24* midget submarine wreck on seabed (Image: No-Frills Dive Club).
