# **t.s.s. JOHN PENN**

## **WRECK INSPECTION REPORT**

**Department of Planning, Sydney 1992**

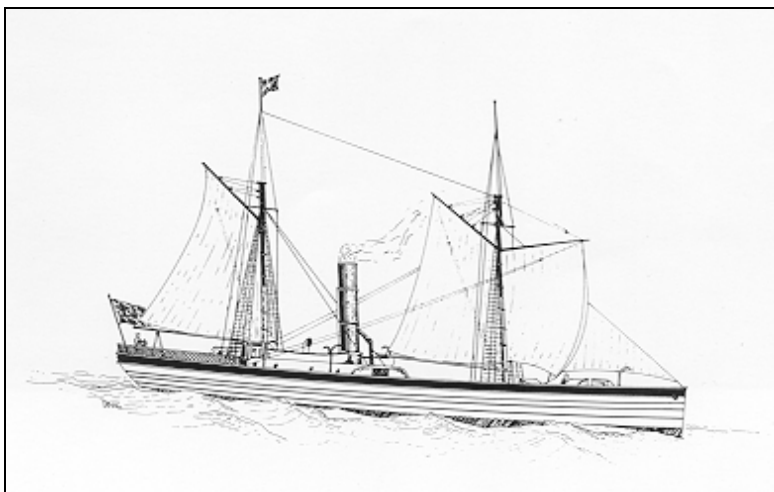
*Figure 2: Sketch of John Penn by Dean Claflin*

The **John Penn's** dimensions were as follows, Length 140', Breadth 22'6" and Depth 8'. The steamer could reach 10 knots on the measured mile. The 'simple' twin horizontally mounted engines were built by John Penn and Sons of Deptford, London. The engines consisted of two pairs of direct acting cylinders working twin propeller shafts, and were capable of achieving 50 horse power (3). The John Penn was named in honour of the shipbuilder, Mr. John Penn.

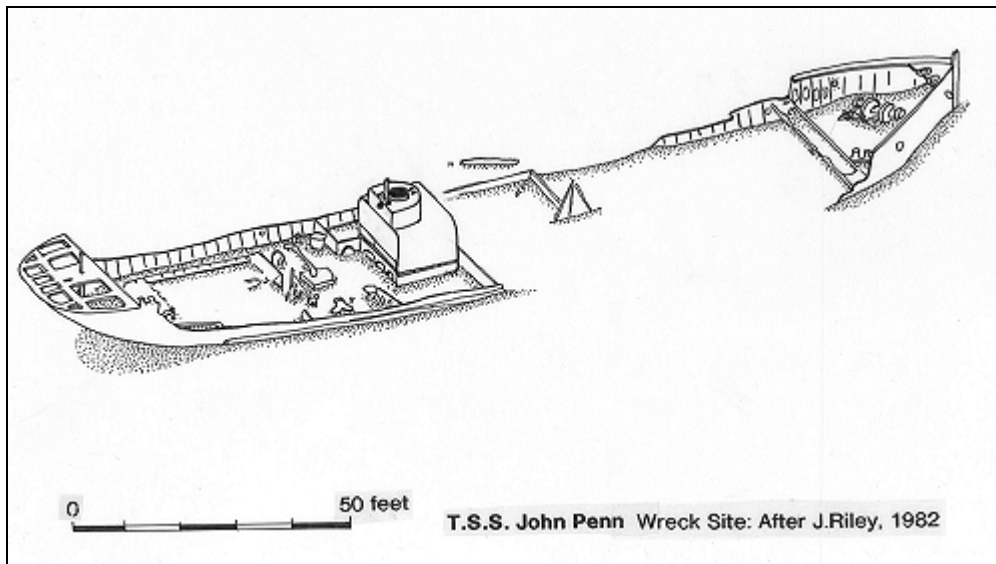
Figure 3: Isometric View Of Wreck Site

Remains of the John Penn survive remarkably intact with the hull sitting upright in sand. The lower midships section is often completely buried whilst the elevated bow and stern generally remain visible. Portions of the vessel's sides have fallen away and lie alongside. The box boiler being the most conspicuous element, is located immediately forward of the engine room.

The bow was found to be intact to the level of the decks, the iron deck beams and internal structure having collapsed. An anchor, winch, bollard and miscellaneous pieces of hull plating were located.

Substantial portions of the engine room remain together with the engines which are in a remarkable state of preservation. The engines consist of two pairs of horizontal, direct acting cylinders working twin propeller shafts. All connecting rods, piston rods, valve slides, etc. remain intact. A donkey boiler is located in the forward port corner of the engine room. Coal bunkers are located on either side of the boiler.

The box boiler has three furnace doors facing aft and includes an economiser mounted around the smoke box uptake and a circular hole for the funnel.

The stern area survives up to the level of the quarter deck, the iron deck beams and tie plates being mostly intact. The rudder post with tiller reaches to above deck level.

An initial underwater inspection located the boiler and the central area of the site. A general survey of the remains followed. The exposed portion of the boiler was photographed and drawn whilst the poorly exposed bow and stern areas were examined. Existing sand levels were recorded using a permanent reference point situated on the aft face of the boiler (Figure 3). There was insufficient structure visible to warrant recording on video.

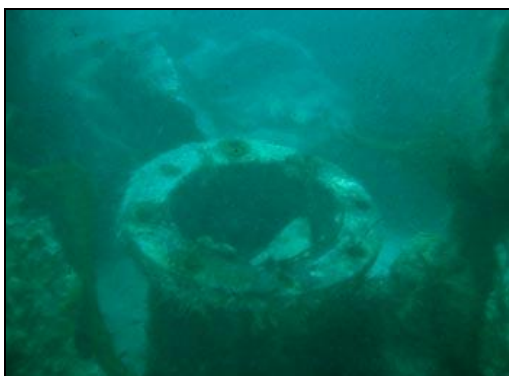
Figure 5: Engine room area (J Riley).

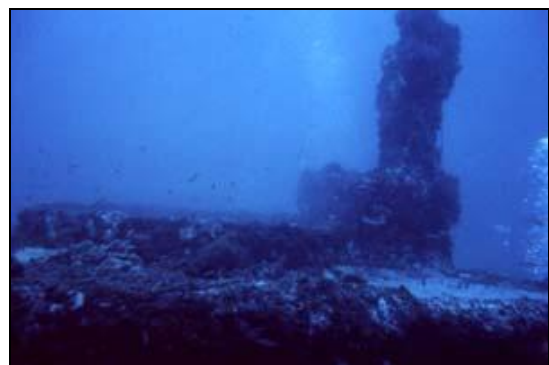
Figure 6: Upper surface of boiler (M Lorimer).
