# CUMBERLAND SHIPWRECK 1917

## Information Sheet NSW Heritage Office

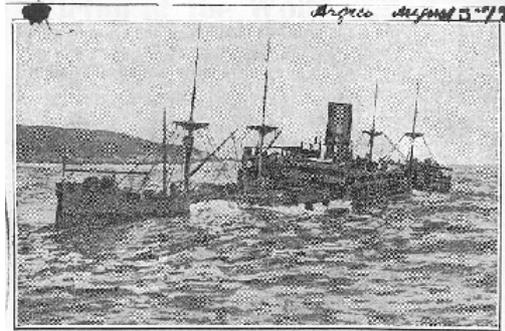
*Cumberland* almost beached at Gabo Island. Melbourne *Argus*, 3 August 1917.

With water flooding into the forward section, *Cumberland* was run aground on Gabo Island for urgent repairs. A diver from the Japanese cruiser *Chikuma* first inspected the hole which

was estimated to be 30 feet (9 metres) in diameter. The Australian light cruiser HMAS *Encounter* arrived next on the scene, while vessels were dispatched from Sydney and Melbourne with dedicated salvage equipment, including pumps and mooring gear. An estimated eleven pumps were used in the operations, many presumably lost when the vessel was finally lost.

Naval and Harbour Trust divers were deployed patching the hole by removing jagged plating, attaching sturdy timber bracing and patches made from layers of canvas. Several vessels were involved in the work including the Illawarra & South Coast Steam Navigation Company's steamers *Merimbula* and *Bermagui*, the tugs *Champion* and *James Paterson* (*Argus*, 3 August 1917).

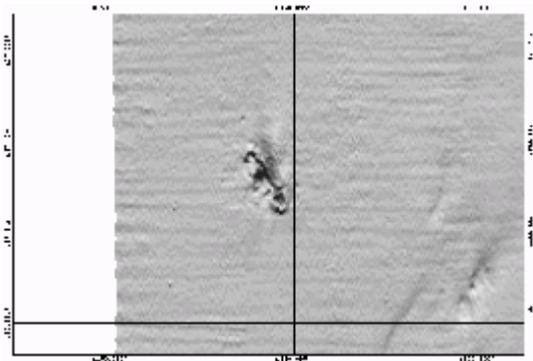
Tss *Cumberland* was imaged by CSIRO, Hobart for the first time in 2000 using a SIMRAD EM1002 swath mapping echo sounder. © CSIRO, Rudy Kloser.

The *Cumberland* sank about five miles south-east of Green Cape, NSW, on 11 August 1917 in an estimated depth of 50-60 fathoms (~91-110 metres).

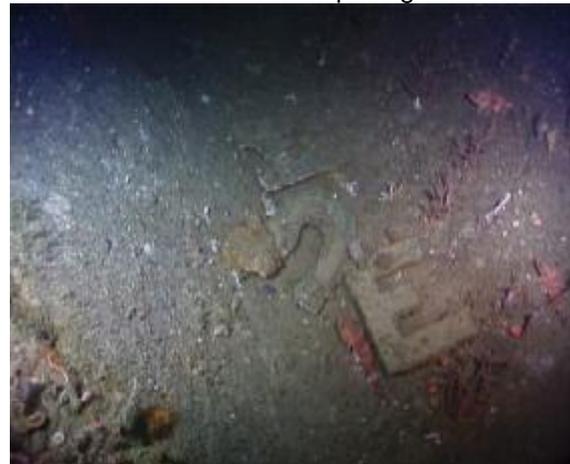
Letters from the bow name plate. © The Sydney Project.

The dive team identified the cargo of livestock meat from the numerous bones scattered about the staggering wreck site, located remnant metal ingots from the 1951-52 salvage operations, and confirmed the site as the *Cumberland* with the discovery of letters “U”, “M” and “E” on a section of plating at the bow.
