The Duckenfield Expedition 31st March -1st April 2005

***ss Duckenfield* 1875-1889**
Maritime Archaeological Survey
31 March – 1 April 2005

NSW Heritage Office
Underwater Cultural Heritage Program
PARRAMATTA 2005

David Nutley, NSW Heritage Office

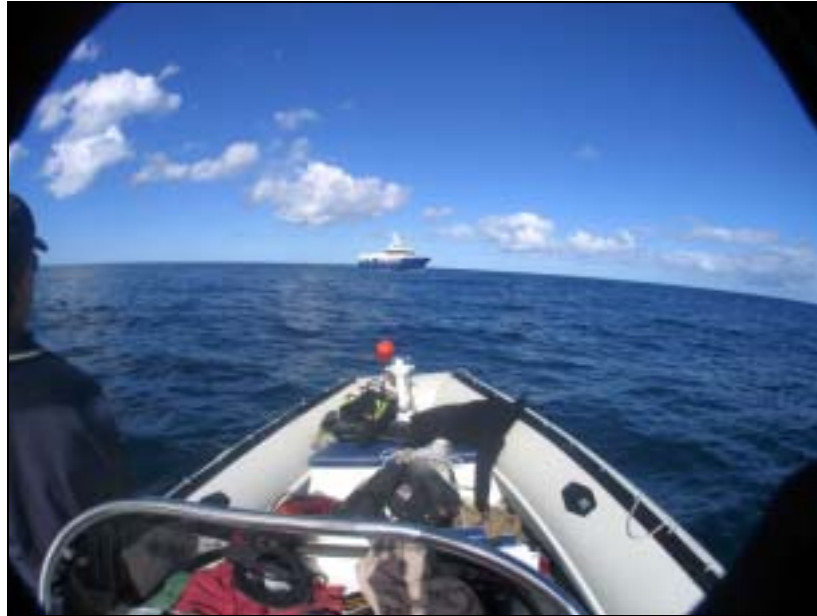
Figure 1: The Niad approaching site buoy - *Ulysses Blue* in background
(S. Smith 2005)

The site was marked with a temporary site buoy which was used as a descent and ascent line. In-keeping with best-practice for anchoring on historic shipwreck sites (to avoid anchor damage to the site), the Niad was anchored upwind/upcurrent from the site and then allowed to hang back close to the site buoy.

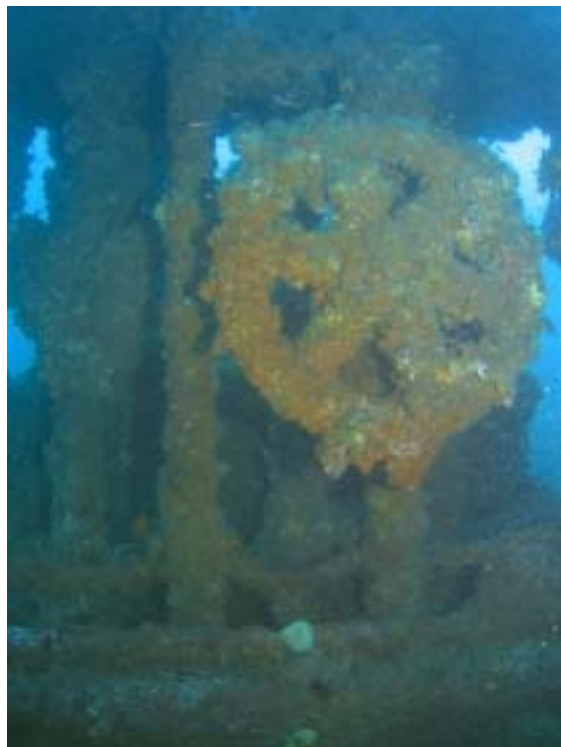
Figure 2: ss *Duckenfield* - compound engine

It illustrated that, overall, the site is in a remarkably stable condition with very few changes since the 1989 survey. The engine itself is essentially unchanged. This is a very positive reflection on the treatment of the site by the diving community and the value given by divers to retaining the attraction of the structure as a long term dive attraction.

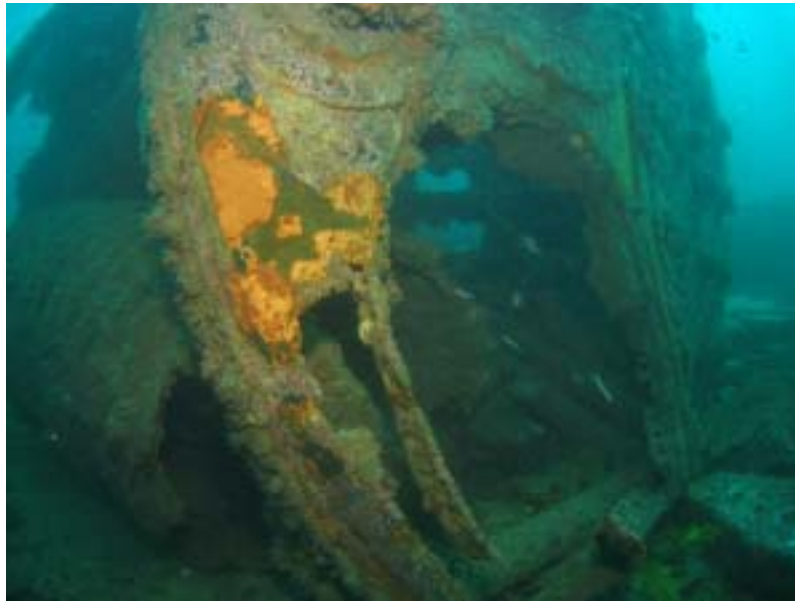
Figure 3: ss *Duckenfield* - fresh corrosion on boiler
(D Nutley 2005)

The boiler however had changed quite substantially. Much of its outer plating of had disappeared leaving its original shape defined primarily by the circular flanges that bound the plates together. The effect is to provide a very clear cutaway of the internal structure. The cause of this deterioration is not doubt partly a natural decay of the weaker components of the boiler. The surge felt during the current survey would have helped to contribute to this process. However, there was also evidence of fresh mechanical damage, most likely the result of fouling by anchors. Slabs of corroded layers of iron had been knocked off the surface of the metal and these areas stand out through the bright orange ferrous oxide that accompanies fresh corrosion activity.

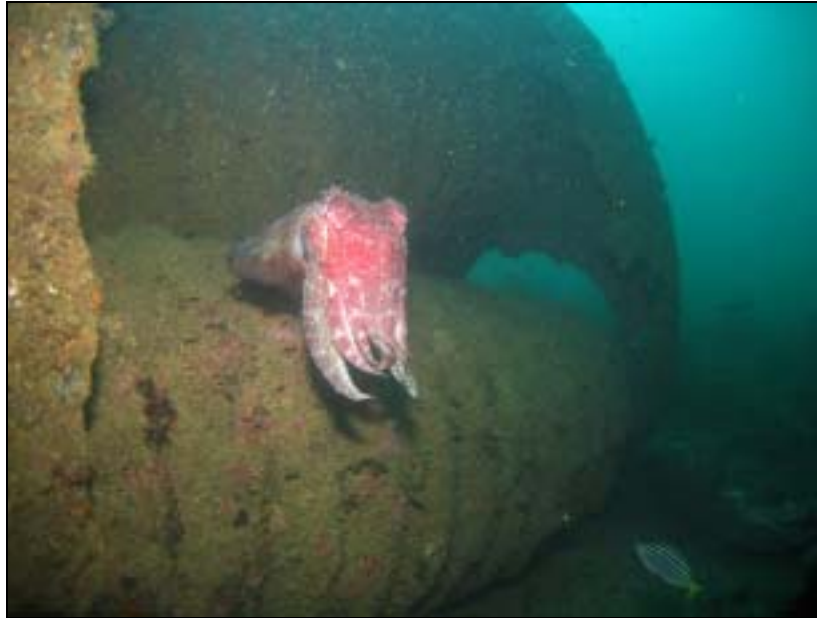
A variety of marine life has colonised the wreck site including algae, small fish and a large cuttlefish that appears to have made the boiler its home base.

Figure 5: Resident cuttlefish at home in the remains of the Scotch boiler
(S Smith 2005)

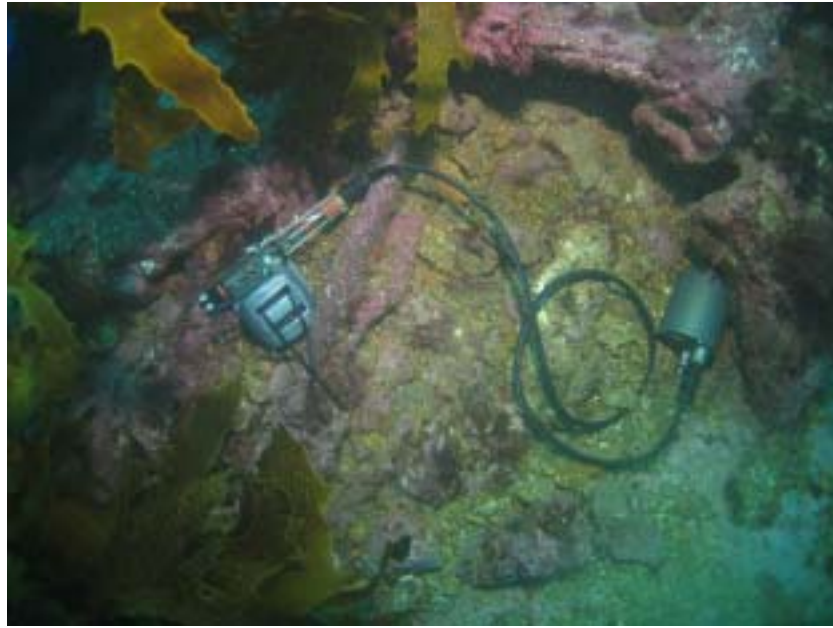
Figure 1. The fluorometer deployed at 24 m on the red alga *Delisea pulchra*. Note deployment is on part of the structure of the Duckenfield. The measuring tube is on the left connected by cable to the logger housing on the right. (Photo: Sterling Smith 2005)

The fluorometer used in this study comprises a cylinder ~120 mm deep by 90 mm diameter, housing the datalogger and battery assembly. This is connected by a cable to an oil-filled clear polycarbonate tube housing the electronic components used in generating and receiving signals that enable measurement of (modulated) chlorophyll fluorescence, temperature and light intensity (irradiance). The oil eliminates the requirement for the measuring tube to have precisely machined waterproof seals, the design has previously resisted seawater ingress to depths of 203 m. The measuring tube is attached to a plastic plate, and samples of macroalgae can be attached to the plate using mesh and elastic material such that the sample is a fixed distance from the measuring tube. Measuring signals are directed through the clear tubing directly to the sample; the sample is positioned about 12 mm from the tube.

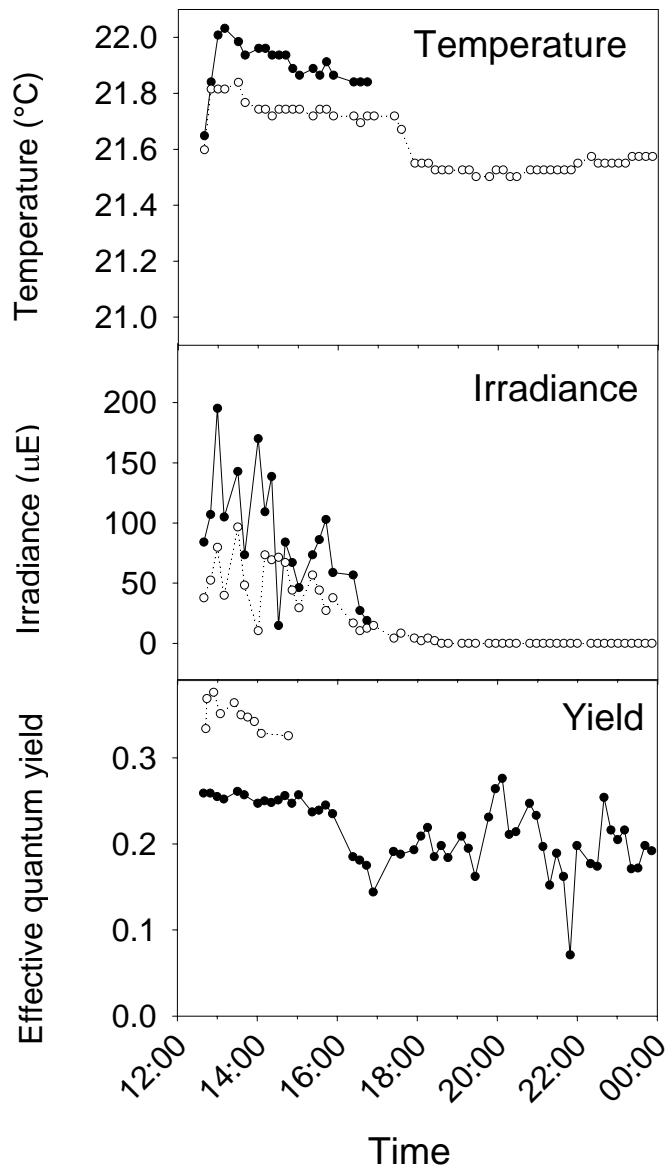
Figure 2. Ambient temperature and irradiance, and effective quantum yield of the red alga *Delisea pulchra* measured close to the Duckenfield in NSW, in 24 m seawater on 31st March 2005. Note the temperature scale represents one degree C.

Estimates of effective quantum yield were low and remained fairly constant at 0.250 until 14:50; after this time values became highly variable with a mean of 0.196. Effective quantum yield values of around 0.3 might be expected after exposure to high noonday irradiances. Maximum irradiances measured in this location were $200 \mu\text{mol quanta m}^{-2} \text{s}^{-1}$; it is likely this light intensity was sufficient to cause prolonged photoinhibition. However the high variability after 16:50 is less easily explained as due to a biological process and is more likely to be due to the instrument. Accuracy of yield measurement during low irradiance conditions and when the battery is partially discharged will be examined. Previous tests suggest low voltage increases variability in yield measurements.

The fluorometer provided important information that has enabled the identification of potential and real design problems. The high background signal from the light sensor even during night time suggests some form of electrical leak, which will need to be rectified as it may influence other measurements in an unpredictable manner. Battery charging difficulties, and residual current flowing to the large LED even when supposedly switched “off” will require a significant redesign of the circuitry. High variability of effective quantum yield measurements may be a consequence of low battery voltage. The physical construction of housing, cables and configuration of light sources appears to be optimal.
