EMU 1874 - 1888

Maritime Archaeological Survey

Report into the exposed shipwreck remains located at Crowdy Bay, NSW.

WRECK INSPECTION REPORT

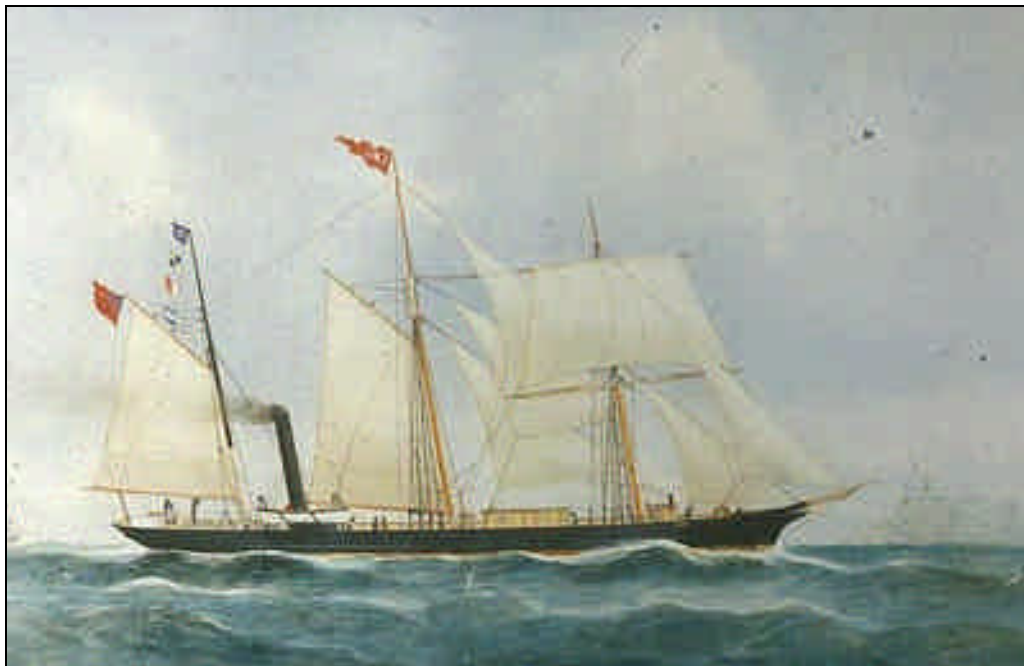
Figure 1: Painting of SS Emu by William Forster. Courtesy Mr John Yeager and Ms Esme Smith.

A fine wooden vessel with a "clipper bow" (Figure 1, 2), the *Emu* was employed in the coastal trade under command of Norbert James Ivaney. At the time of loss in 1888, the steamer was on a voyage from the Richmond River laden with timber for Sydney (5). With nine hands onboard, the voyage went well until near Seal Rocks when a sleety gale set in. The heavy south-east weather caused the vessel to spring a leak, lose all sail and seek safety in Crowdy Bay. While riding at anchor with 60 fathoms (110 meters) of cable out, it parted at 9.30 a.m., sending the *Emu* ashore to become a total wreck. When beached, the sides of the vessel rapidly broke open, partly due to the heavy load of timber onboard (6). The *Emu* was said to be lying "one mile north of Crowdy Head, on the beach, and full of water". There was no loss of life (7). A Marine Board inquiry into the disaster found no fault in the captain (8).

Further, it was evident that the boiler had moved from its original position forward of the high pressure cylinder to a position aft of the low pressure cylinder (assuming a rear engined vessel - Figure 1,2). Mr Riley believed that the engine was still attached to the hull (due to remaining in an upright position) and that the buried portion of the hull probable runs on an axis through the line of the engine. Apparent damage to the low pressure cylinder of the engine appeared reminiscent of explosives, perhaps used during salvage work on the wreck. The cylinder head cover is missing and the cylinder wall is damaged to the rear.

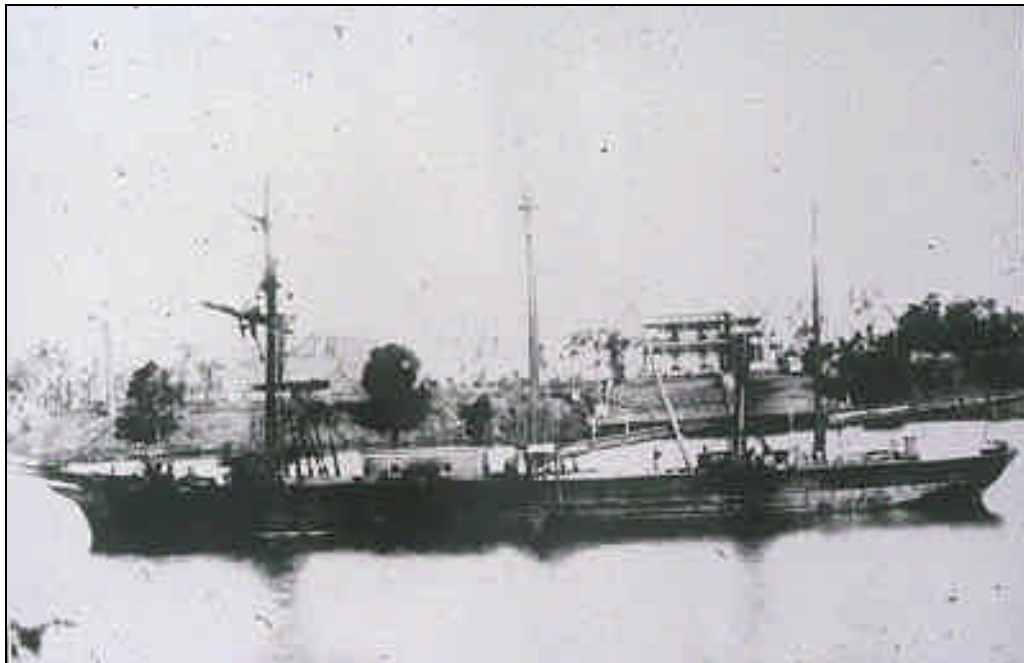
Figure 2: Original photograph of the SS Emu taken in front of W.T. Yeager's home "Oakland House". Courtesy Mr John Yeager and Ms Esme Smith.

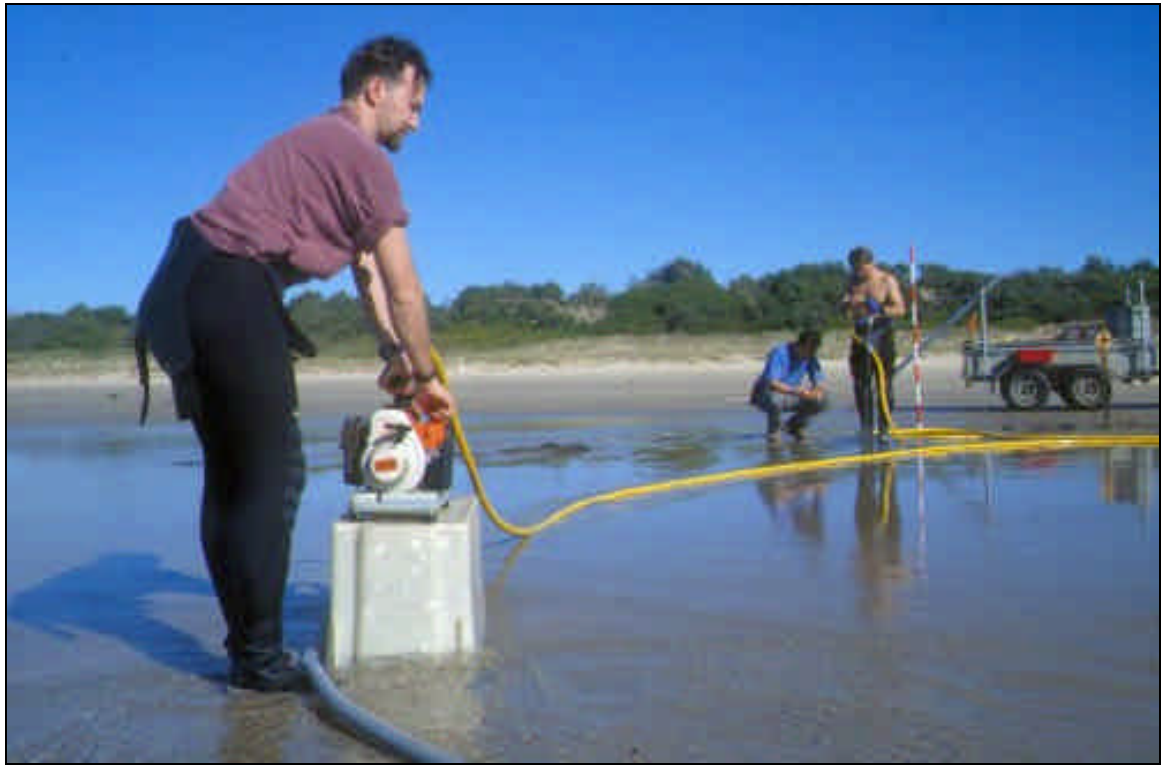
to be timber, it would further point to the wreck being the *Emu*. A probe survey was therefore employed. This had the benefit of minimal intrusion on the wreck remains and being able to detect wood as opposed to metal refusals. The 3 meter probe could be manually handled with water intake via a hand held compressor. A theodolite enabled all probes to be plotted and tied into the Australian mapping grid.

Figure 3: Tim Smith operating water pump for probe survey

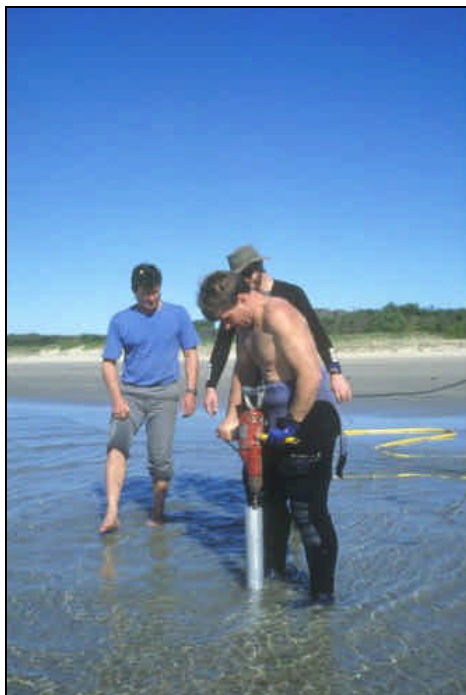
Figure 4: Extracting core sample of timber from inside aluminium pipe

A timber sample was removed from the site with the aid of a powered drill. The sample was taken forward of the engine after timbers were encountered using the 3 meter probe. A metal caisson was lowered through the sand and onto the buried timber. With the tube jettted free of sand, the drill was employed to remove a c. 2.5 centimetre square sample of timber. This sample was forwarded to CSIRO in Melbourne for species identification.

Division of Forest Products in Melbourne. The sample was analysed and found to be New Zealand Kauri Pine, a timber well used in shipbuilding. This finding adds strength to the argument that the inspected remains are those of the steamer *Emu*, a wooden vessel built in New Zealand in 1874.

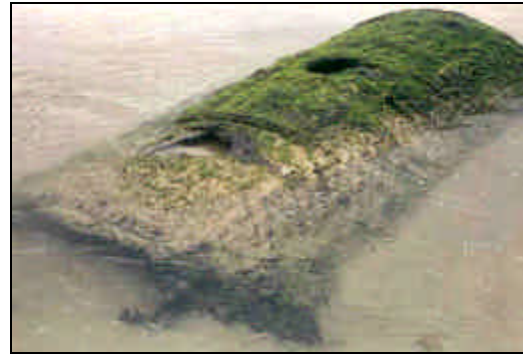
Figure 8: Photograph of exposed boiler

The weight of the engine and boiler would have aided the retention of the wooden hull lying under these features. It can be noted that wave action has carried the large boiler and re-located it aft of the engine remains.

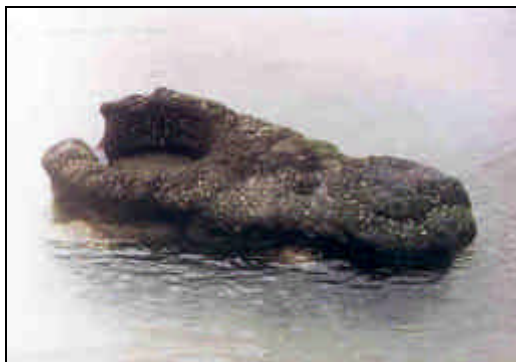
Figure 7: Photograph of exposed engine

Available information on the wreck site was forwarded to shipwreck specialist, Mr John Riley, prior to the site visit. Mr Riley confirmed that the visible engine was a vertical compound type consistent with that of the *Emu*.

Mr Riley predicted that the buried hull remains would be located some 5 feet below the upper level of the cylinder casing (Figure 6). This figure was based on the calculation of the length of the engine's stroke.

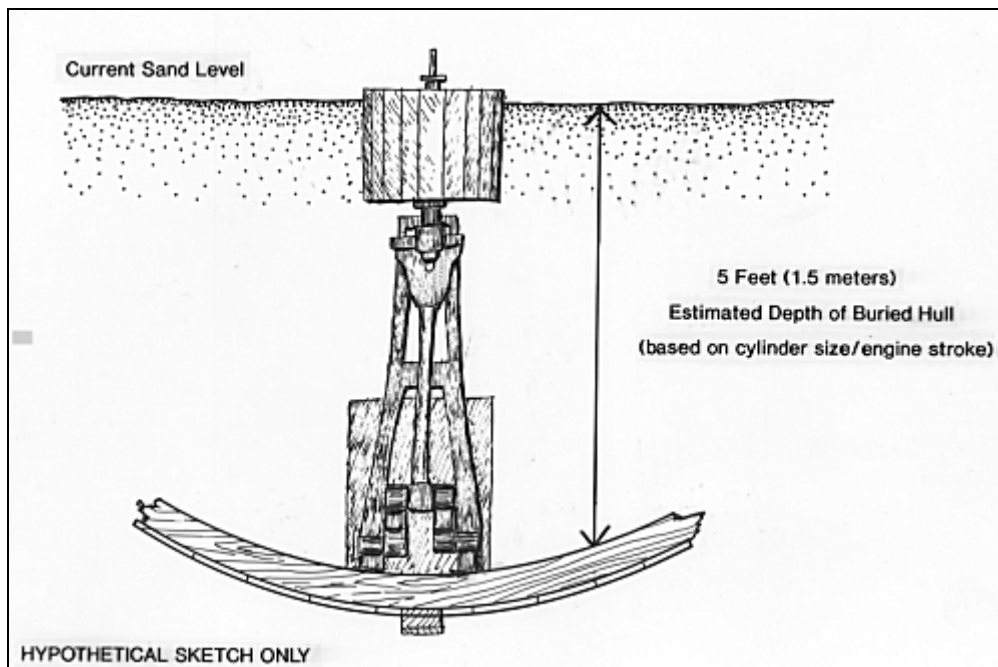
Figure 9: Predictive plan showing the exposed remains and the likely extent of buried structure. Proposed by Mr John Riley.

Two star pickets were placed to delimit the main search area (comprising approximately 100 x 50 meters). This search area was obtained by mapping out the known length and breadth of the *Emu* in relation to the orientation of the engine and boiler. Working on the proviso that the vessel was of engine aft design, this placed the majority of the wreck out from the beach, into the water.

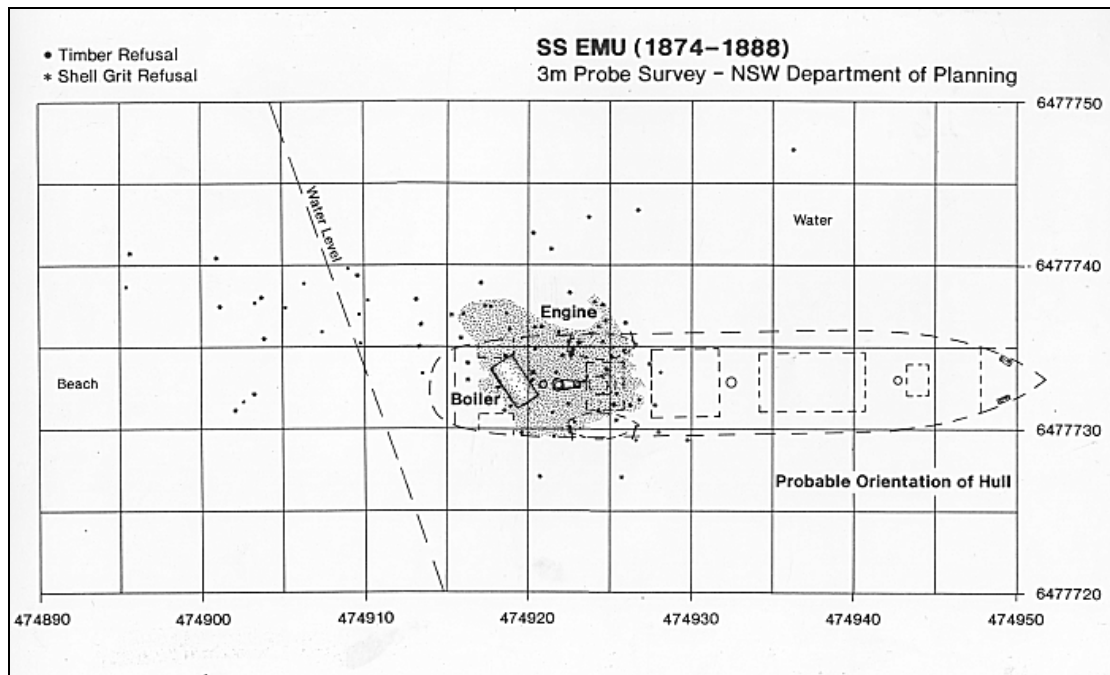
Figure 10: Results of probe survey, showing all probe refusals within the surveyed area.

The probe survey however, confirmed that there is more to the shipwreck remains than those visible. A number of probes met a solid refusal at approximately 1.5 - 2 meter depth. These refusals were compatible with the probe striking timber remains. The majority of refusal were clustered around the engine. This was predicted earlier, as the upright nature of the engine suggested that it was still attached to a solid base. Timbers were encountered for a distance roughly equal on either side of the engine suggesting that the engine was attached centrally within the hull. Approximately 4 meters of the buried hull survives on the port side of the engine, and approximately 2-3 meters on the starboard side. The majority of the timber refusals were found to run in a line consistent with the orientation of the engine. The bulk of refusals were detected around the engine and aft of it (back towards the beach) that is, towards the stern of the vessel (Figure 7).

These findings suggest that the bulk of the hull lying forward of the engine room (towards the bow and ocean - some 60-70 feet), has disappeared. This would not come as a surprise, the section of hull directed out towards the deeper water being more prone to direct wave and storm action. With continual buffeting subsequent to the wreck event, this portion of the vessel would have been more likely to quickly break up. The timber and other structure would have been easily carried away by natural forces.

1. the Department of Planning undertake no further inspection of the site until such time as the remains largely buried on Crowdy Beach are again exposed. A detailed inspection of these remains may aid the current inspection of the shipwreck relics.
2. interested groups or individuals be encouraged, where possible, to undertake research into known vessel losses in the Crowdy Bay/Manning River area, in an attempt to further identify this site and other shipwreck remains.
