EDWARD LOMBE

WRECK INSPECTION REPORT

Prepared by Tim Smith and David Nutley
June 2006

EDWARD LOMBE
MIDDLE HEAD, PORT JACKSON
WRECK INSPECTION REPORT

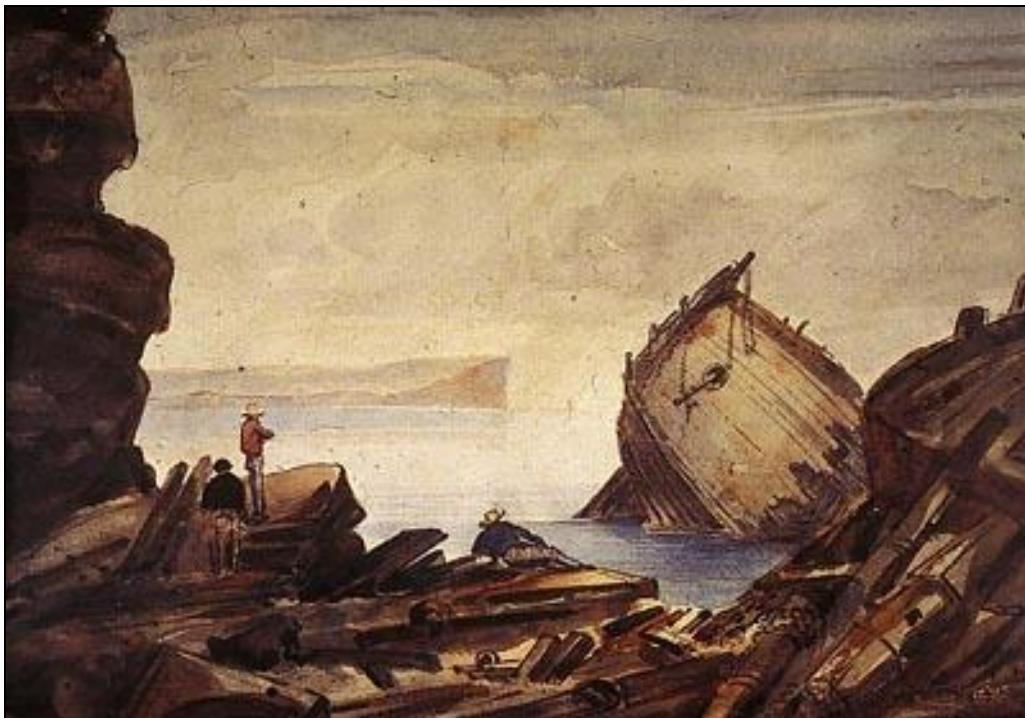
Figure 3 - "Wreck of the Edward Lomb [sic]", water colour attributed to Conrad Martens. Undated. Dixon Gregory Collection, Mitchell Library. Sydney.

Such images are important as they correspond closely to the newspaper accounts of the wreck's appearance and current configuration of Middle Head and North Head, suggesting that the preliminary sketches for such paintings were based on actual visitation. This painting shows the shattered stern and what appears to be the remains of the bow section against the rocks (to right).

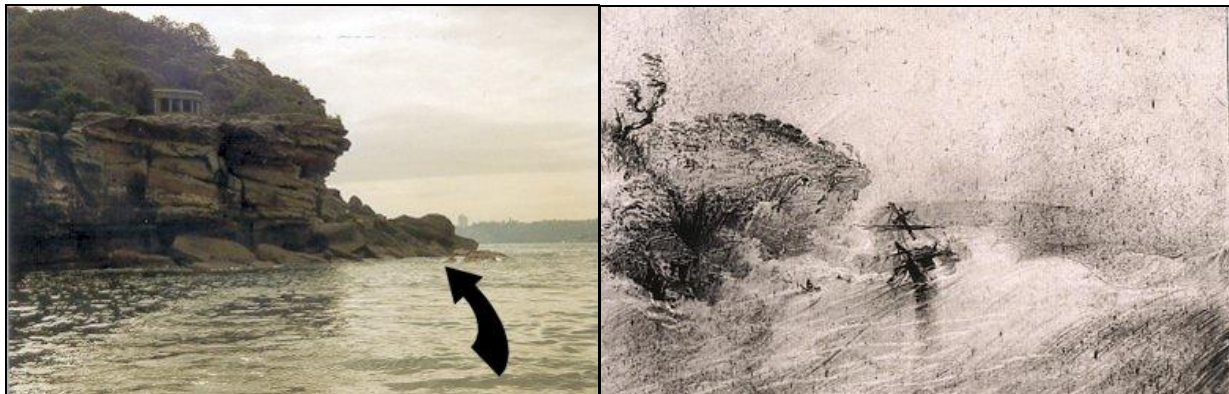
The most probable position for the wreck event was readily established by comparing contemporary paintings of the tragedy to the modern coastal features. Several isolated table rocks lying out from Middle Head on its south eastern side, closely resembled those portrayed in contemporary paintings of the disaster and indicated that the observed features had changed very little.

Figure 6: Juxtaposition of Middle Head in 2006 with 1834 drawing of the shipwreck event. (Photo: D Nutley; Pencil sketch, Sir Oswald Walters (Undated), Mitchell Library. Sydney)

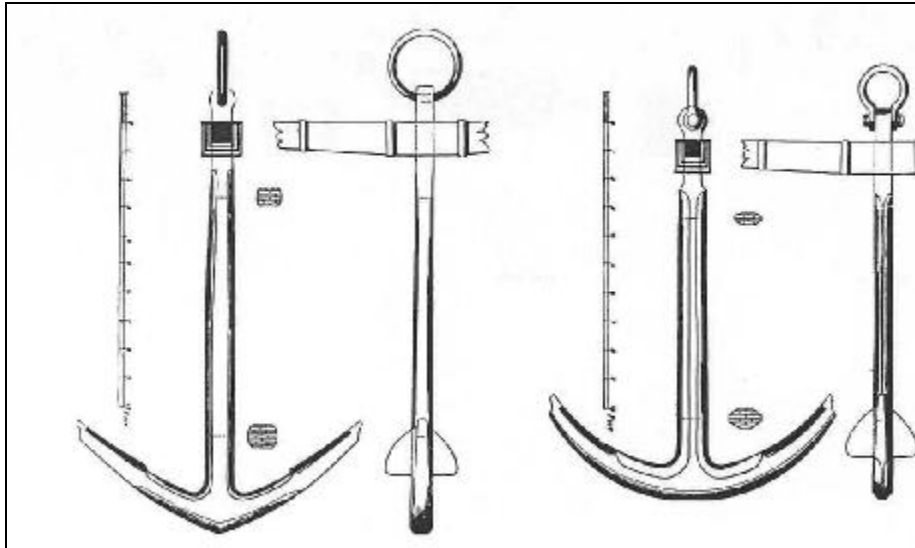
The anchors appear to be of the Pering's type. Between 1813 and 1839 Pering developed a range of improvements to the traditional Admiralty Long-shanked anchor. The form of anchors off Middle Head appears to be an early variant of these improved anchors.

Although heavily obscured by marine growth and concretion products, the anchors have the probable curvature and earlier ring shackle of the "First Anchor" type, together with the sectional nature of the shank's cross section. A diagnostic feature of many Pering types is the size and shape of the palms, and their set-back from the tip of the fluke. Pering's anchors would suit the date of *Edward Lombe*, a vessel built and fitted out in 1828. They appear to be about 10-15cwt anchors, with anchor 1 being approximately 9'8" in length.

Figure 7: Pering's anchor types, after Curryer, p76, 1999 Chatham Publishing, London
