SHIPWRECKS OF TWOFOOLD BAY & DISASTER BAY

WRECK INSPECTION REPORT

TWOFOLD BAY / DISASTER BAY SHIPWRECK SURVEY

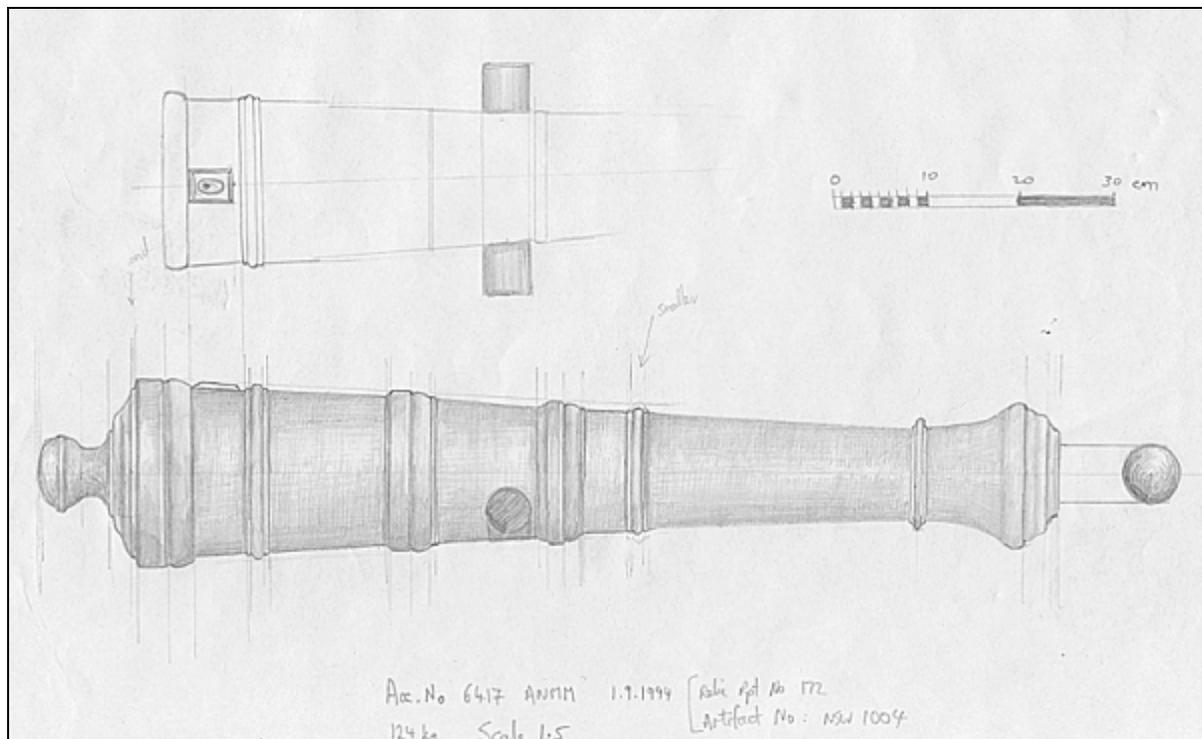
Figure 4: Drawing of a small cannon (probably a signal gun) recovered from Disaster Bay in the 1960's by Mr Carlo Filippetti. The isolated cannon was allegedly found sitting on the seafloor in its original wooden carriage and not associated with any of the well known Disaster Bay shipwrecks. (Drawn by Tim Smith)

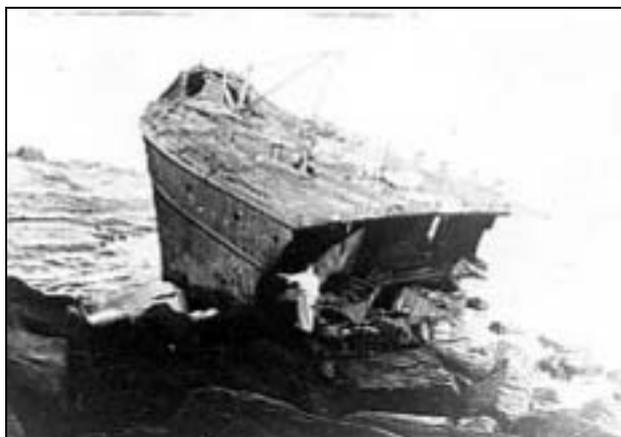
Figure 6: ss *New Guinea*'s bow on Green Cape before it was broken down by waves action. (Photo: Courtesy, Mr John Mathieson, Eden.)

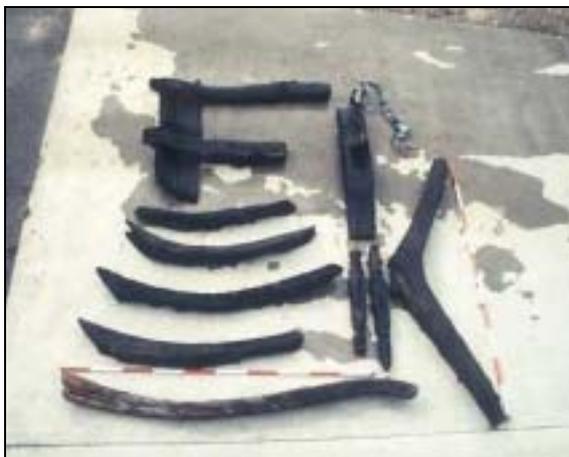
Figure 10: Ship's timbers raised in fishing nets from unidentified shipwreck south-east of Disaster Bay. (Photograph by David Nutley)

Positive identification of the shipwreck structure remains unlikely, due to the depth of the site, the fragmentary nature of material accidentally raised to the surface, and the number of other wrecks potentially lost between New South Wales and Victoria.

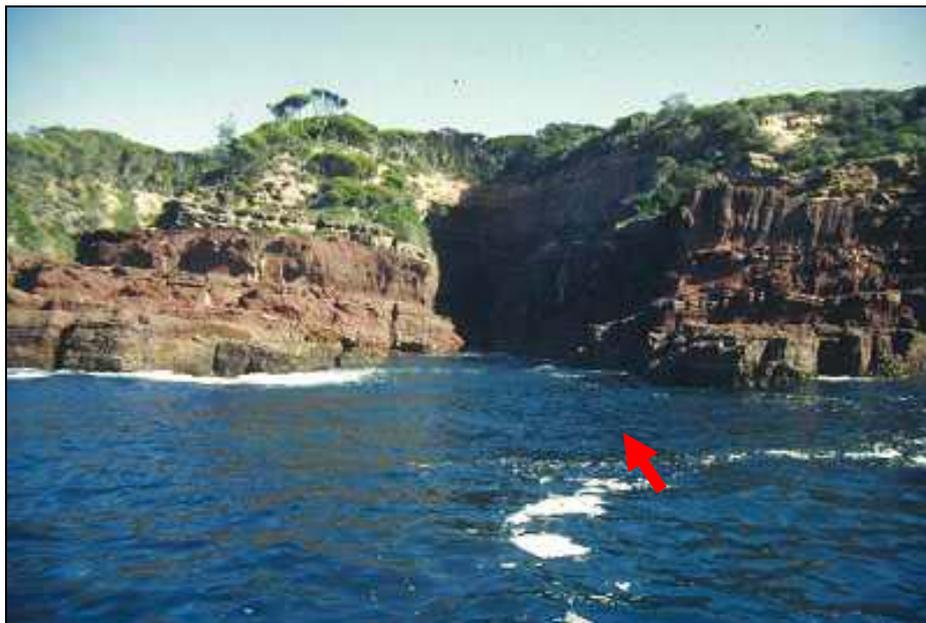
Figure 11: General photograph showing the location of the *Olive Cam* wreckage which is spread within a large gully (marked by arrow), close up to the fringing reef. (Photograph by David Nutley)

The staff of the *Merimbula Divers Lodge*, Merimbula pinpointed the position of wreckage attributed to the *Olive Cam* site. Exposed to heavy seas from the south, the wreck site is largely broken up with isolated items spread along several underwater gullies. The boiler, winch and a Lt. Rodges small palm anchor were located very close to a reef which extended from the shore. The maximum depth of the site was found to be thirteen metres. Attribution of the wreck site to the *Olive Cam* was confirmed based on the surviving components of the vessel. The site was not photographed or recorded in detail as it has been adequately identified and is not presently protected under the *Historic Shipwrecks Act, 1976*. A GPS position was obtained for the remains.

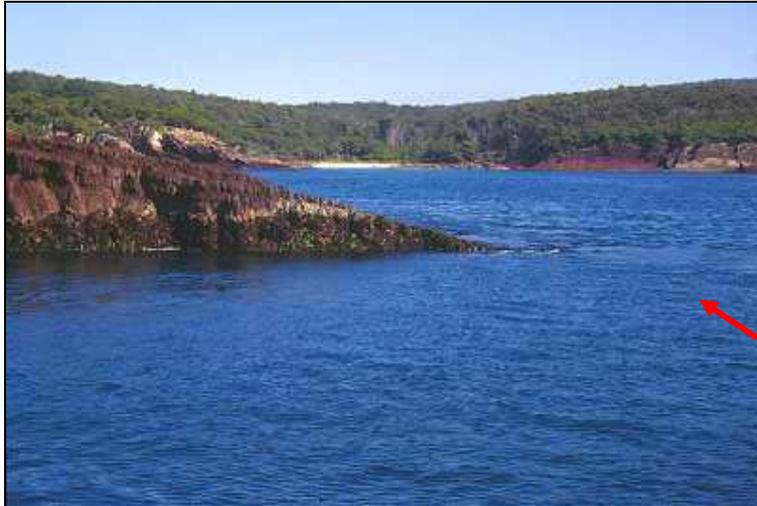
Figure 12: General photograph showing the location of wreckage tentatively attributed to the *Lanercost* (1872). The arrow to the left indicates the location of the gully in which scattered wreckage was located. The arrow to the right denotes the approximate position of the buried hull section. (Photograph by David Nutley)

Fastenings included copper alloy clinch bolts and wooden treenails of 3.5 centimetres (~ 1.5 inches) diameter. The timbers were generally sound although some showed evidence of toredo worm damage suggesting that they become periodically exposed. A GPS position was obtained for the buried hull structure.

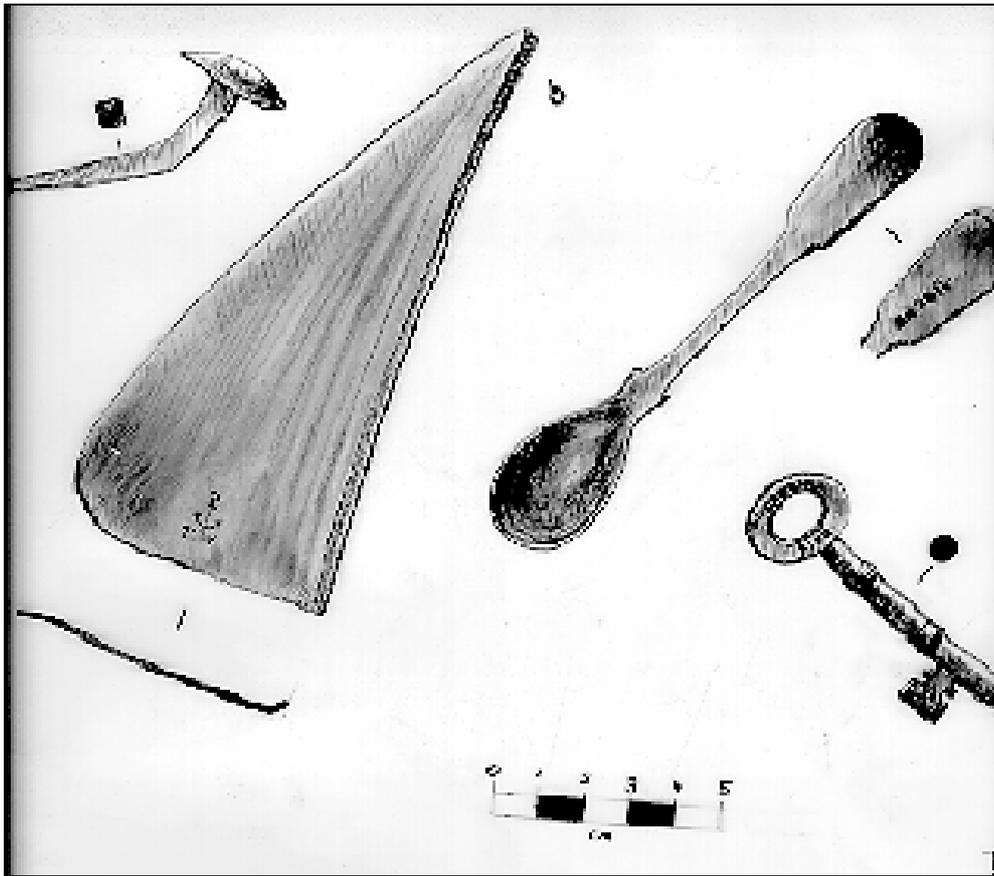
Figure 13: Measured drawings of artefacts recovered from the Lanercost (1872) wreck site and declared under the Commonwealth's Historic Shipwrecks Amnesty. Courtesy: Mr John Mathieson, Eden. (Drawn by : Tim Smith)

Local diver, John Mathieson also recovered several artefacts from the site which were subsequently declared under the Amnesty. These were loaned to the Heritage Office for detailed study during the current survey period. They consisted of a silver plated spoon, a key, a vane from a ship's log, a copper fastening spike and the lens of a telescope. These items were drawn and photographed (Figure 13 & 14).

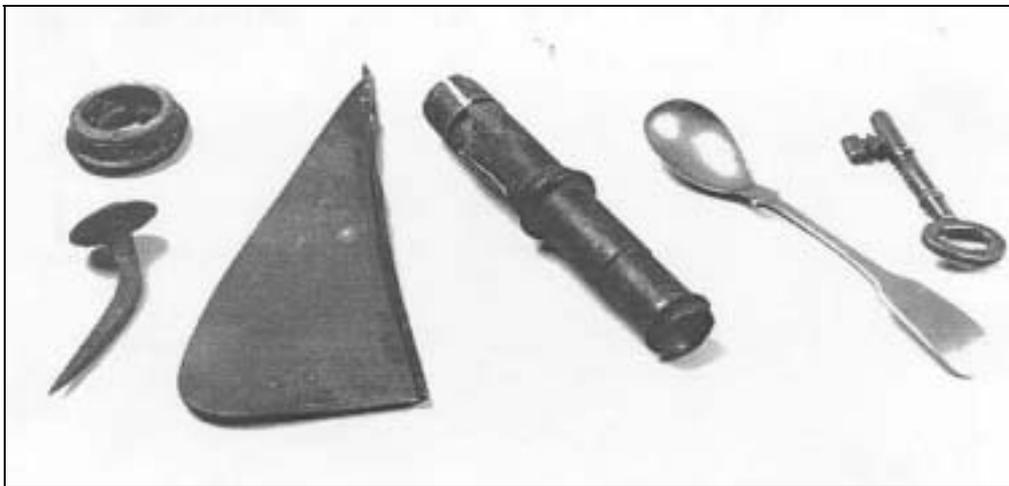
Figure 14: Photograph of the same objects recovered from the Lanercost wreck site.

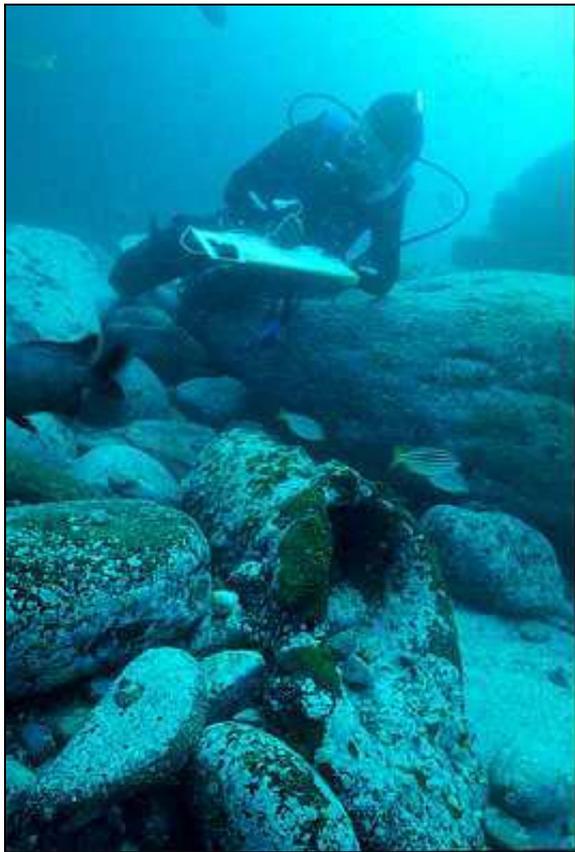
Figure 15: Tim Smith recording section of hawse pipe from Lanercost .
(Photograph by David Nutley)

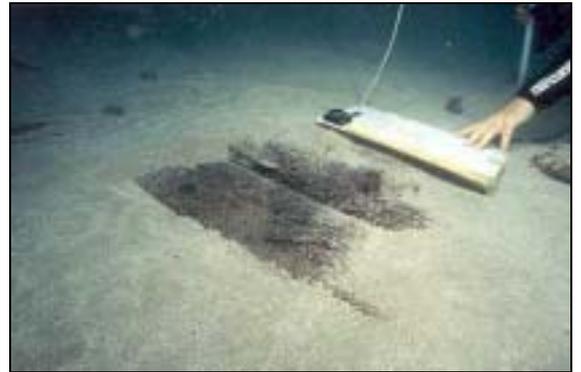
Figure 16: Ceiling timbers from buried portion of hull, tentatively attributed to Lanercost wreck.
(Photograph by David Nutley)

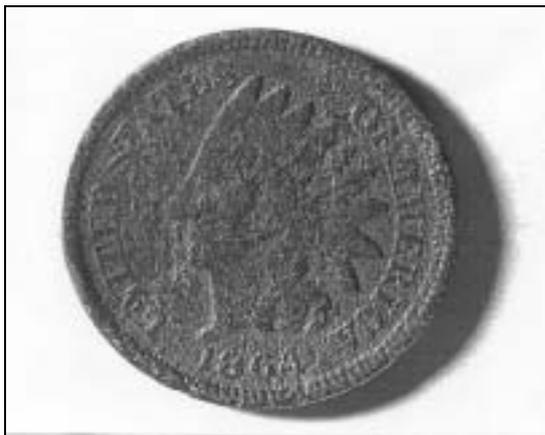
Figure 17: American one cent coin from Lanercost site.
Dated 1864, the coin is 19 millimetres in diameter.
Courtesy Mr John Riley.

gully, was minted in 1864, and is currently the strongest evidence for the wreckage being linked to the *Lanercost*. The brigantine *Oliver Frost*, was wrecked in 1856 and could not have had an 1864 coin aboard.

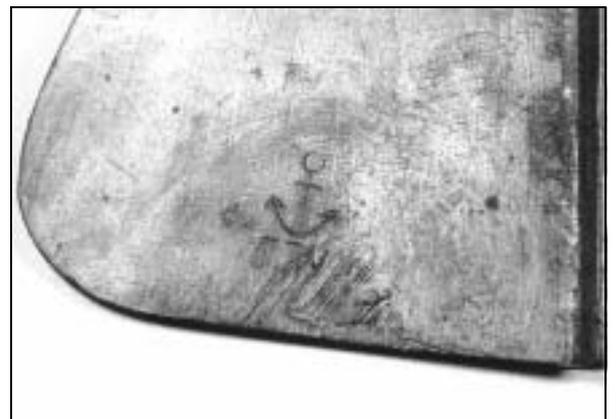
Figure 18: A vane from ship's log, Lanercost site.
Dated to c. 1866.

The vane from the ship's log (Figure 18) was marked with an anchor insignia and the letters "T.W." beneath. These letters refer to the maker's name, Thomas Walker, a prominent designer and manufacturer in the development of ship's logs during the nineteenth century. The markings indicate that the vane or fin came from a Walker's "Harpoon Log No.2" type which was patented in 1866. This model, according to Mr Kieran Hosty, Curator of Maritime Archaeology at the Australian National Maritime Museum, was superseded in 1879 by the Taffrail Log made by his sons, following Walker's death in 1873 (Source: Peabody Museum: Collection of Navigational Instruments, 1967). The *Oliver Frost*, wrecked in 1856, could not have carried an 1866 designed log aboard.

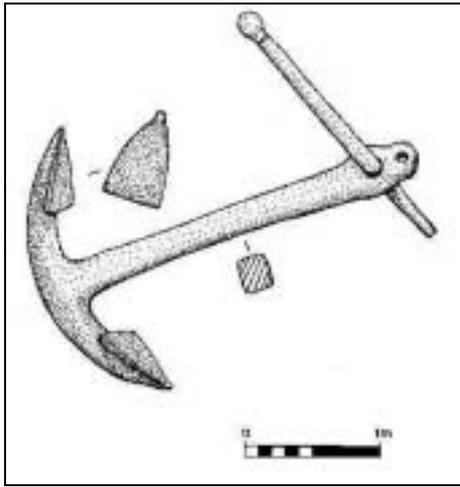
The two anchors were drawn (see example in 19), the rest of the site being recorded on video and still photography. A GPS position was obtained for the site.

Extensive wreckage can be readily detected, spread down the gentle slope from the shore into deeper water. Prominent features include the two identical large iron Admiralty pattern anchors, 2.5 metres in length. One is located on sand in twenty two metres of water at the deepest part of the site, the other amidst the greater part of the wreckage in approximately 16 metres. The majority of the site comprises fragments of the hull's iron plating and framing, although the wreck is extensively broken up due to the exposed nature of the site and early salvage activity.

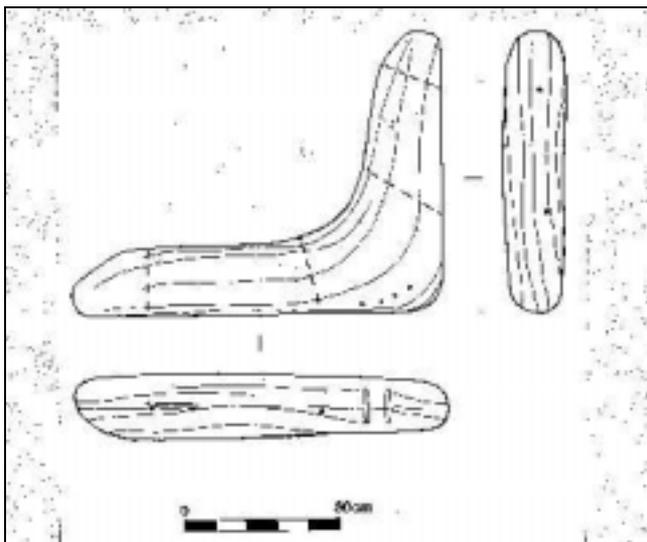
Figure 20: Drawing of timber "knee" located in small bay west of ss New Guinea site. (Drawn by Tim Smith)

While moving from the *City of Sydney* wreck site to the *New Guinea*, Mr Cam McColl (Merimbula Divers Lodge) pinpointed a large timber located in a small bight on the southern side of Green Cape. Wading ashore and inspecting the beach, the timber was identified as being a 'knee' or 'framing piece', which might have derived from a large timber vessel. Located amongst extensive deposits of drift wood, which seem to collect largely at that spot, the origin of the timber could not be determined. Based on the dimensions (1.20 x 0.90 metres), the object appears to be a 'stern knee' (an angular timber that reinforces the joint between the keel or lower deadwood and the stern post, or perhaps a hanging knee (deck support) on a large timber vessel such as a barque or ship. The knee was drawn and photographed (Figure 20-21).

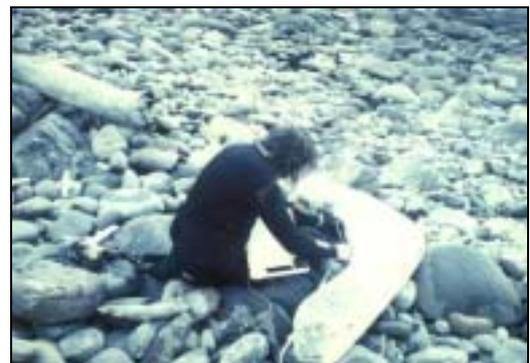
Figure 21: Photograph of the timber "knee" in a small bay near New Guinea wreck site. (Photograph by David Nutley)

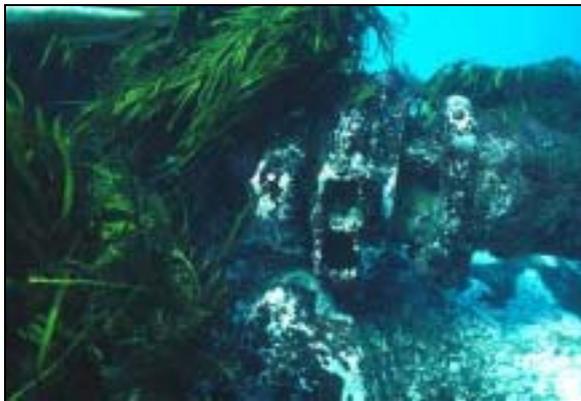
Figure 22: Wreckage of the ss *New Guinea* - includes a portions of the vessel's drive shaft. (Photograph by David Nutley)

Similar to the *City of Sydney* wreck, the area is prone to extreme sea activity from the south, resulting in the wreckage being fragmentary and scattered. Major features included a large section of hull flooring, the propeller shaft lying in two pieces, and portions of the four bladed propeller. The site extends from the shoreline (although this area could not be fully inspected due to swell on the day), out to approximately 10 metres in depth. A GPS position was gained for the principle wreckage. Like the *City of Sydney* and the *Ly-ee-Moon* sites, substantial salvage activity has effected the site's integrity and its archaeological potential.

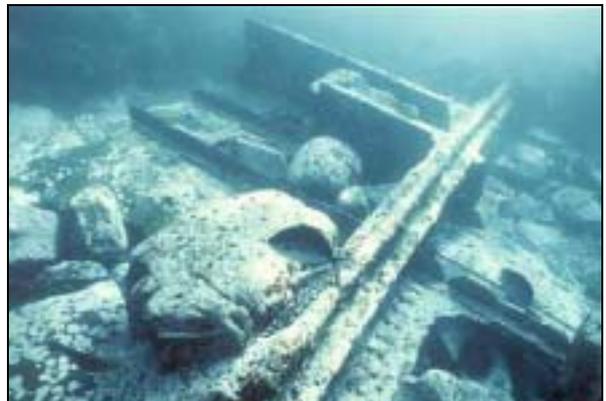
Figure 23: Section of lower hull, ss *New Guinea*, fragments of which can be found across the site. (Photograph by David Nutley)

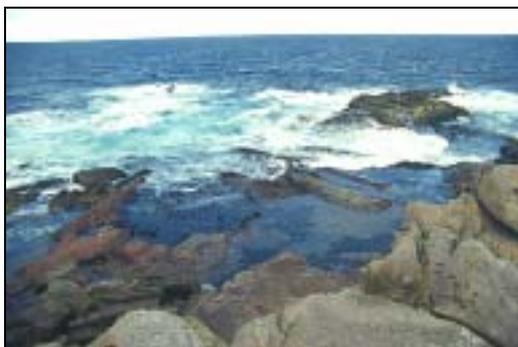
Large seas repeatedly carry over the wreck, located amongst two exposed bommies under the point of the Green Cape lighthouse. The major identifiable piece of wreckage include a large propeller shaft previously noted by Mr David Warth (*Merimbula Divers Lodge*). It was evident that the wreckage is extremely broken up and scattered around the point. Few shipwreck relics could be identified at the seaward end of the main gully leading into the site. The remains have been largely dispersed by the extreme sea conditions, although extensive salvage activities undertaken during the 1960's, have contributed to its denuded nature.

Figure 24: View of the tip of Green Cape where *Ly-ee-Moon* came to rest in 1886 (Photograph by David Nutley)

Several lead ingots were located in the smaller gullies. David Warth had also previously located a smaller propeller shaft on the site which seemed at odds with the scale of the *Ly-ee-Moon* wreckage. It was postulated that the *Lady Dorris*, a vessel used to salvage materials from many of the local wrecks, was also lost there (see Section 4.2). Later conversations with Mr Carlo Filippetti indicated that this vessel was actually wrecked at Bittangabee. Video footage was taken of the site and an accurate position determined.

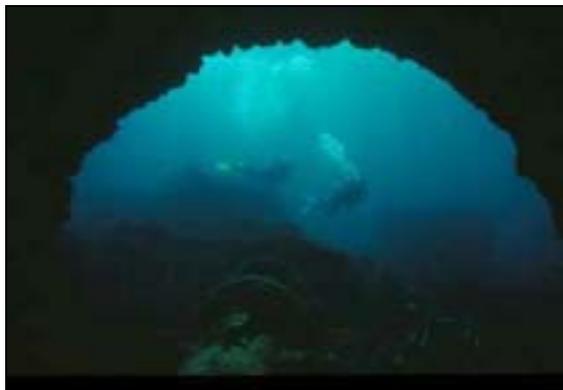
Figure 27: Diver inspecting cabin sections of the *Empire Gladstone* wreck
(Photograph by David Nutley)

Remains of the wreck have survived well, despite large swells which periodically flow over the site, located in just ten metres of water. The vessel settled upright and portions of deck structure and associated machinery can be readily identified across the 135 meter extent of the site. Principal remains include the relatively intact 'cabin' areas amidships, the large boilers upended, the engine and both propeller shaft housings, which offer excellent swim throughs. The bow and stern of the site have suffered more deterioration and are less discernible. A GPS position was obtained for the remains.

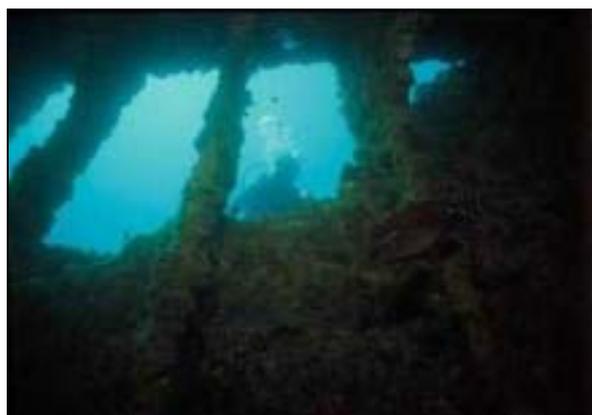
Figure 26: Heritage Office maritime archaeologists exploring the *Empire Gladstone* wreck site at Merimbula. The vessel's large boilers can be seen in the background.
(Photograph by David Nutley)

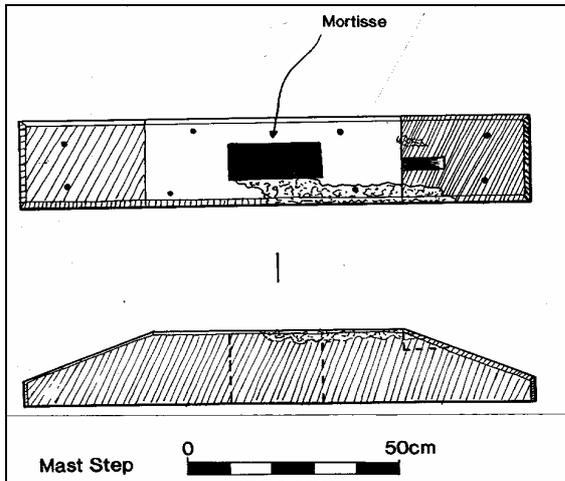
Figure 29: Timbers recovered from the unidentified wreck site located off Cape Howe (Drawings by Tim Smith)

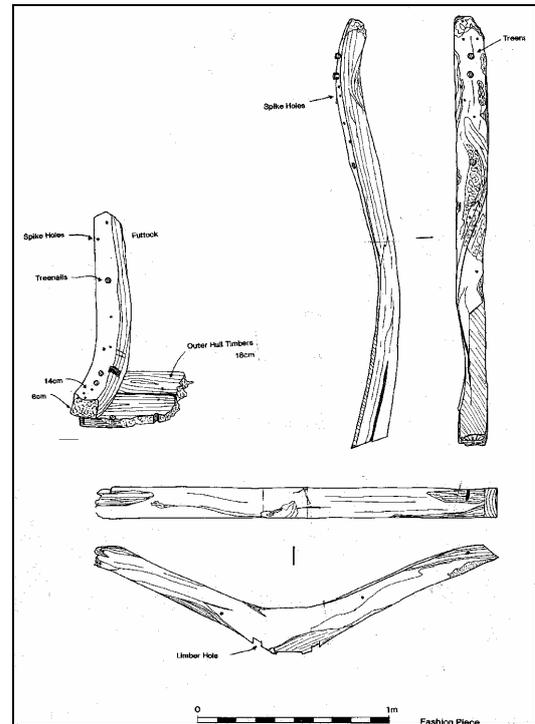
Figure 30: Timbers recovered from the unidentified wreck site located off Cape Howe (Photographs by David Nutley)

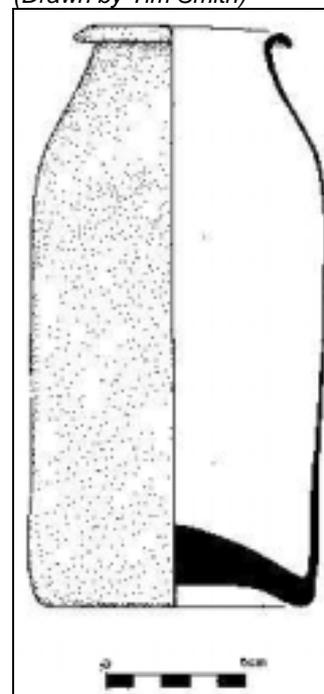
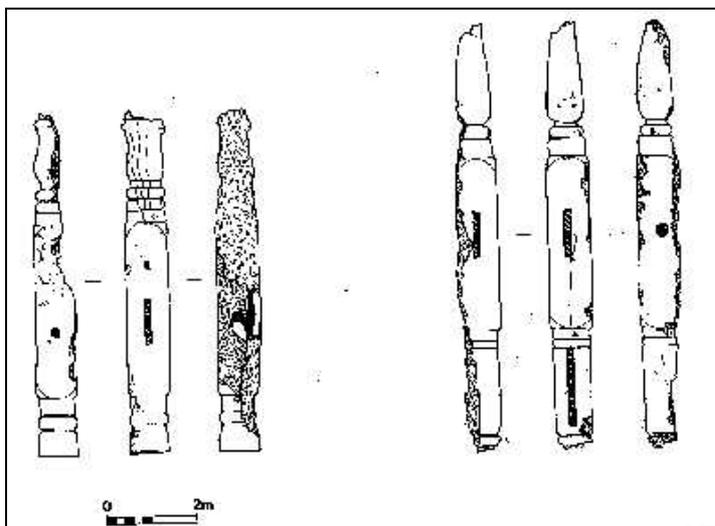
Figure 32: Measured drawings of two small turned posts, recovered from the unidentified wreck off Green Cape. They may belong to a fence or rail aboard the vessel. (Drawn by Tim Smith)
