# Section 91 Licence

## **GEOTECHNICAL OPINION** **REMOVAL OF TREE NEAR DRIVEWAY** **59 HERBERT AVENUE, NEWPORT**

# ARBORICULTURAL IMPACT REPORT

59 HERBERT AVENUE  
NEWPORT

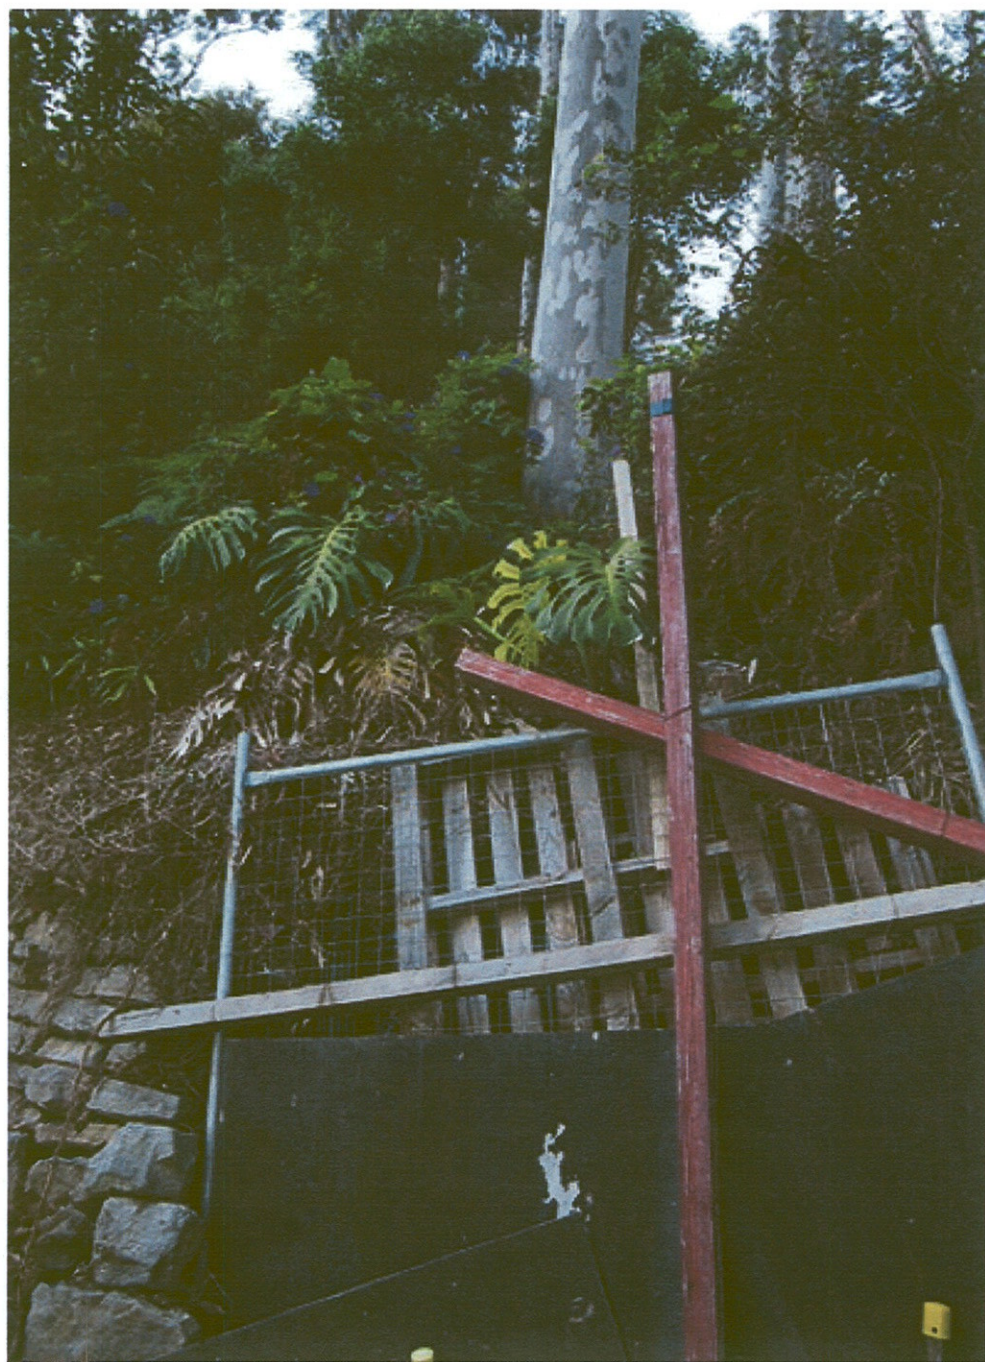
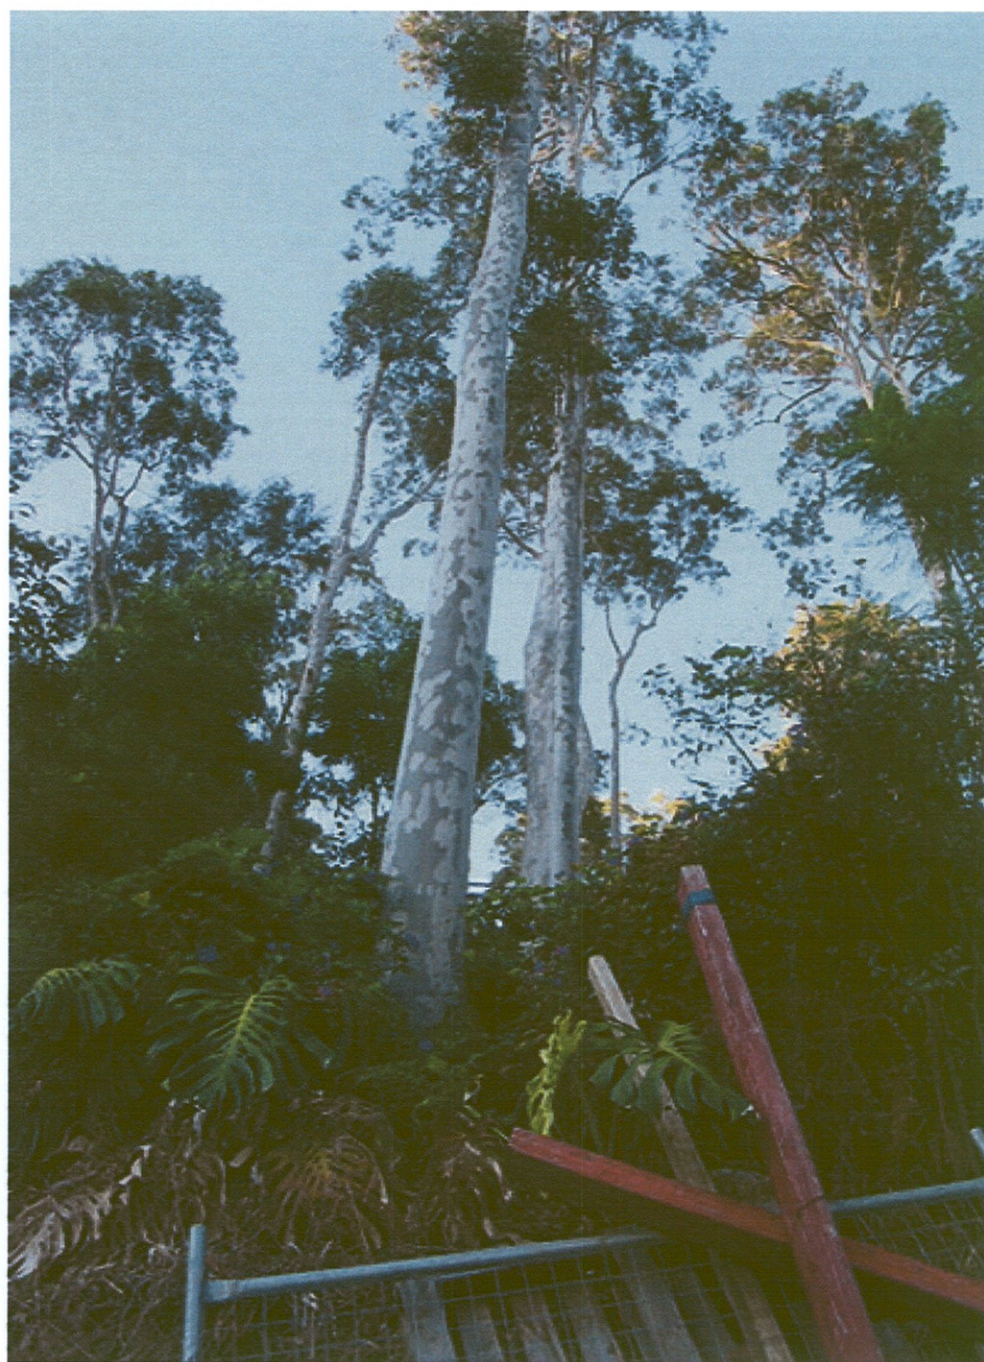
Enc. Selected photographs of tree to be removed.

At the time of our site visits during the construction of the driveway widening, we noted distress to the retaining wall on the high side of the lower portion of the driveway which needs to be repaired. At that time, the damaged wall was propped from the driveway slab, and the retaining wall needs to be repaired for long term stability. As part of the retaining wall repairs, it will be necessary to remove this temporary propping and the careful removal of the damaged portion of retaining wall. There will also be some scaling back of loose soil behind the retaining wall.

Once the retaining wall and some of the soil is removed, the support to a tree immediately behind the works area will be compromised. Further, the presence/weight of the tree could have a destabilising effect on the temporary soil face during the works. This obviously forms a risk to worker safety during the works.

In addition, it is likely that some of the roots of the tree will be cut during the works, further destabilising the tree. Should the tree be left in place, due to its proximity to the

retaining wall, it is likely that the replaced portion of retaining wall will be further damaged by root growth.

Our recommendation is that the tree be removed prior to the commencement of any further work to repair the retaining wall. While the tree should be removed, we recommend against the grubbing out of the roots as the roots assist the near surface stability of the soil, and the disturbance from grubbing out increases the risk of erosion and surficial soil slumping.

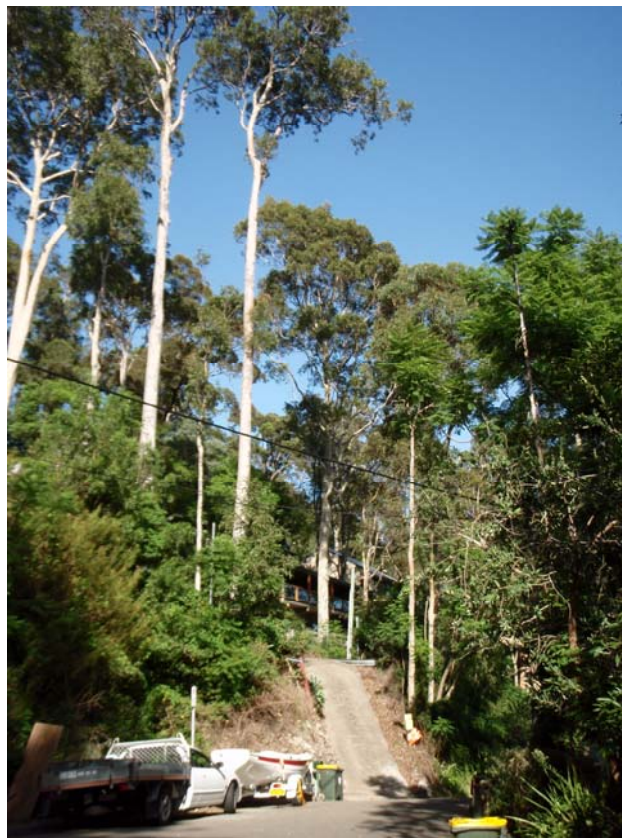
The tree is located in a steeply sloping area above the existing driveway access to the site. The location and context of the tree is illustrated in the photograph on the cover page of this report.

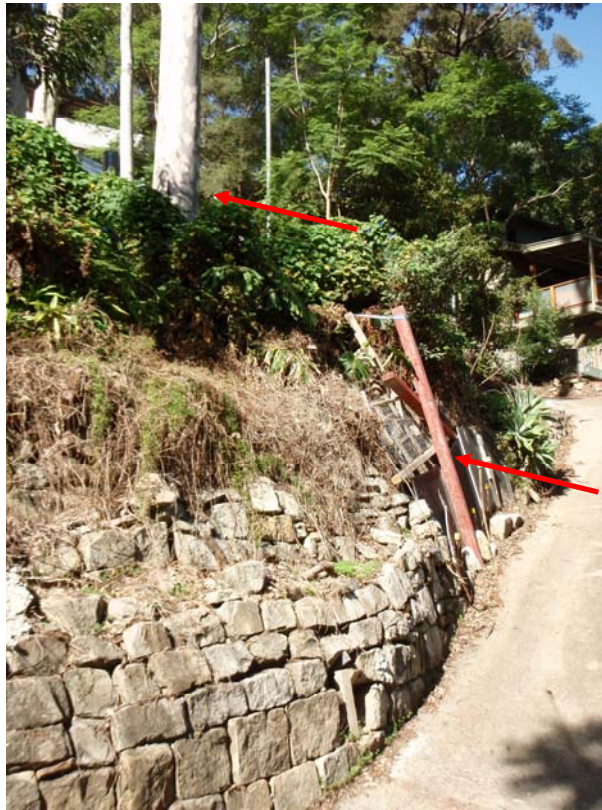
As noted earlier in this report, the tree is located in a steeply sloping area above the existing driveway access to the site. There has been disturbance within the tree's root in the recent past during a heavy rainfall event. This disturbance comprised the partial failure of the retaining wall located below the tree and immediately adjacent to and above the driveway access to the site.

- The section of retaining wall that has collapsed/failed is located 2.1 metres from the tree on the northern side of the tree;
- There is evidence of landslip behind the failed section of wall;
- The embankment below the tree has been identified as unstable by the site geotechnical engineer (K Weston Pers. Comm.);
- The area where the failure has occurred and identified as unstable by the site geotechnical engineer is within the tree's structural root zone (i.e. the area required for stability (as identified in AS4970);
- The majority of the tree's canopy is to the north of the trunk; and
- Further disturbance is required to effect repair works to the retaining wall including drilling back into the soil within the tree's structural root zone.

Photograph 1: Illustrating the location of the tree immediately above the failed section of retaining wall and adjacent embankment.

In the event a suitable restraint system is not available the removal of the tree must be considered an option given the location of high occupancy targets (dwellings) within the failure zone of the tree.

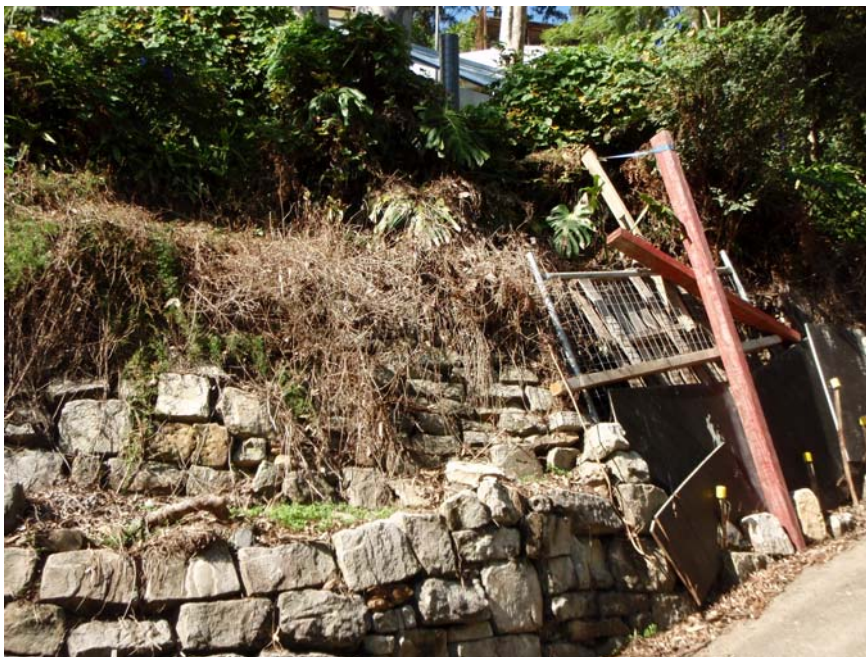
Significant concerns are raised in regard to the tree's stability given the recent failure within the tree's structural root zone on the north side, the tree's canopy imbalance to the north and the advice of the geotechnical engineer that the embankment area in the structural root zone below the tree is unstable.

Photograph 2: Illustrating the failed section of retaining wall and adjacent embankment.

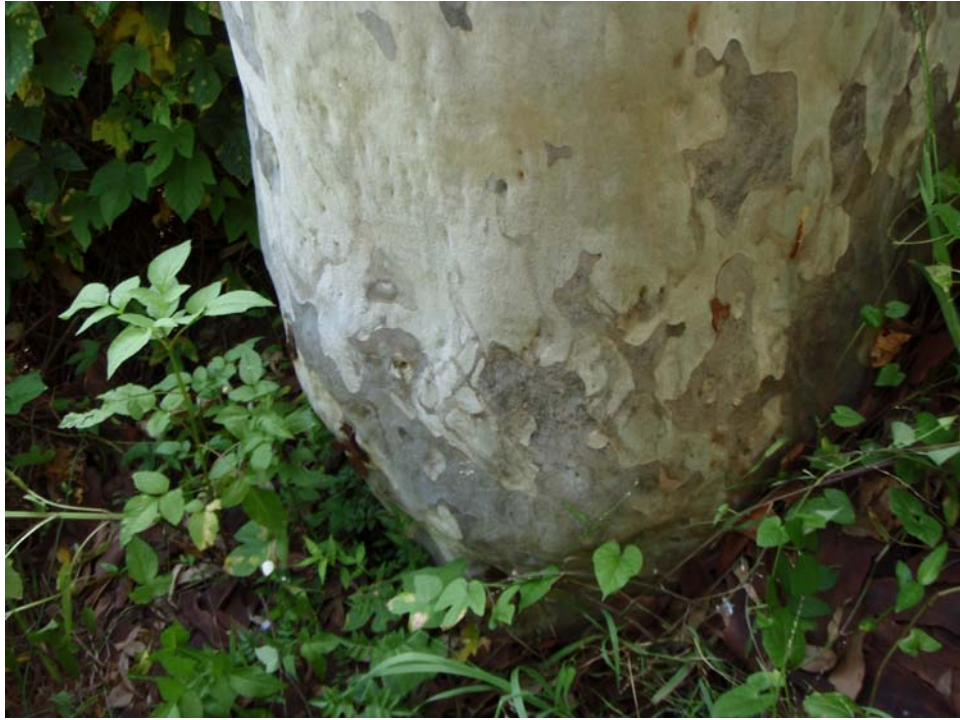
While there was no visual evidence of significant pest or disease there was reaction wood present in the basal trunk. The presence of this reaction wood is indicative of possible internal damage from termite activity or decay - without further, invasive testing, it is not possible to confirm the structural integrity of the basal trunk of the tree.

Photograph 3: Illustrating the reaction wood in the basal trunk possibly indicative of internal decay or termite damage.
