YANGA

CONSERVATION MANAGEMENT PLAN PART 2

FEBRUARY 2013

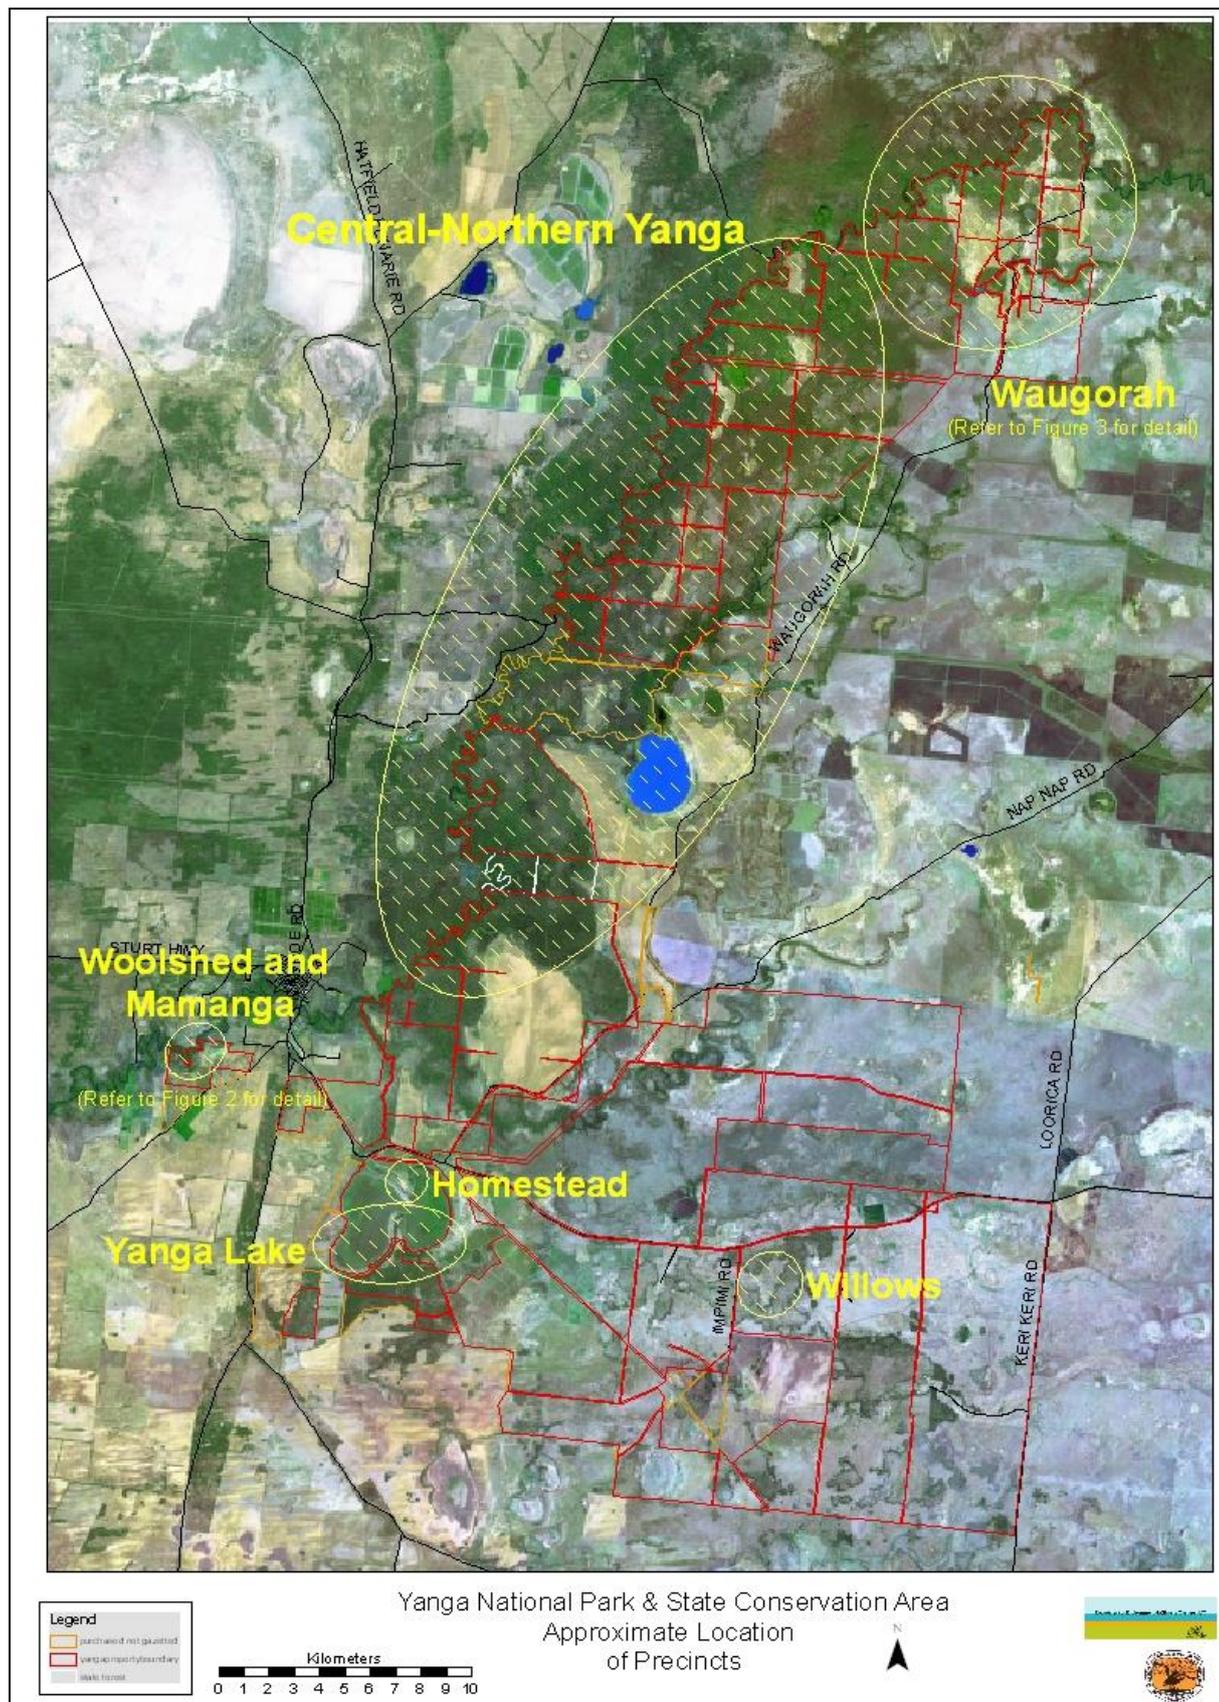
Figure 6.5.1 Approximate location of precincts in Yanga as identified in Visitation Establishment Plan 2008.

The following map was prepared for the Visitation Establishment Plan and indicates the sites and precincts discussed in the plan. The following more detailed plans show the Mamanga and Waugorah areas and sites addressed in the VEP.

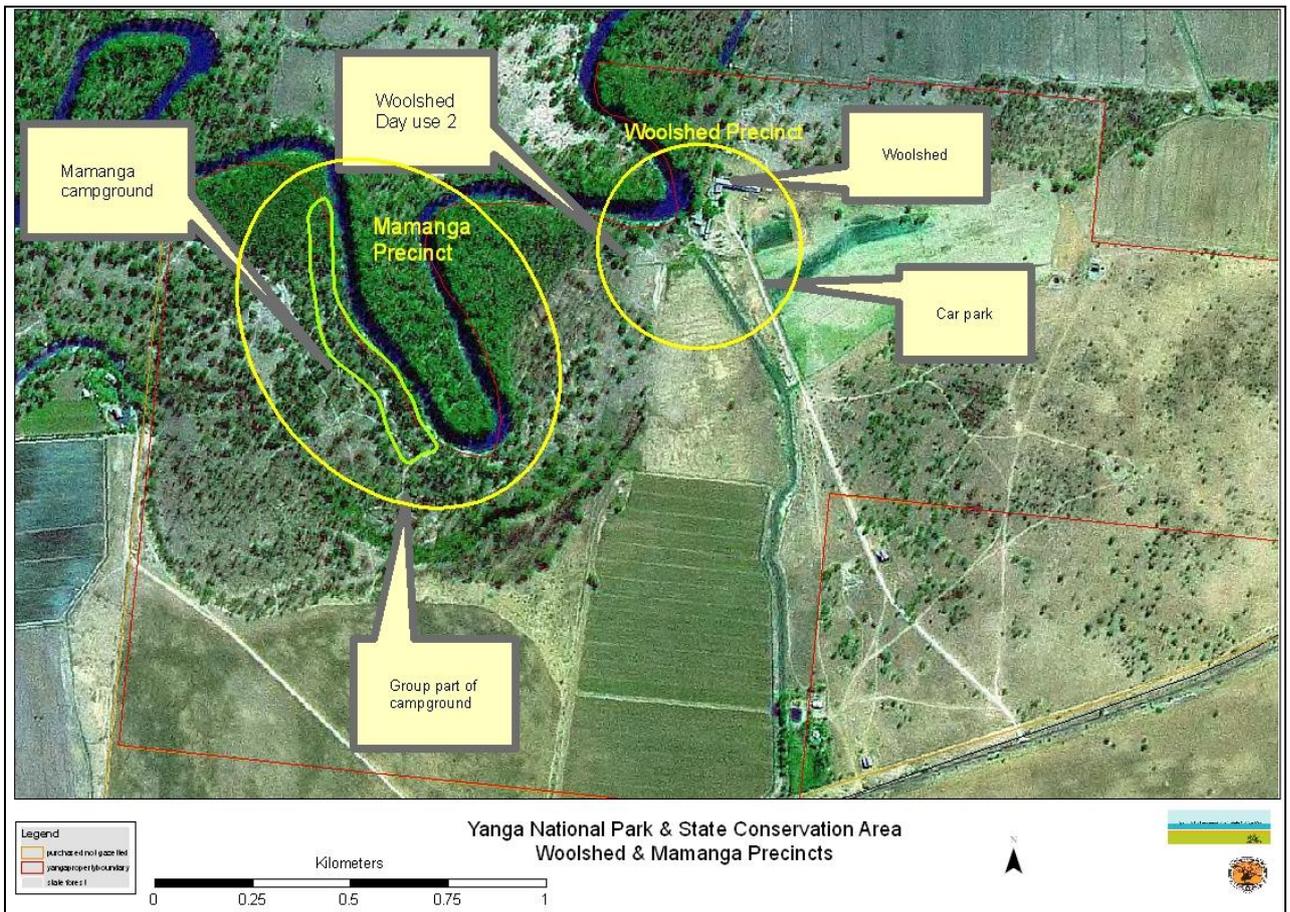
Figure 6.5.2 Woolshed and Mamanga precincts detail, contained in Visitation Establishment Plan, 2008. The final Camp Ground location differs from this plan but is in the vicinity.

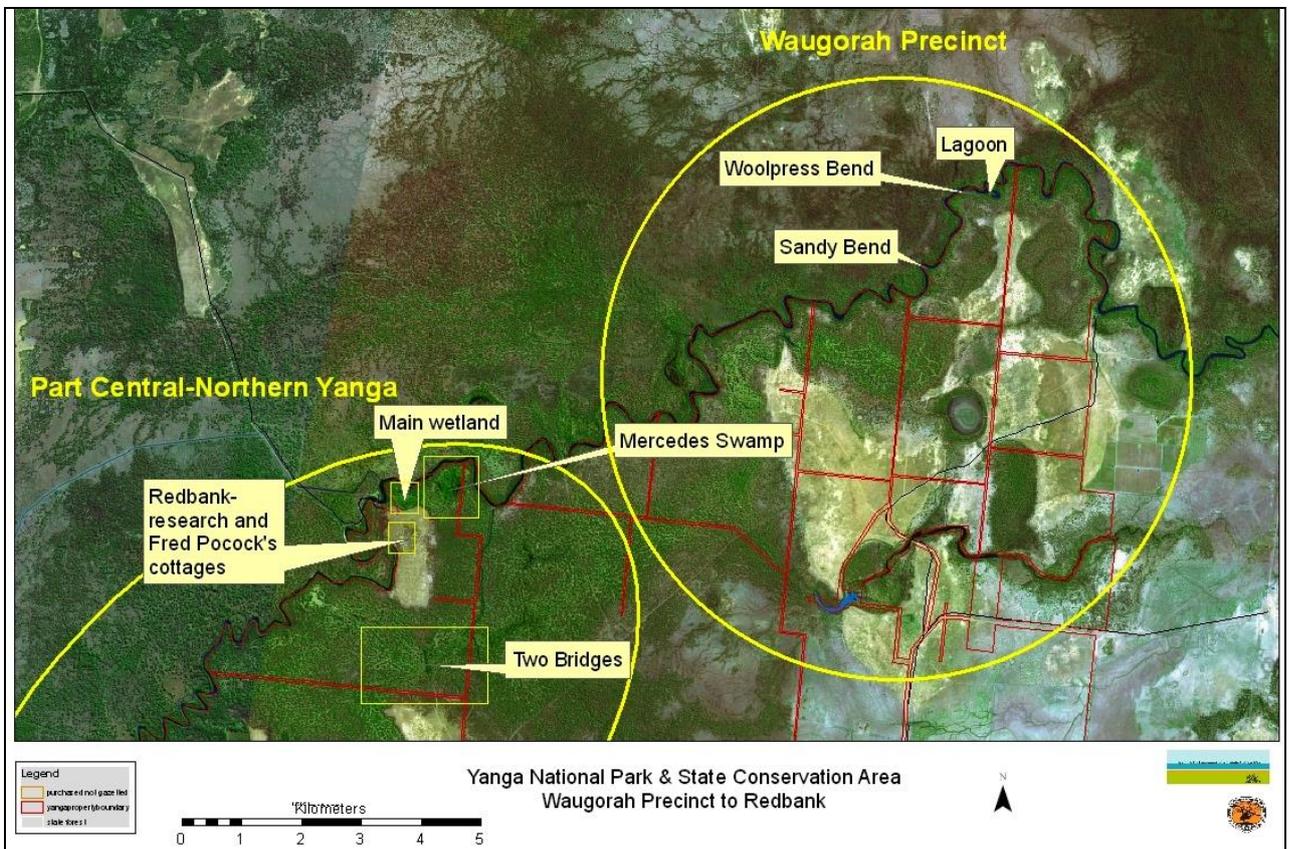
Figure 6.5.3 Waugorah Precinct to Redbank detail, from Visitation Establishment Plan 2008.

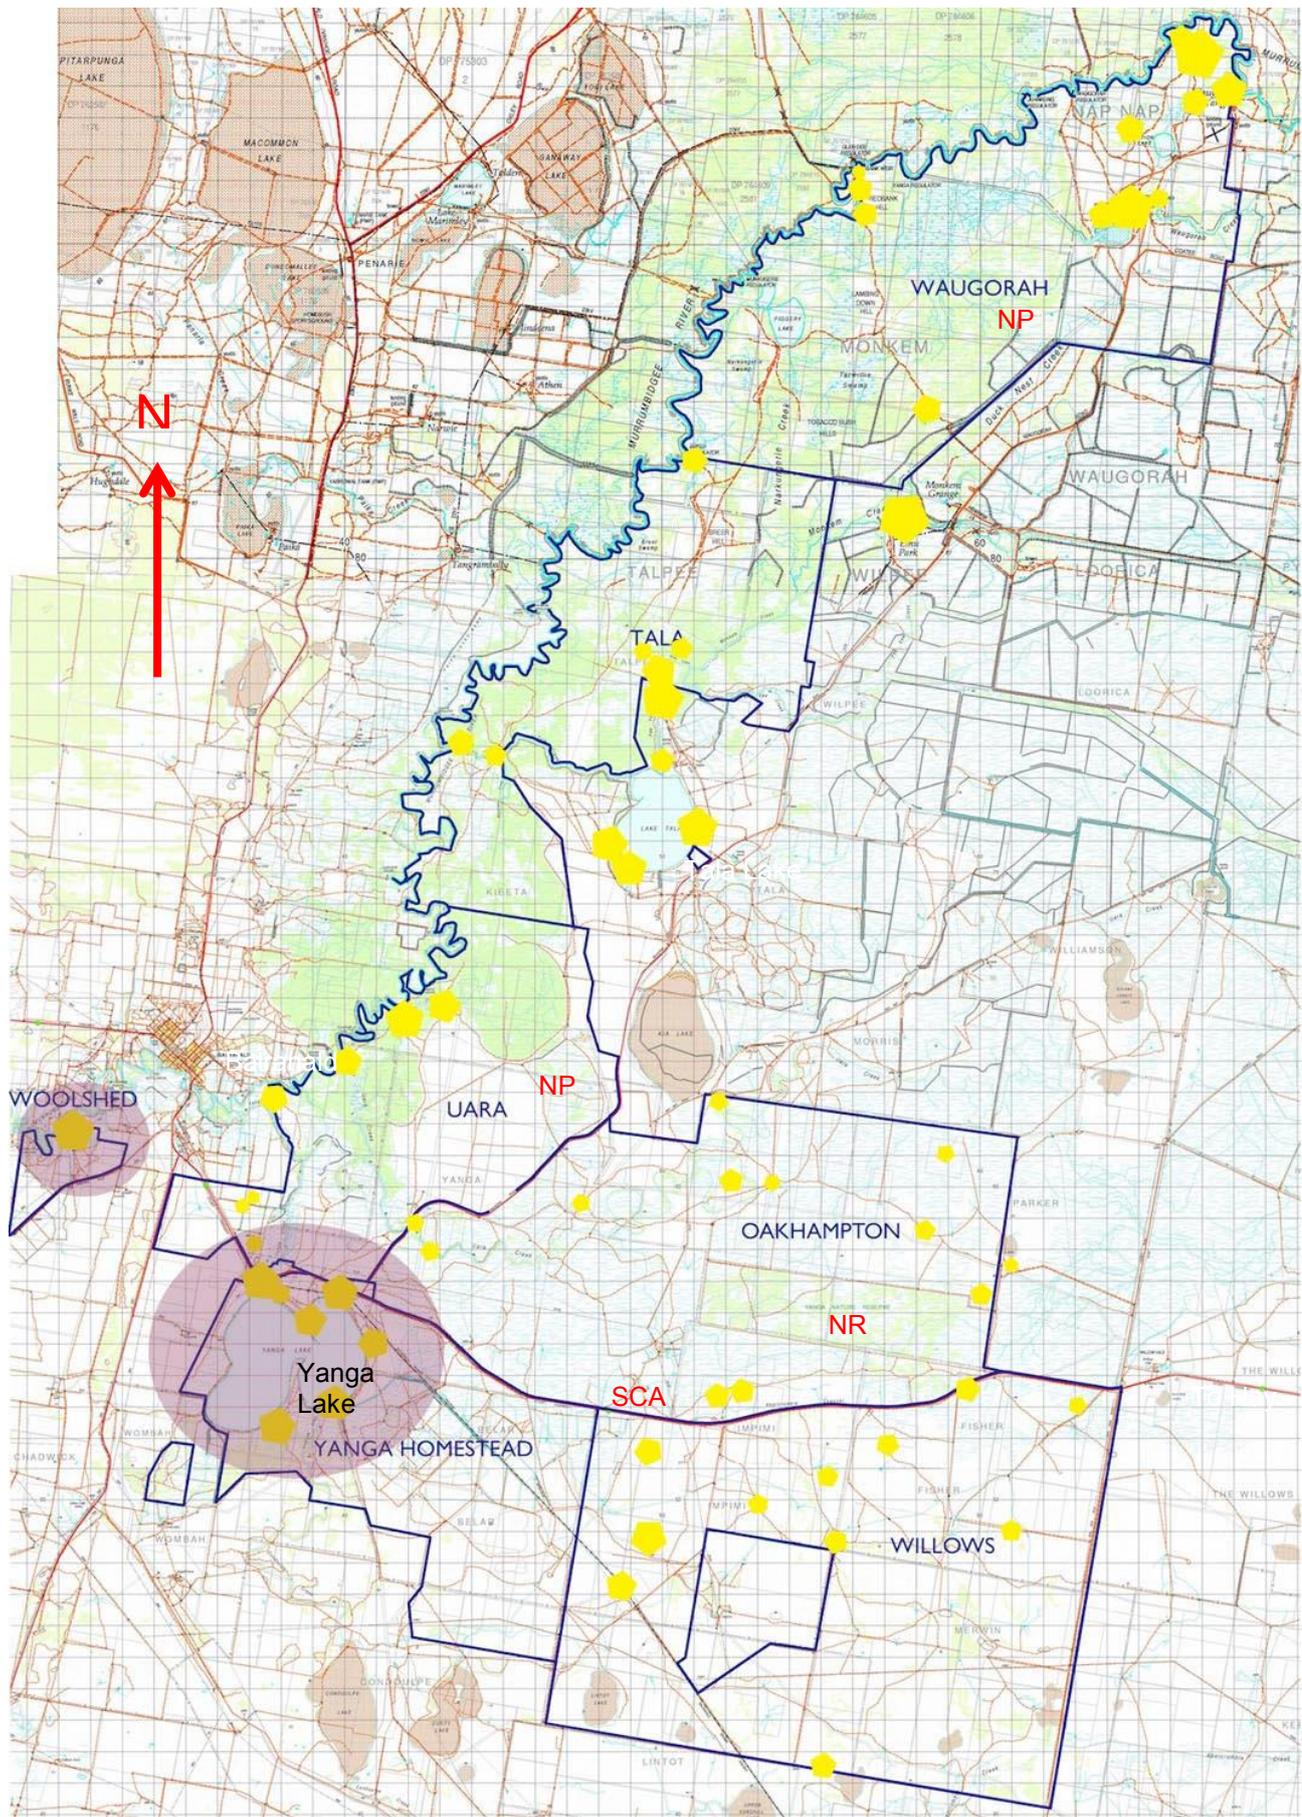
Figure 7.1 Yanga Reserves Archaeological Zoning Plan - Historical. Archaeological remains may be found anywhere but can be predicted to be found at the sites indicated above. The yellow shapes indicate sites where historic structures exist or where historic maps show earlier structures. The large circles indicate areas intensively used in the past and where there is a higher likelihood of remains. Source: Authors.
