# Darling Baaka River Health Project 2023 to 2025

## Chapter 5 Riparian vegetation condition

Department of Climate Change,  
Energy, the Environment and Water

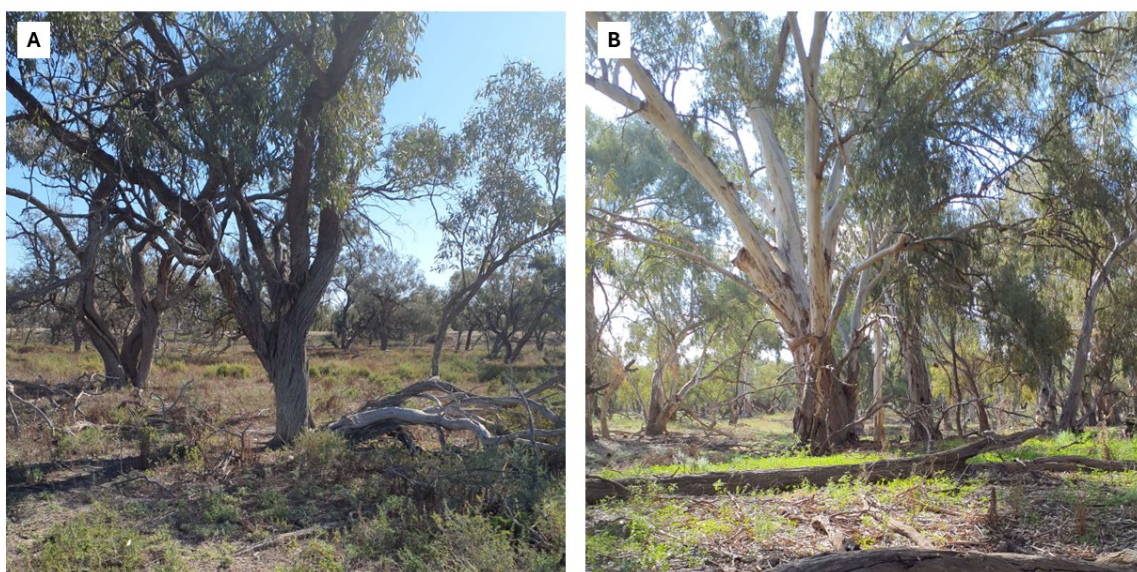
**Figure 15**      **A:** Black box plot near Cawndilla Channel (subcatchment 1474) indicating 3 vegetation layers **B:** River red gum open forest adjacent to the Darling Baaka at Kincheha National Park (subcatchment 1518)
