SCHEYVILLE NATIONAL PARK CONSERVATION MANAGEMENT PLAN

Volume 1

HISTORY

Prepared for the NSW National Parks and Wildlife Service
Department of Environment and Climate Change

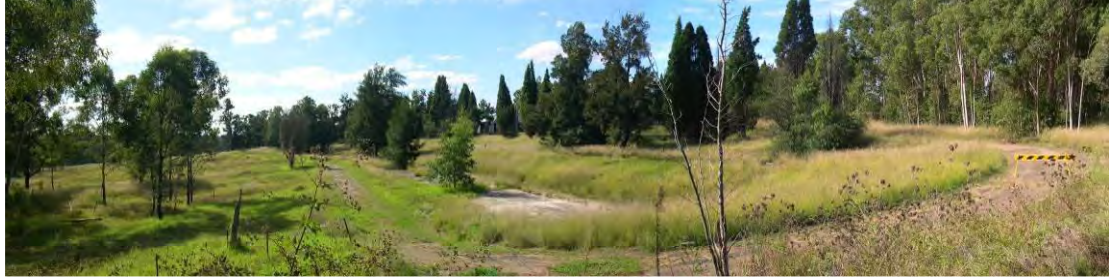
Figure 79 Roadway & slabs near parade ground with distinctive Cypress trees around Huts, 2005. This area is becoming infested with Lemon-scented Gum (*Eucalyptus citriodora*) which has seeded from ornamental plantings.

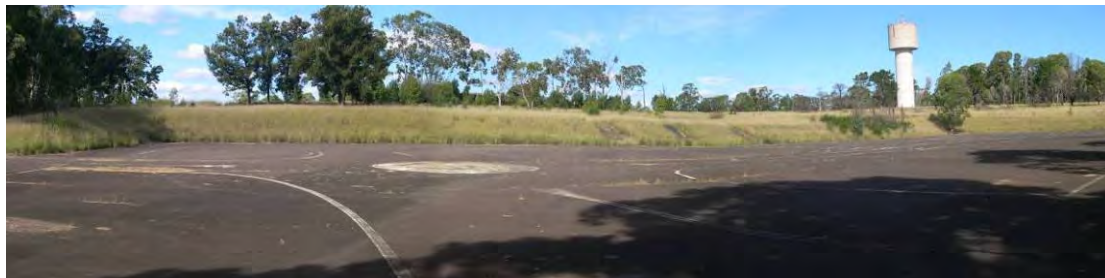
Figure 85: Parade Ground and water tower

The Parade Ground, (Figure 95) from the OTU period, is located in the south-western corner of the camp. It is a large rectangular area paved in bitumen. A set of steps leads from the Parade Ground up a small embankment to a cement platform where official guests officiated at Graduation Parades and other special occasions. A cannon and a flagpole were situated near the bottom of the steps. In the background the 1967 water tower can be seen.

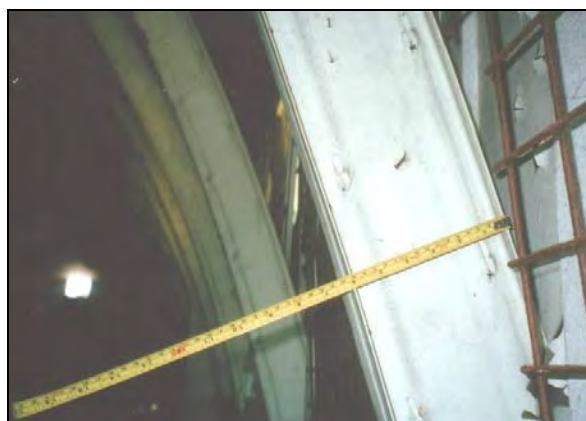
Figure 4.2: Structural “I” rib showing rivets and U section
(Source - P Lofthouse)
