**Beachwatch**

# State of the beaches 2021–22

North Coast Region

Department of Planning and Environment

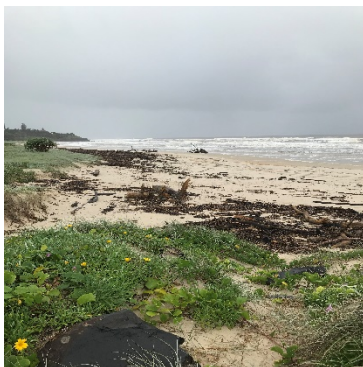
Debris at Lighthouse Beach following extreme wet weather and flooding in March 2022

While microbial levels returned to normal at many swimming sites, there was still a large amount of debris or other hazards, such as murky water, which posed a risk to recreational activities.

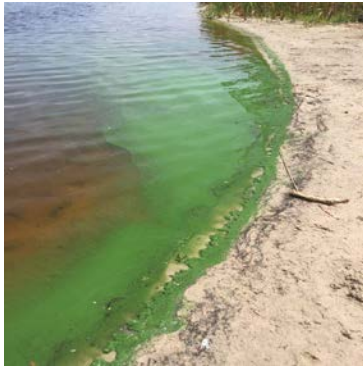
Blue-green algal bloom present in the water  
Photo: Rachael Jenner/  
Ballina Shire Council

Water NSW and Ballina Shire Council reported the occurrence of freshwater blue-green algal blooms, *Dolichospermum circinale* impacting Lake Ainsworth in October to December 2021. Water NSW also issued a caution alert for *Trichodesmium* sp. in the Richmond River and its tributaries and on the coast in October and November 2021.

The appearance of **algae** is sometimes mistaken for **sewage contamination** due to a strong odour and thick green scum or discolouration in the water caused by the blooms.

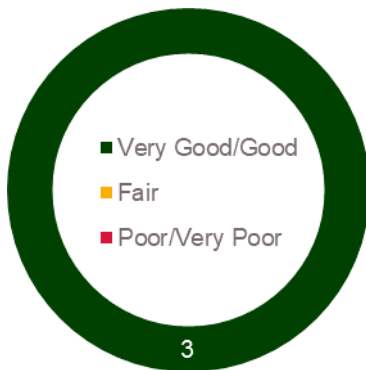
**Beach Suitability Grades for Ballina Shire Council ocean beaches**

Seven Mile Beach, Shelly Beach and Lighthouse Beach continued to be graded as Very Good in 2021–2022. These beaches had excellent water quality and were suitable for swimming almost all of the time.

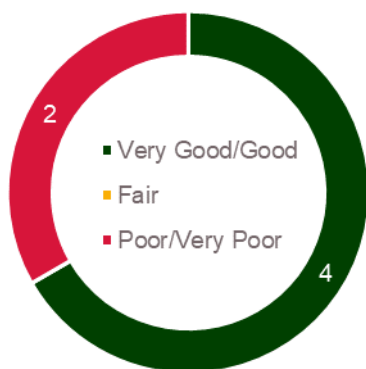
**Beach Suitability Grades for Ballina Shire Council estuarine beaches**

Four of the 6 estuarine swimming locations were graded as Good in 2021–2022: Shaws Bay East, Shaws Bay East Arm, Shaws Bay East Beach and The Serpentine. Water quality at these sites was frequently suitable for swimming in dry weather, with 91% or greater of dry weather samples within the safe swimming limit.

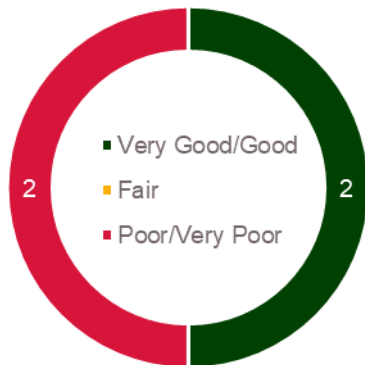
Lake Ainsworth North and Lake Ainsworth West were graded as Poor, a result consistent with previous years. Elevated bacteria levels were recorded at these lake swimming sites during dry and wet weather conditions. Despite the poor grades, between 72% and 81% of dry weather samples were within the safe swimming limit. These sites may be impacted by a number of significant potential sources of faecal contamination, including stormwater, and have low levels of flushing. During 2019, council investigated the source of microbial contamination by testing additional samples for faecal sterols at sites within Lake Ainsworth. The results found that the main contributors to elevated bacteria levels are from avian (bird) sources.

**Beach Suitability Grades for Ballina Shire Council lake/lagoon swimming sites**

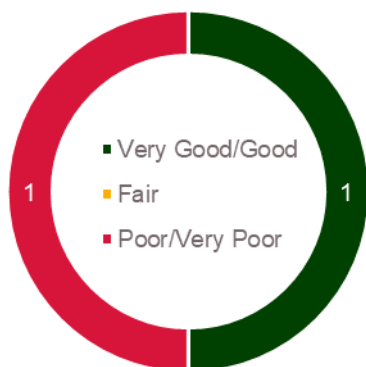
Beach Suitability Grades for Richmond Valley Council estuarine beaches

Elm Street Bridge North in the Evans River was graded as Good in 2021–2022, a similar result to previous years. Water quality was mostly suitable for swimming during dry weather, with 85% of samples within the safe swimming limit. Elevated bacterial levels were often recorded following rainfall.

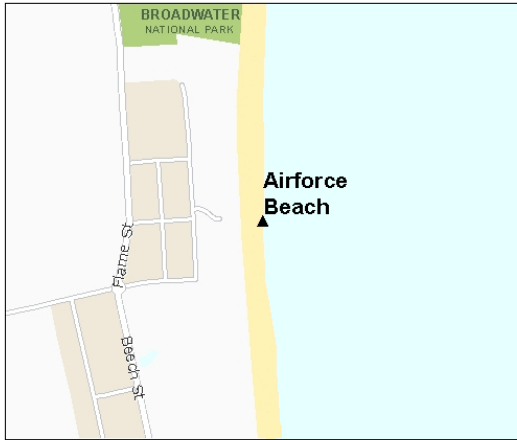
# Airforce Beach

Beach grade: **G**

Airforce Beach is located on a 31 km stretch of beach and is not patrolled by lifeguards.

The Beach Suitability Grade of Good indicates microbial water quality is considered suitable for swimming most of the time but may be susceptible to pollution after rain, from several potential sources of faecal contamination including stormwater.

Airforce Beach and Main Beach continued to be graded as Good in 2021–2022, a similar result to the previous year. While water quality at these beaches was suitable for swimming most of the time, elevated results were occasionally recorded in dry and wet weather conditions.

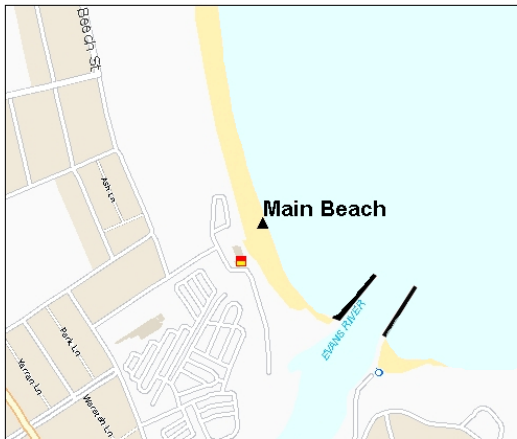
# Main Beach

**Beach grade:** G

Main Beach is located at the southern end of a 31 km stretch of beach and is patrolled during holiday periods.

The Beach Suitability Grade of Good indicates microbial water quality is considered suitable for swimming most of the time but may be susceptible to pollution after rain, from several potential sources of faecal contamination including stormwater.

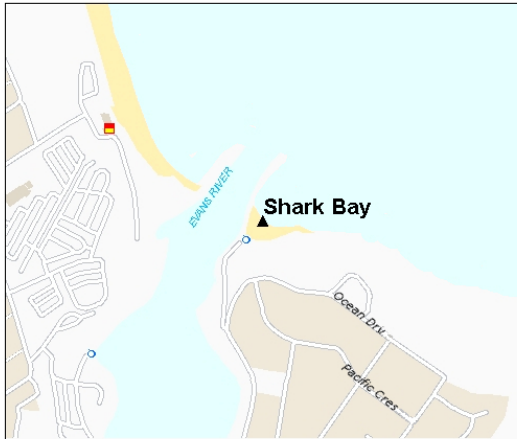
# Shark Bay

Beach grade:

Shark Bay is a small beach located between the southern entrance wall to the Evans River and the cliffs below Razorback Lookout and is not patrolled by lifeguards.

The Beach Suitability Grade of Very Good indicates microbial water quality is considered suitable for swimming almost all of the time, with few potential sources of faecal contamination.
