## Beachwatch

# State of the beaches 2023–24

North Coast region

Department of Climate Change,  
Energy, the Environment and Water

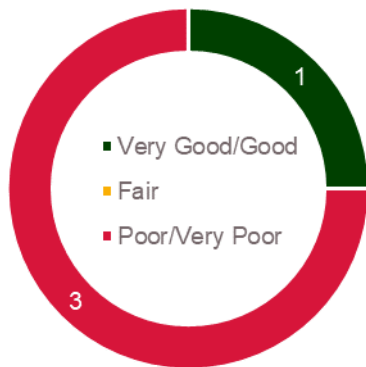
**Beach Suitability Grades for Ballina Shire Council lake/lagoon swimming sites**

Lake Ainsworth South continued to be graded as Good in 2023–2024. This site was mostly suitable for swimming during dry weather, with 84% of dry weather samples within the safe swimming limit. Elevated enterococci levels were frequently recorded at this site after heavy rainfall.

Lake Ainsworth North, Lake Ainsworth East and Lake Ainsworth West were graded as Poor in 2023–2024, a result consistent with previous years. Elevated bacteria levels were recorded at these lake swimming sites during dry and wet weather conditions. Despite the poor grades, between 66% and 78% of dry weather samples were within the safe swimming limit. These sites may be impacted by a number of significant potential sources of faecal contamination, including stormwater, and have low levels of flushing.

Microbial assessment categories decline slightly for Lake Ainsworth swim sites due to wet weather impacts, with a higher proportion of samples collected at these sites during wet weather conditions compared to the 2022–2023 assessment period.

During 2019, council investigated the source of microbial contamination by testing additional samples for faecal sterols at sites within Lake Ainsworth. The results found that the main contributors to elevated bacteria levels are from avian (bird) sources.
