# Towards safer swimming – Terrigal region

Terrigal Bay sediment contaminants report

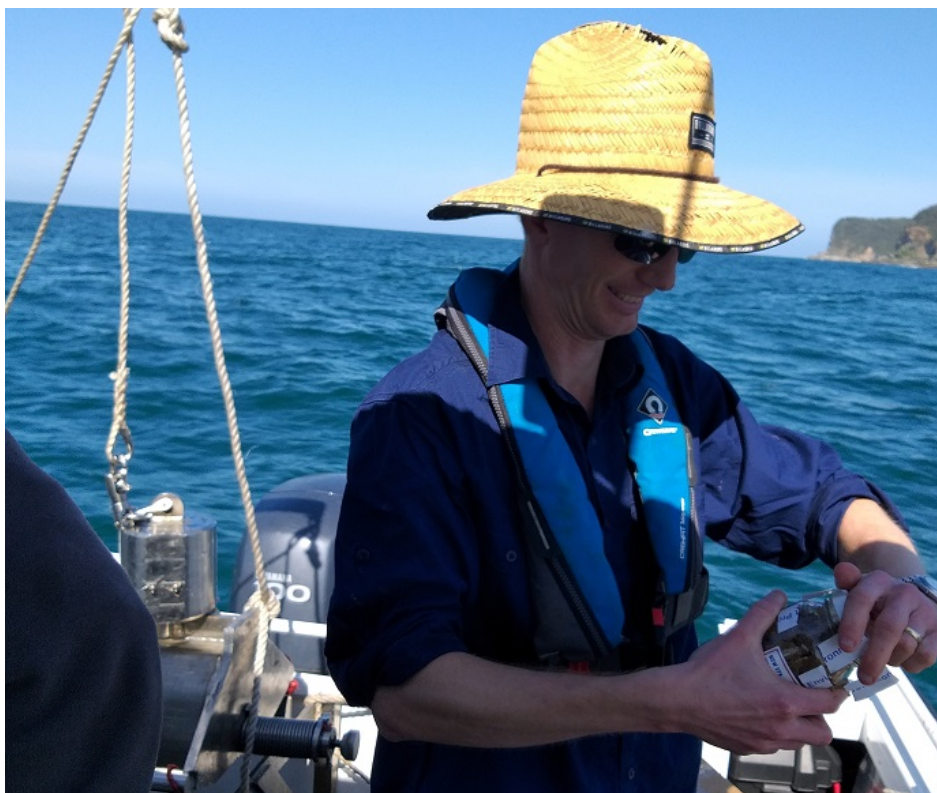
Collecting samples to test sediment at Terrigal. Photo: DPIE

Sediments were sampled by two methods. At the near shore sites (~1 m depth), sediments were collected by hand in the surf zone using polycarbonate cores. Cores were pushed into the sediment, capped and retrieved. At the 5 and 10 metre depth sites, sediments were collected from the DPIE research vessel Badoo using a Shipek grab sampler. This heavy weight sampler (about 50 kg) is designed to collect an approximately three-litre sample from a sampling area of about 20 centimetres × 20 centimetres. The grabs were lowered and retrieved from the boat using a davit and capstan. Once retrieved, 50 millilitres of the top 2 centimetres of sediment in each core and grab were sub-sampled and placed in a sterile vial for genomic testing. A further 10 millilitres of this top 2 centimetres was mixed with 100 millilitres of filtered ocean water before the supernatant was collected (Boehm et al. 2009), chilled to <4°C and retained for enterococci assessment at Kincumber wastewater treatment plant (Enterolert™). The remainder of the sediment sample was homogenised and placed into separate glass and plastic containers for contaminant analysis. Genomic samples were placed in an onboard cryogenic Dewar and immediately frozen. Glass and plastic containers for contaminant analysis were placed on ice in an esky and transported to DPIE laboratories for analysis.

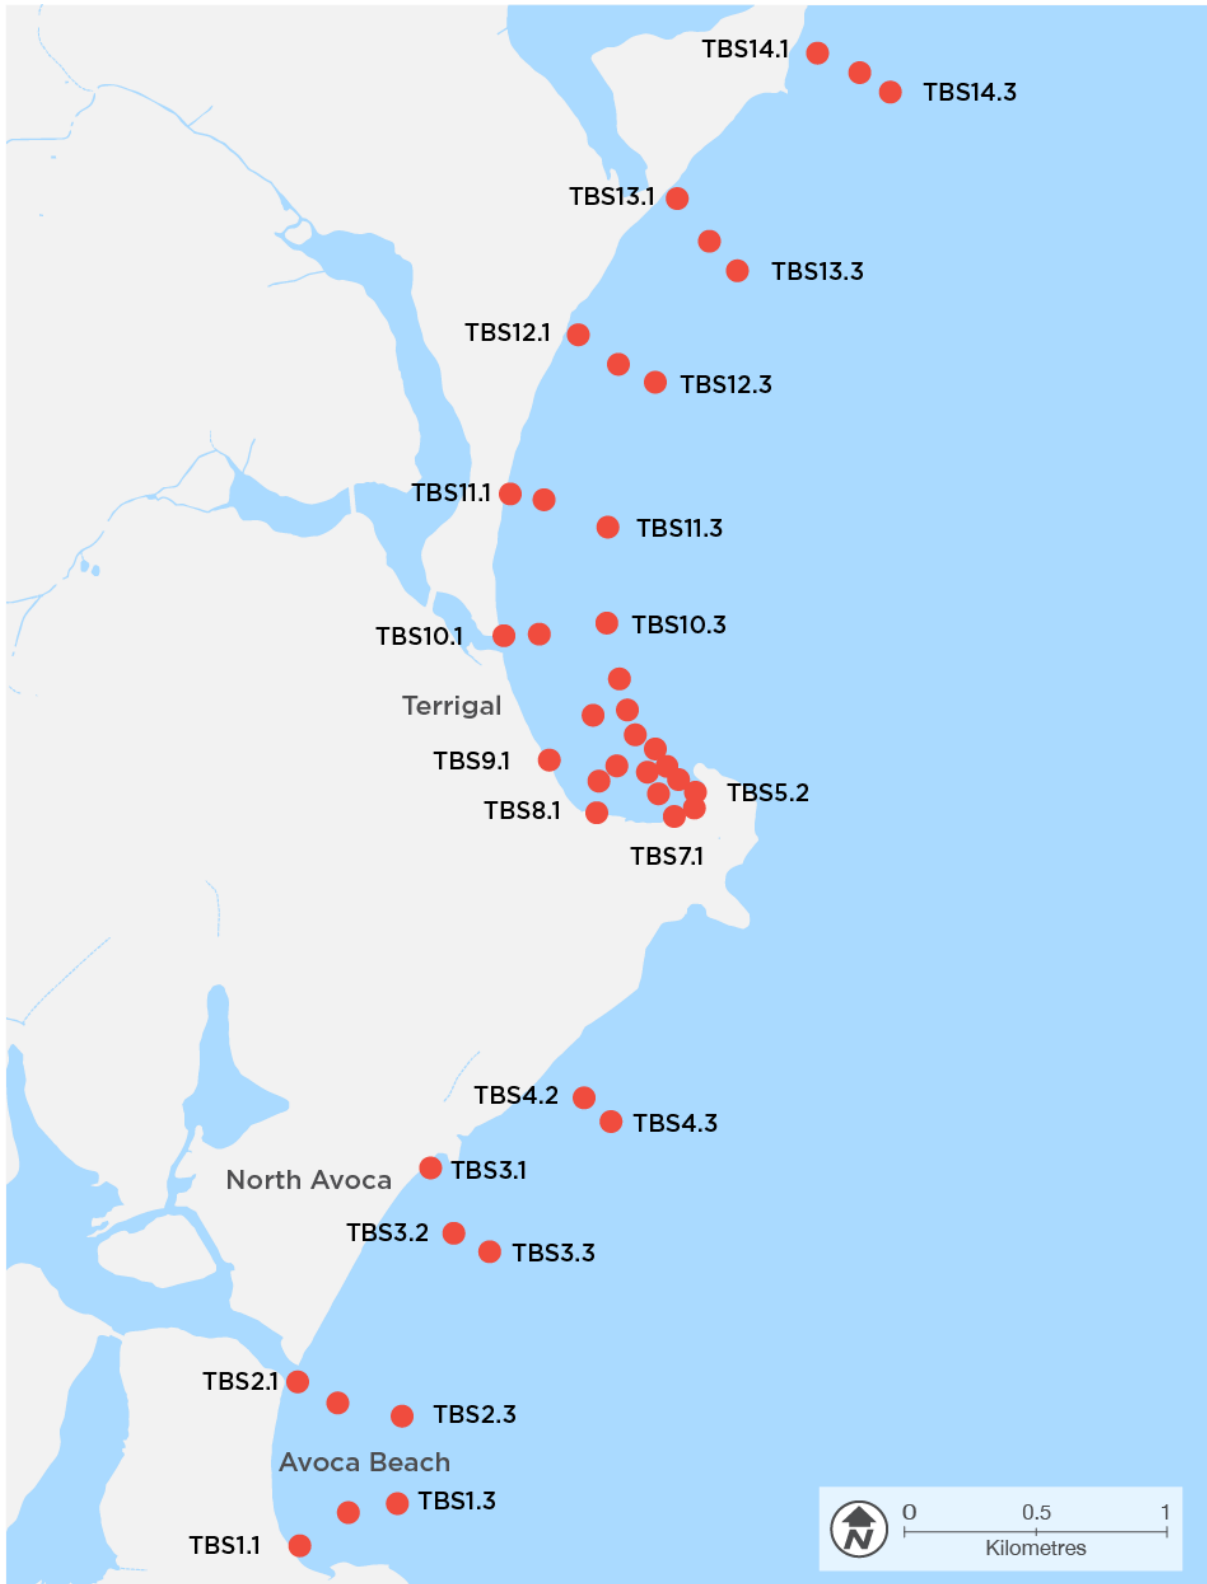
**Figure 1** Sediment sampling sites across the 14 transects from Avoca Beach to Jewy Bay

Site codes TBS X.Y refer to transect #X numbered from south to north and .Y refers to distance offshore with TBSX.1 a shoreline sample (~1 m depth), TBSX.2 at ~5 m depth and TBSX.3 at ~10 m depth.

Forty-two sediment sampling sites were selected along 14 transects at three depth contours at 1, 5 and 10 metres between Avoca Beach to the south and Jewy Bay Beach to the north (Figure 1) from LiDAR bathymetry maps produced by DPIE.

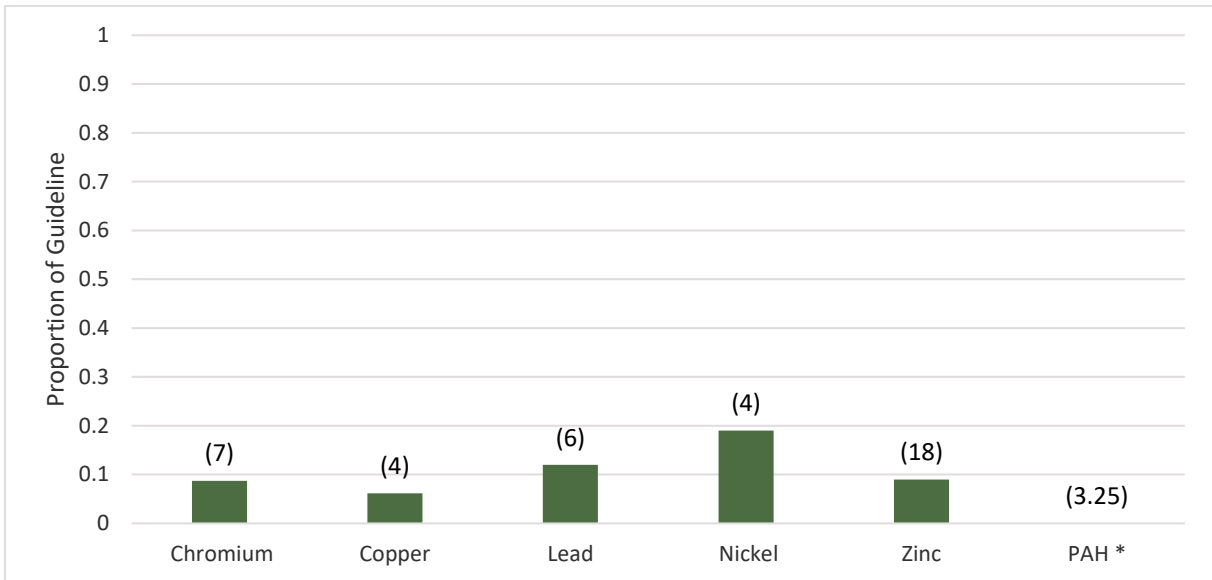
**Figure 3 Maximum concentration found as a proportion of ‘low’ guideline value (ANZG 2018)**

Maximum detected concentration ( $\text{mg}/\text{kg}$ ) in brackets. \* denotes concentrations normalised to 1% total organic carbon as per guidelines.

Of the 73 analytes assessed in sediment across the study area, 33 were detected (Table 2), with the remainder below detection limits indicating they were well below ANZG (2018) guideline thresholds (Figure 2). All detected contaminants were PAHs, metals or metalloids with no PCBs, pesticides or polychlorinated benzene compounds detected. Of those that were detected, and for which trigger values are available, maximum concentrations were mainly well under the lowest ANZG (2018) trigger values (Figure 3). The only exception was arsenic, which had a maximum concentration of 21 milligrams per kilogram at sites TBS 3.2 and TBS 4.2 in Avoca Bay, slightly higher than its lowest guideline value (20 mg kg<sup>-1</sup>). Arsenic showed a similar concentration distribution to metals that are not associated with anthropogenic sources such as manganese and vanadium, with which it shares geochemical properties (Figure 4).

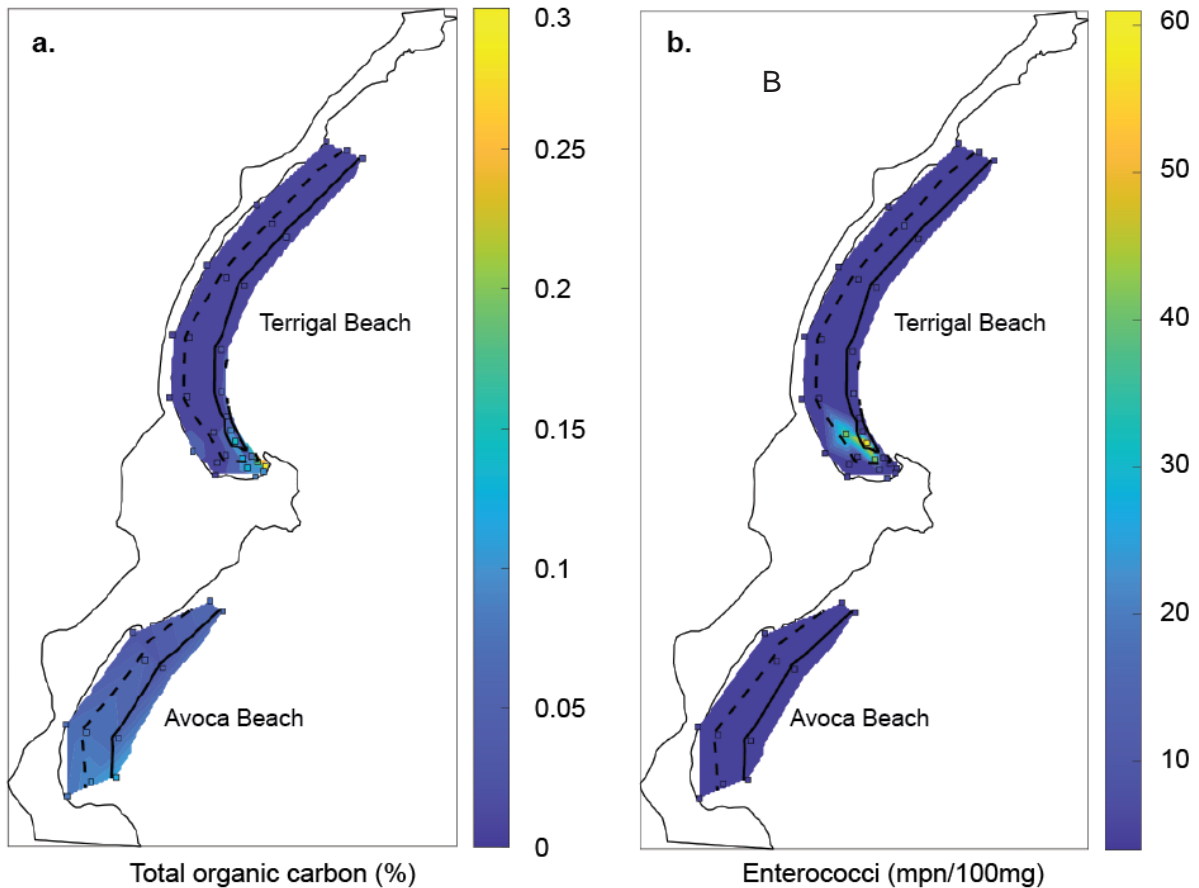
**Figure 5** Maps of sediment distribution of total organic carbon (A) and enterococci concentrations (B) in Terrigal and Avoca bays  
Dashed line: 4 m depth; solid line: 9 m depth.

The concentration of total organic carbon was very low across all sites, ranging from <0.01% (LOD) to 0.3% with greatest values within the Haven (Figure 5a). Enterococci levels in sediment were likewise low in most areas, with greatest levels found in the Haven (Figure 5b). Microplastics, in the form of fishing line fragments, were only detected at one site off Avoca Beach.
