ix. Hull plating / main sheerstrake

2. DISCUSSION

c. Identification of the Shipwreck: Comparison with SS *Nemesis*

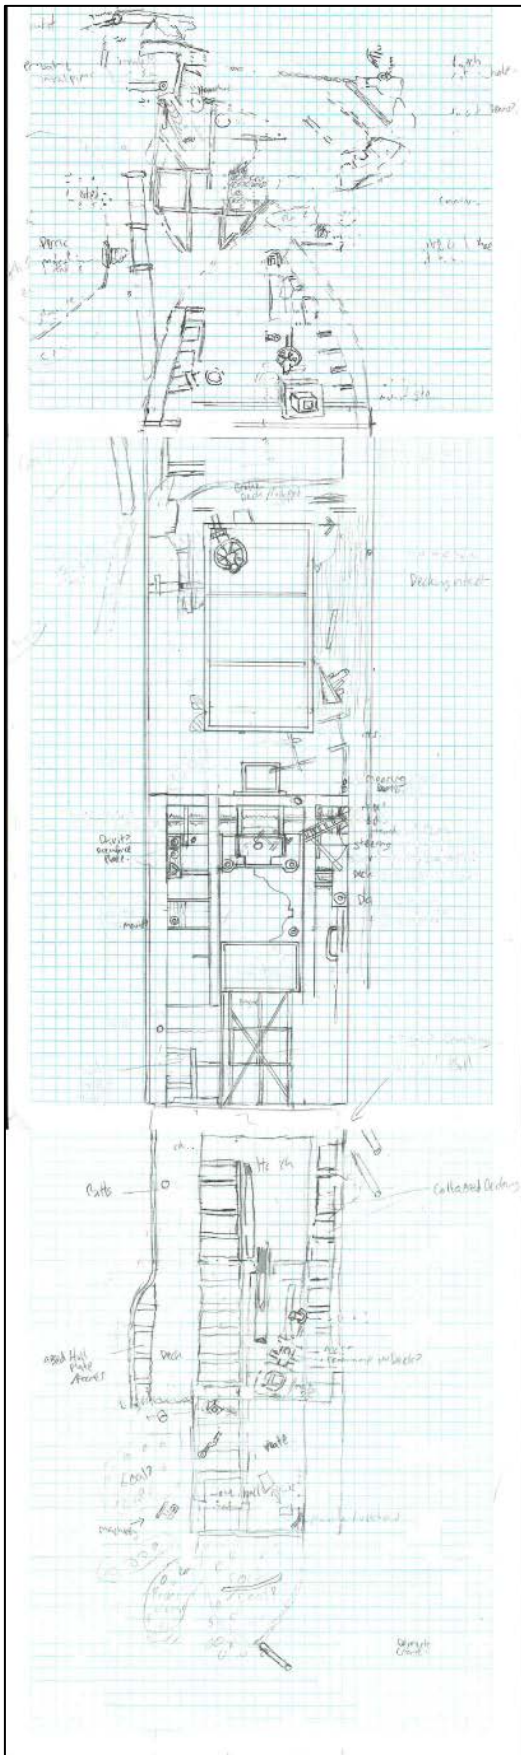
Figure 94: Interim site plan of the wreck site (Image: B Duncan, Heritage NSW Nov 23)

An interim site plan is included below (and will be replaced with inked version in the final comprehensive version of this report).

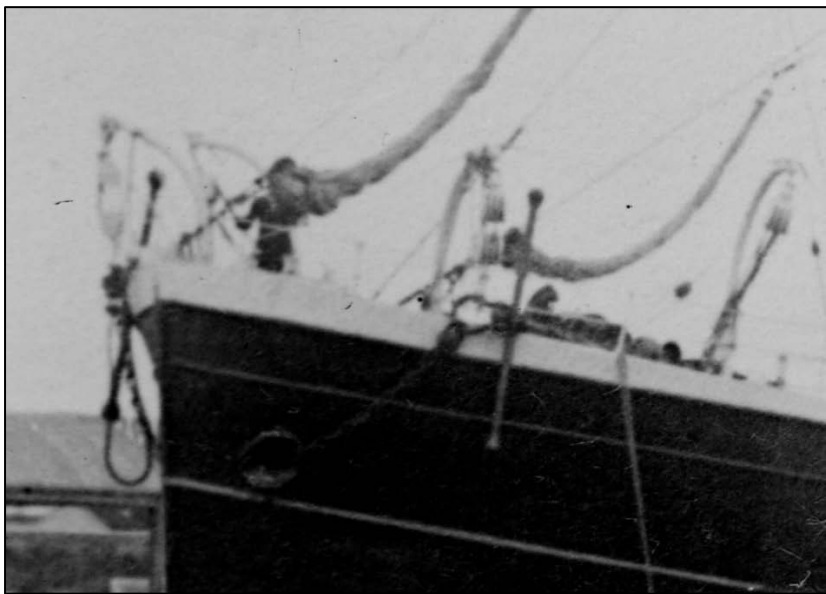
Figure 100: Anchor and Hawsepipe Bridge (Image: Green c 1900 (# gr005471), Nemesis at Wharf BW v SLV collection gr005471 cropped)

The anchors on the *Nemesis* in photos (Figure 100) and paintings (Figure 101) dating to the early 1900s appear to be admiralty pattern anchors with straight stocks with ball ends, bow shackles and (possibly) stud link chain. The anchors are stowed on a raised forecastle deck with a length of chain leading to the hawsehole (which are identical to those observed on the wreck – see Figure 3, Figure 4, Figure 8). Davits were used to fish and cat the anchor and are similar with that observed in the bow wreckage (see Figure 11, Figure 12). The wreck has evidence of a collapsed foredeck (Figure 8, Figure 9, Figure 10, Figure 11, Figure 13), a probable bosun's locker hatchway (Figure 17, Figure 20) and associated relics (Figure 15, Figure 16); and a possible steam winch used to operate a derrick which was probably mounted on well/ main deck (Figure 28, Figure 29). This is consistent with the configuration of the bow remains of the wreck.

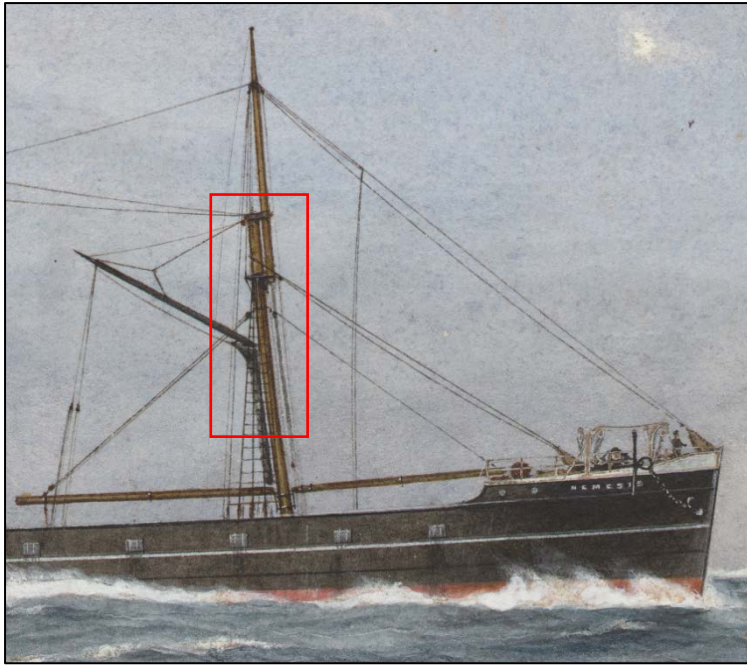
Figure 102: Bow area of Nemesis showing scalloped transition from forecastle deck to well/ deck below the bow (Image: After Green c 1900 (#wp004986))

The presence of the forward derrick crane on the well deck is consistent with the SS *Nemesis* painting (Figure 102). The forward derrick crane mast on the wreck has collapsed forward across the bow and is lying on the port side (Figure 18, Figure 24, Figure 25, Figure 26, Figure 27), and the remains of the mast step are located inside the well deck (Figure 28, Figure 29, Figure 30, Figure 31, Figure 32). The configuration and fittings of these derrick crane features and the cargo winches located in the bow (Figure 28, Figure 29) and in the well deck cargo hatchway (Figure 34, Figure 35); matches the rigging components of the foremast fittings and cargo winch locations on the *Nemesis* (Figure 102, Figure 103). This is consistent with the original design of the *Nemesis* as a coastal cargo trader, and the configuration of the derrick masts within the found wreck also matches that vessel.

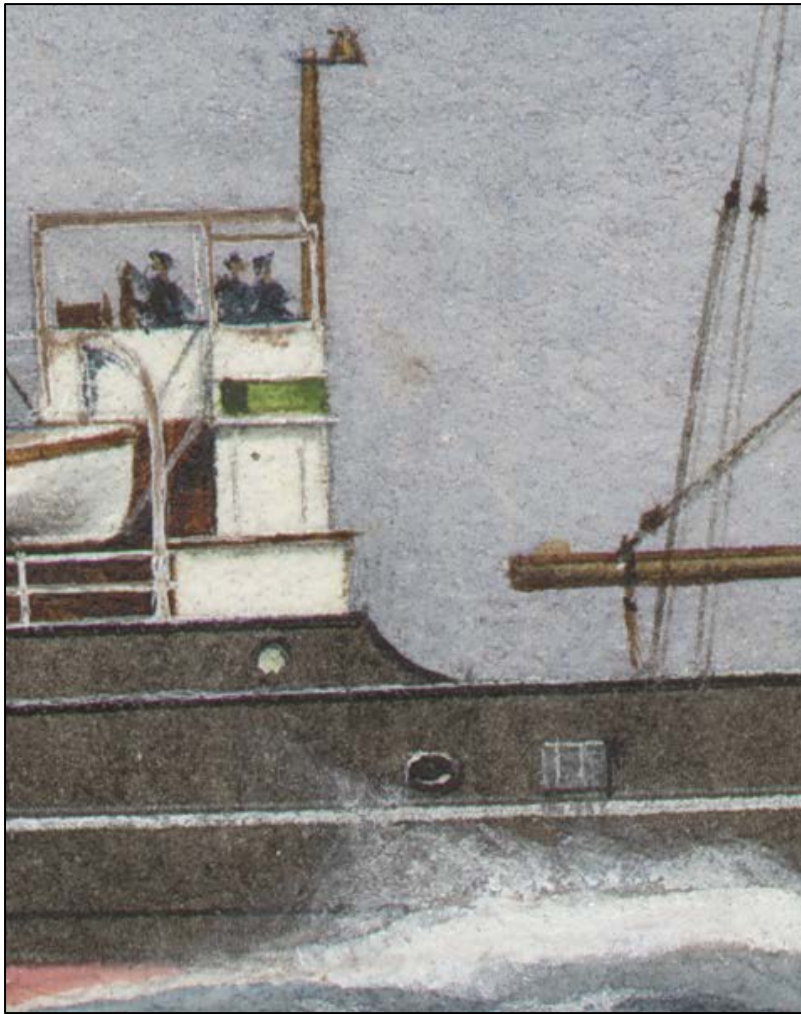
Figure 104: Scalloped bulwarks, mooring ports and cargo rigging shown at the aft extremity for the starboard side (Image: Green c 1900 (wp004986))

The presence of scalloped edges on the well deck bulwarks (Figure 39, Figure 40) at the aft starboard side of the well deck match the well deck bulwarks features and location shown on various images of the *Nemesis* (Figure 104, Figure 105). A mooring port, leading to a bitt (Figure 45, Figure 46, Figure 47) evident in this location on the wreck also aligns with a similar feature in the painting (Figure 104).

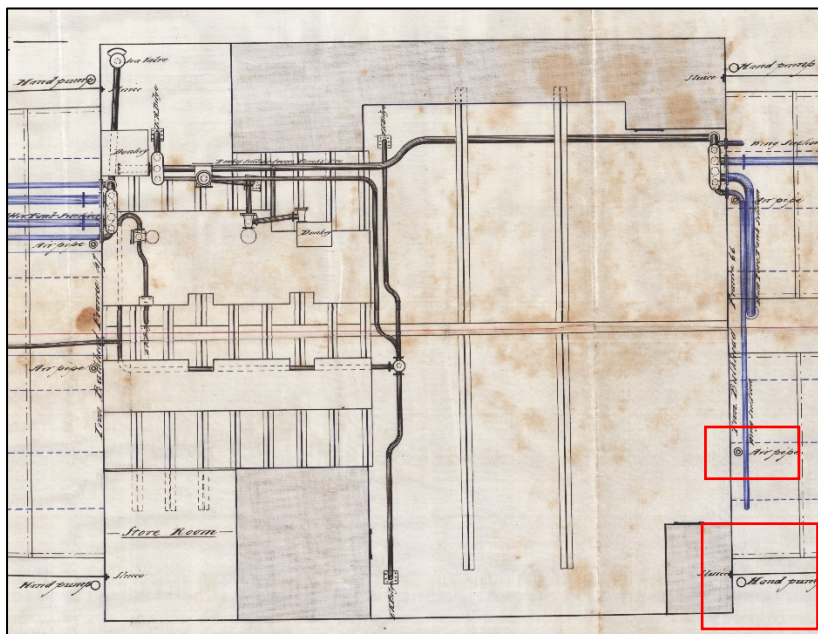
Figure 106: Location of hand pump, sluice and airpipe forward of bridge bulkhead area in a piping plan of the vessel (Image: LRF 1879 (#LRF-PUN-STK902-0133-P_0001))

Located close to this same area, the archaeological remains of what is likely to be a water pump (Figure 49) aligns to a hand pump shown on a construction piping plan for the Nemesis (Figure 106, Figure 107). A horizontal pipe leading to a vertical pipe flange (Figure 61, Figure 62) on the wreck is in the same location as an airpipe shown in the same piping construction plan leading up to the bridge structure, which may possibly be for a steam whistle? (Figure 107).

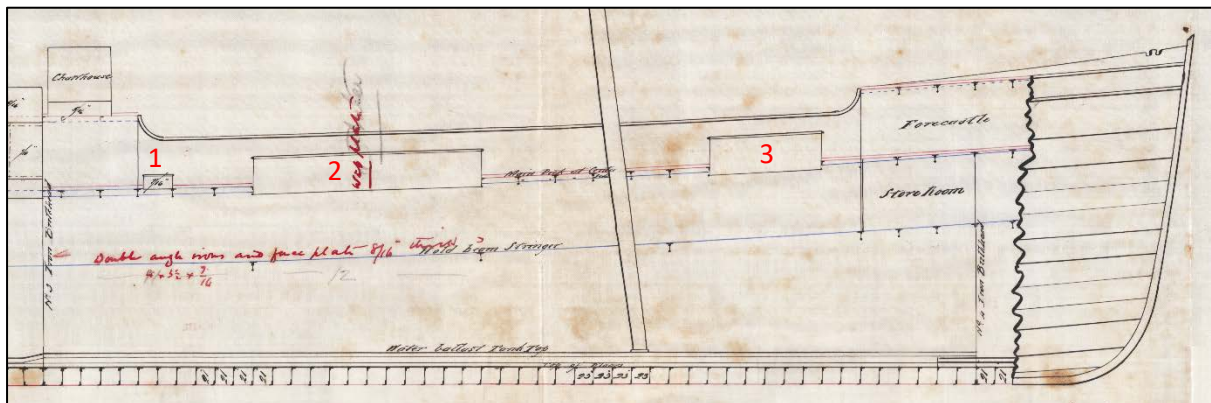
Figure 108: Location of forward hatches, including inspection hatch (1); second cargo hatch (2) and first cargo hatch (3) (Image: LRF 1880 (#LRF-PUN-STK902-0132-P))

The wreck has evidenced the remains of one and possibly two cargo hatchways on the stern main deck (Figure 37) with another smaller access hatchway directly forward of the bridge bulkhead (Figure 43). This conforms exactly to the hatches shown in longitudinal construction plans for the *Nemesis* (Figure 108).
