# REPAIRS TO SEAWALL AT 6B CHILDE STREET

## RESPONSES TO RFI BY NSW COASTAL PANEL

**RE: NO 6B CHILDE ST, BELONGIL**

**REF DOC 17/8231**

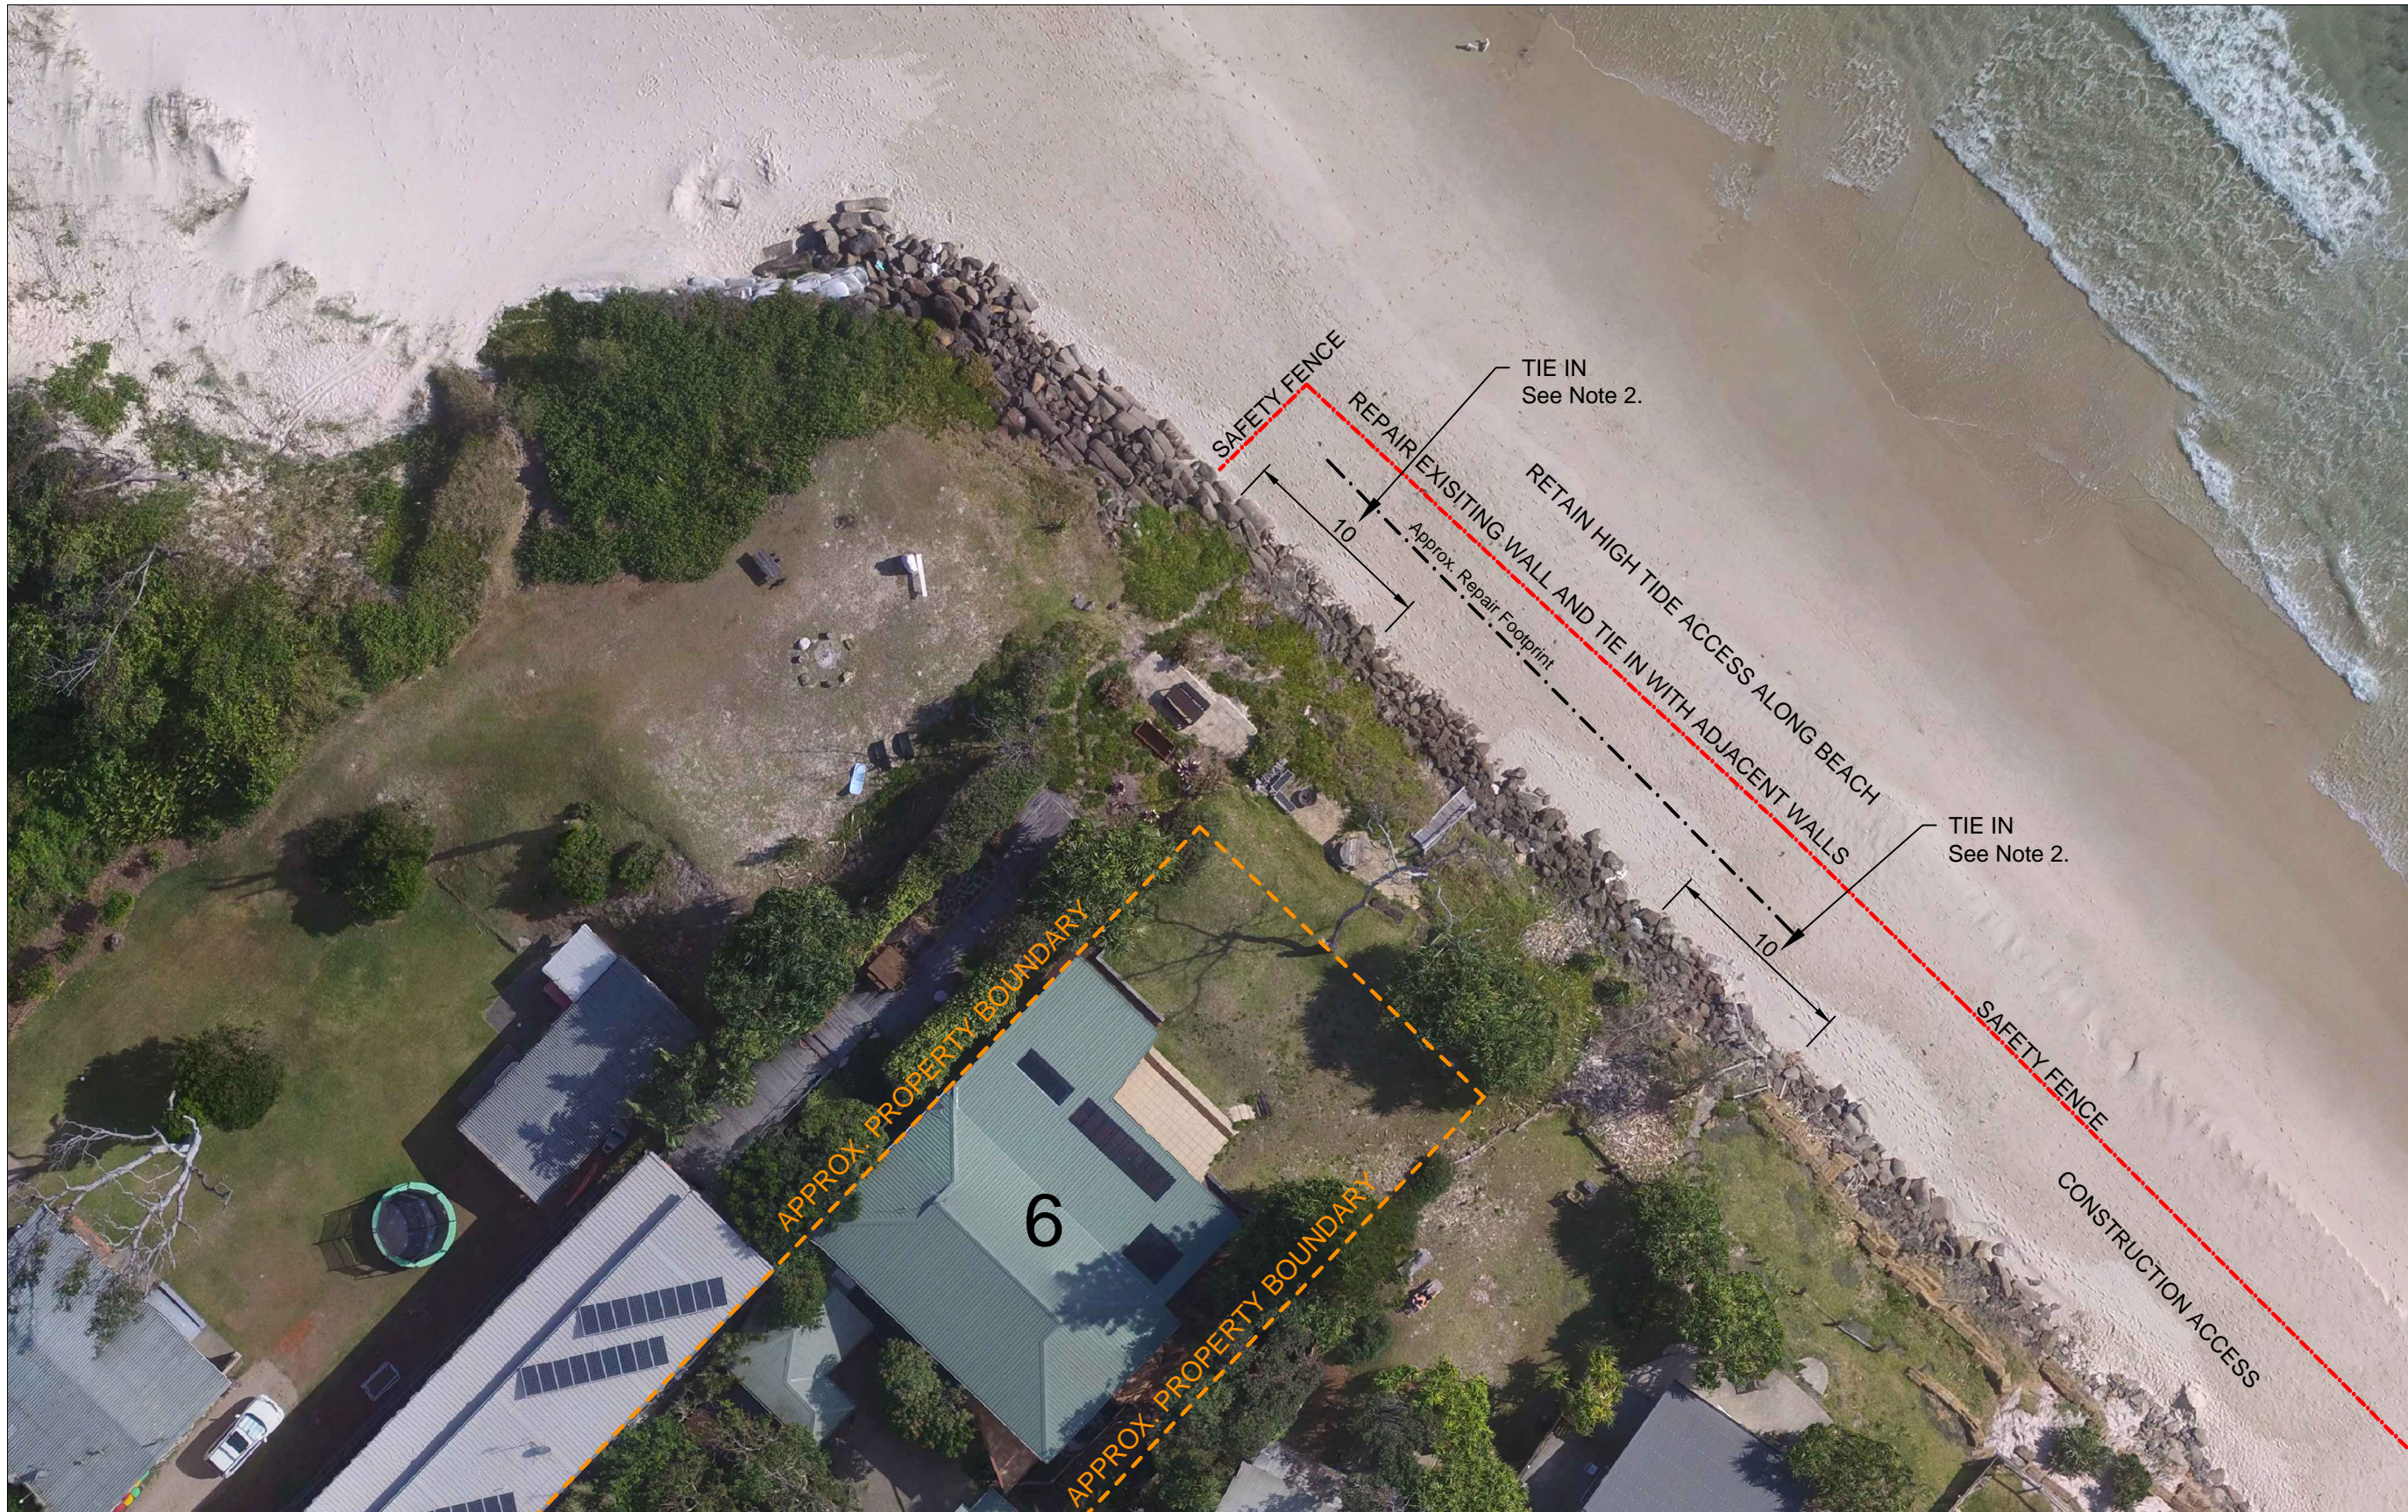
**TYPICAL REPAIR PROFILE**

~11.5m Repair Footprint

- NOTES
1. Construction access to be from 'Old Jetty Site' - Construction access to be adequately fenced
  2. Smooth transition of crest and toe to adjacent wall (Typical)
