# **URGENT REPAIRS TO SEAWALLS AT 6 CHILDE STREET, BELONGIL**

**International  
Coastal  
Management**

21<sup>st</sup> December 2016

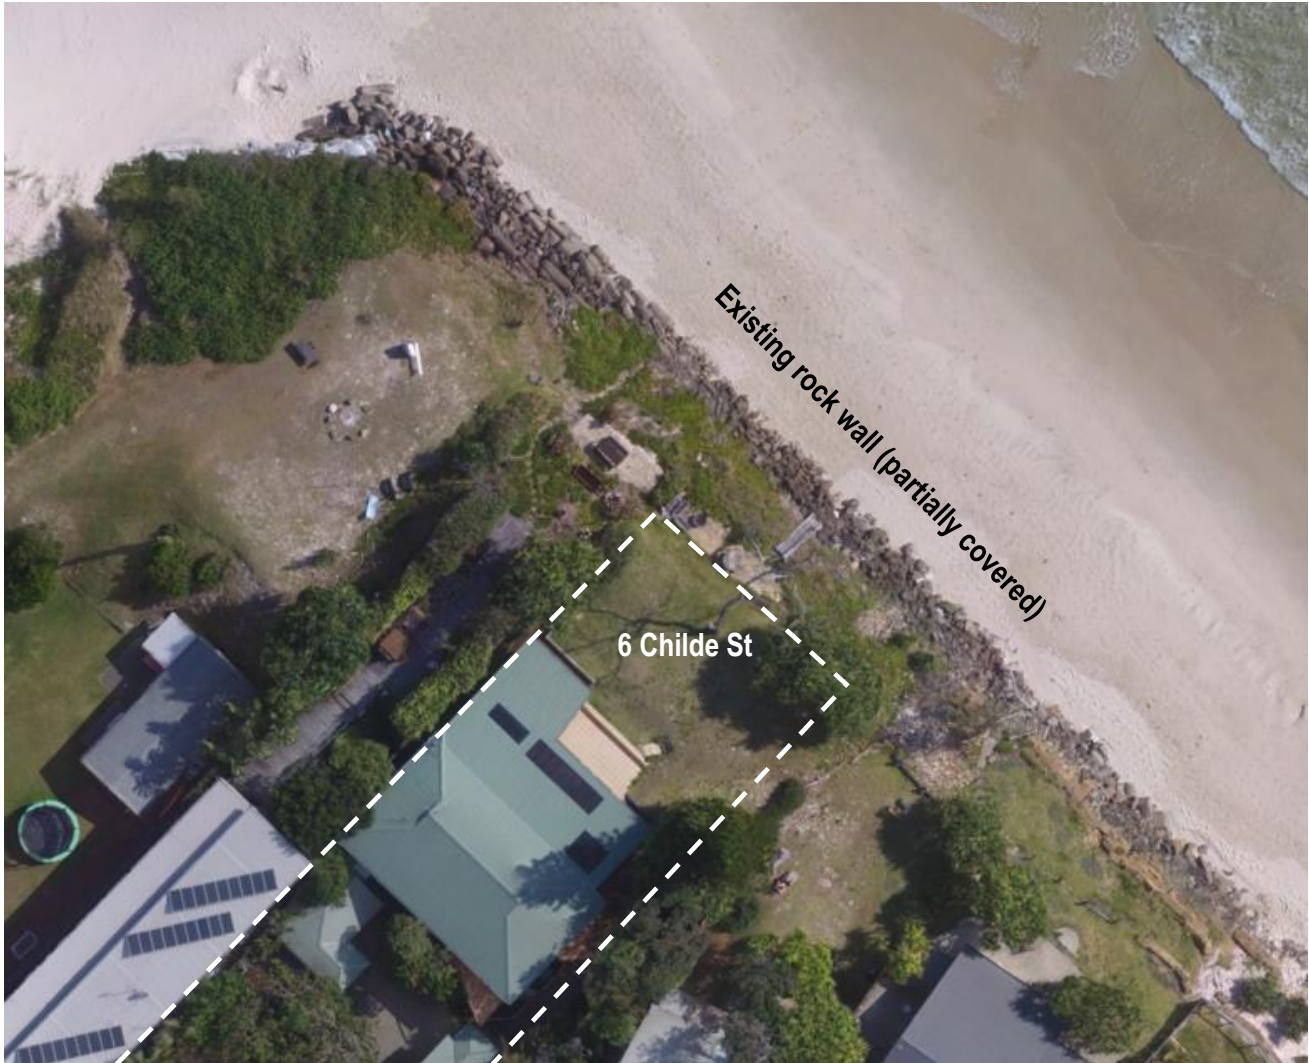
The existing erosion protection works consist of a rock along the seaward boundary of the subject property. The rock protection works extend along the seaward boundaries of private properties to the NW and SE (Figure 1).

Figure 1 High definition aerial image of 6 Childe Street (ICM 13/10/16)
