REPAIRS TO SEAWALLS AT 6B CHILDE STREET, BELONGIL

URGENT WORKS

**International
Coastal
Management**

August 2017

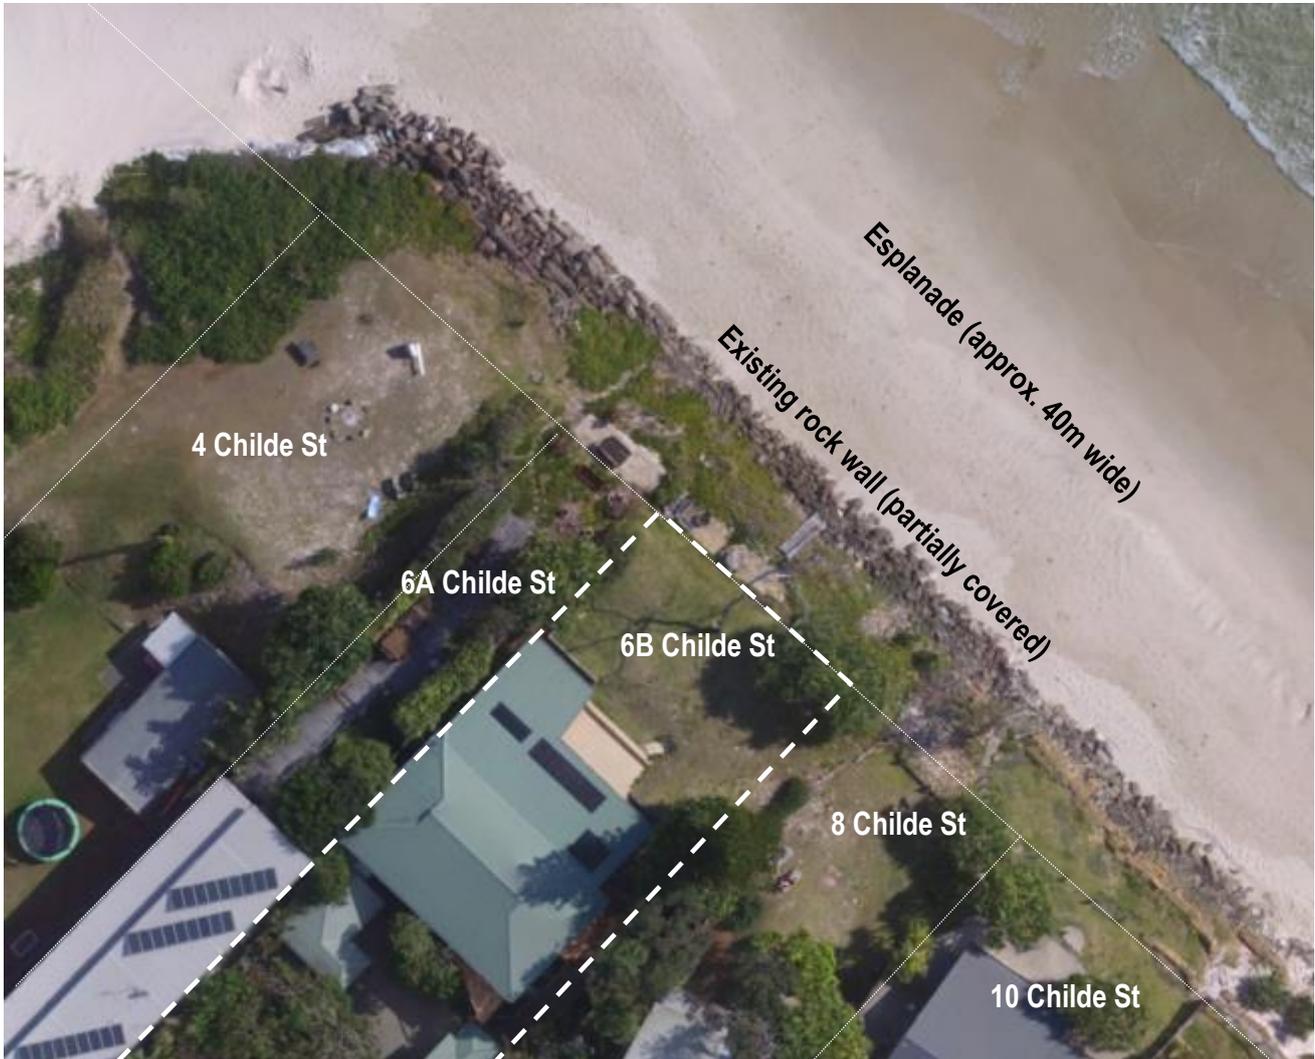
Figure 1 High definition aerial image of 6 Childe Street (ICM 13/10/16)

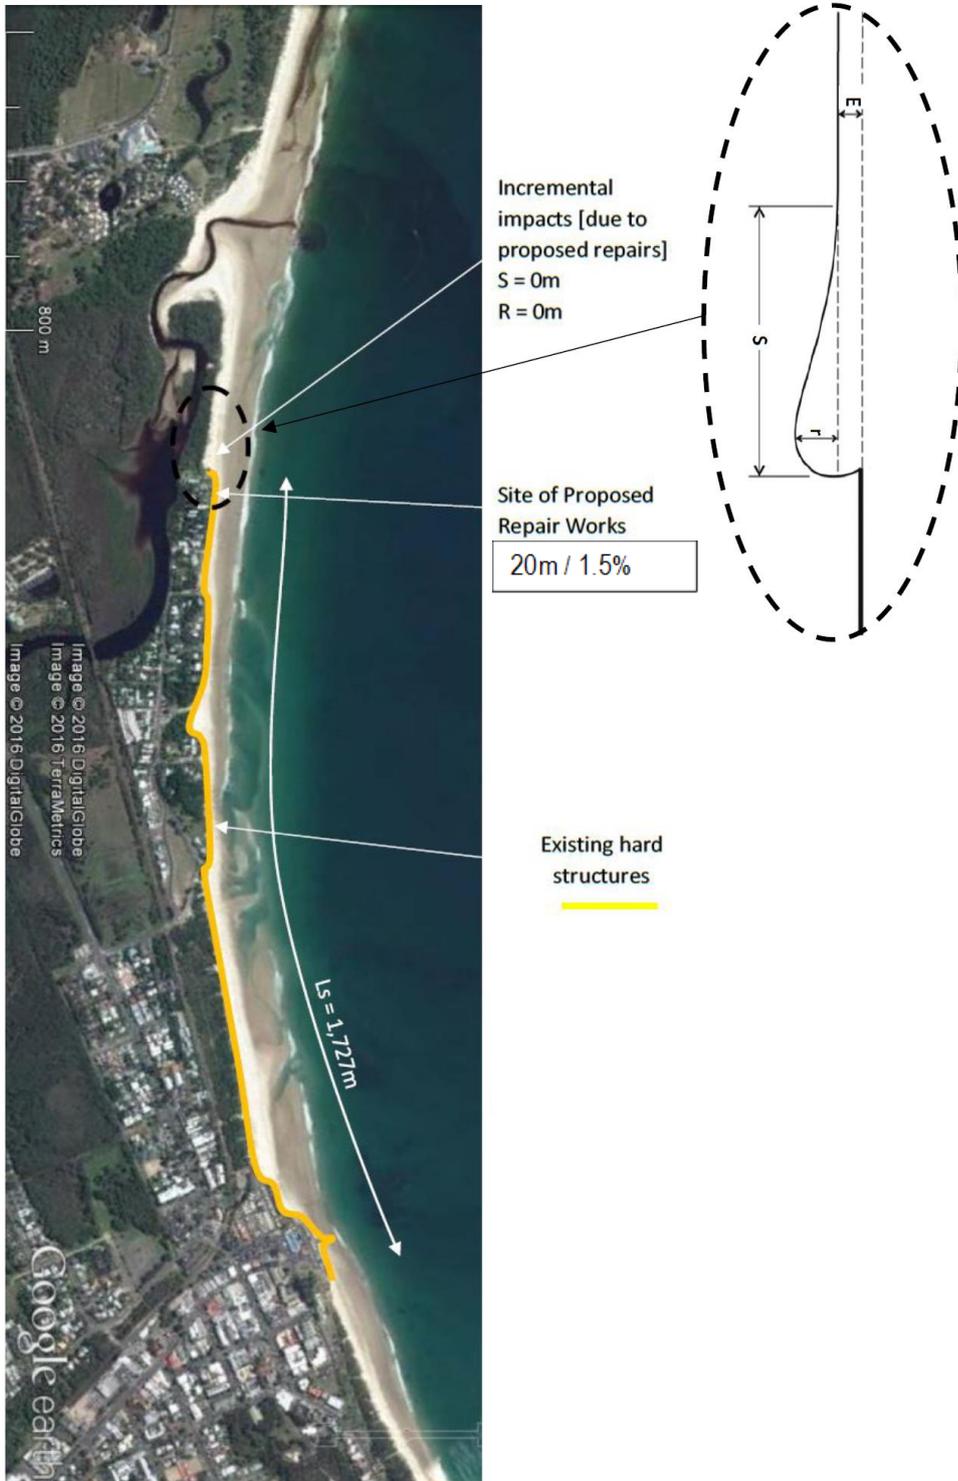
ICM concluded, similarly, that there will be no incremental end effects from repairing the existing wall with a length of 20m at the subject site. That is, $r = 0\text{m}$ and $S = 0\text{m}$ as per the McDougal et al 1987 diagramme overlaid on Belongil (Figure 10) with dimensions.

Figure 10 McDougal et al 1987 diagram applied to Belongil curved coastline
