# **REPAIRS TO SEAWALLS AT 44-48 CHILDE STREET, BELONGIL URGENT WORKS**

**International  
Coastal  
Management**

August 2017

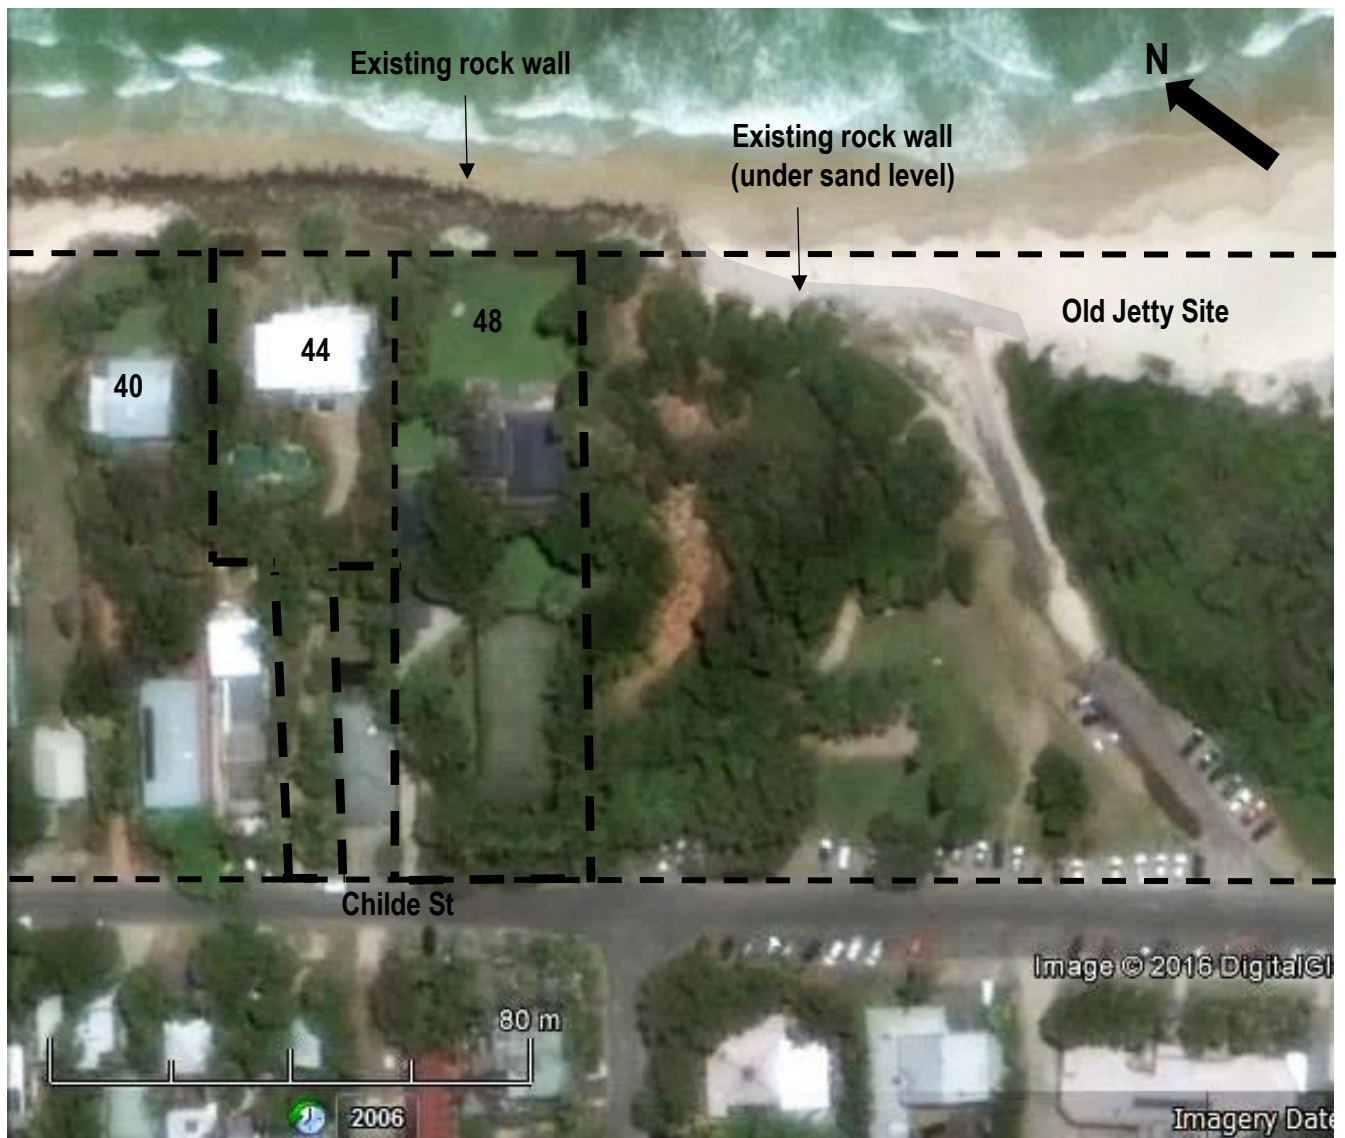
Figure 1 Subject properties

The existing rock wall protecting 44-48 Childe Street (lots 18,19, 20, 21, 23, 57, 59, 60 and 61 Section 2 DP 1623) from erosion consists of large rocks along the seaward boundary of the subject properties and extending both to the NW and wrapping around the south-east boundary (Figure 1). The property to the NW is private property and the property to the SE is the old jetty site (State controlled public lands).

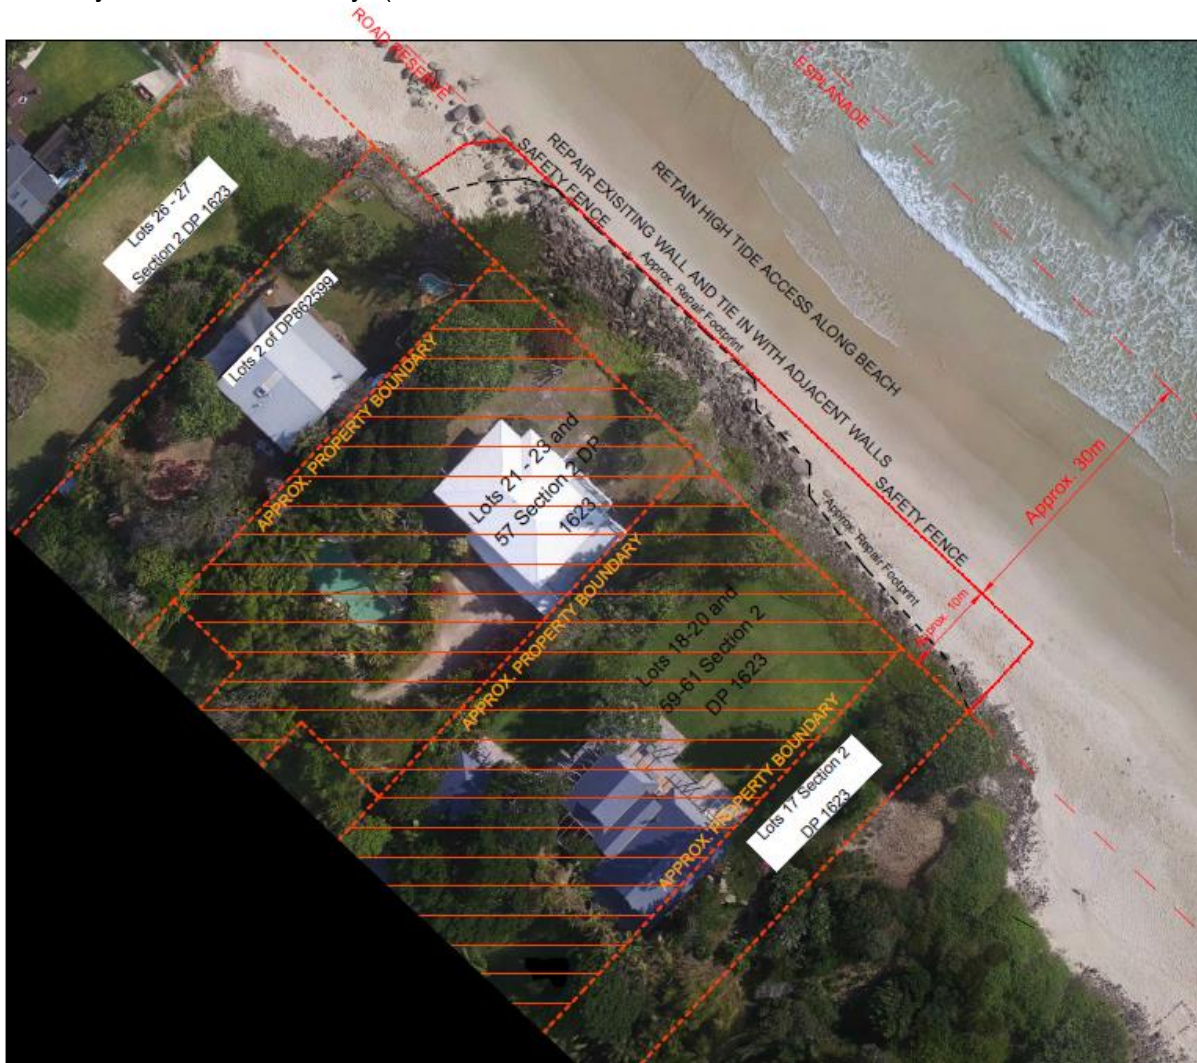
**Figure 2 Extent of works – repairs and construction equipment access (footprint shaded in green)**

As the January DA is still under consideration and as it is known that the seawall needs to be made safe, a second DA for more minor but necessary repair works to make safe the existing seawall is being prepared for lodgement in early August 2017. These works can be carried out from the private properties and the 10m wide road reserve under the control of Council without the need for any works, or equipment access, on the Esplanade that would require the approval of Department of Industry – Lands & Forestry. (

Figure 2). This will simplify the approval process and time to allow the works to be implemented asap.

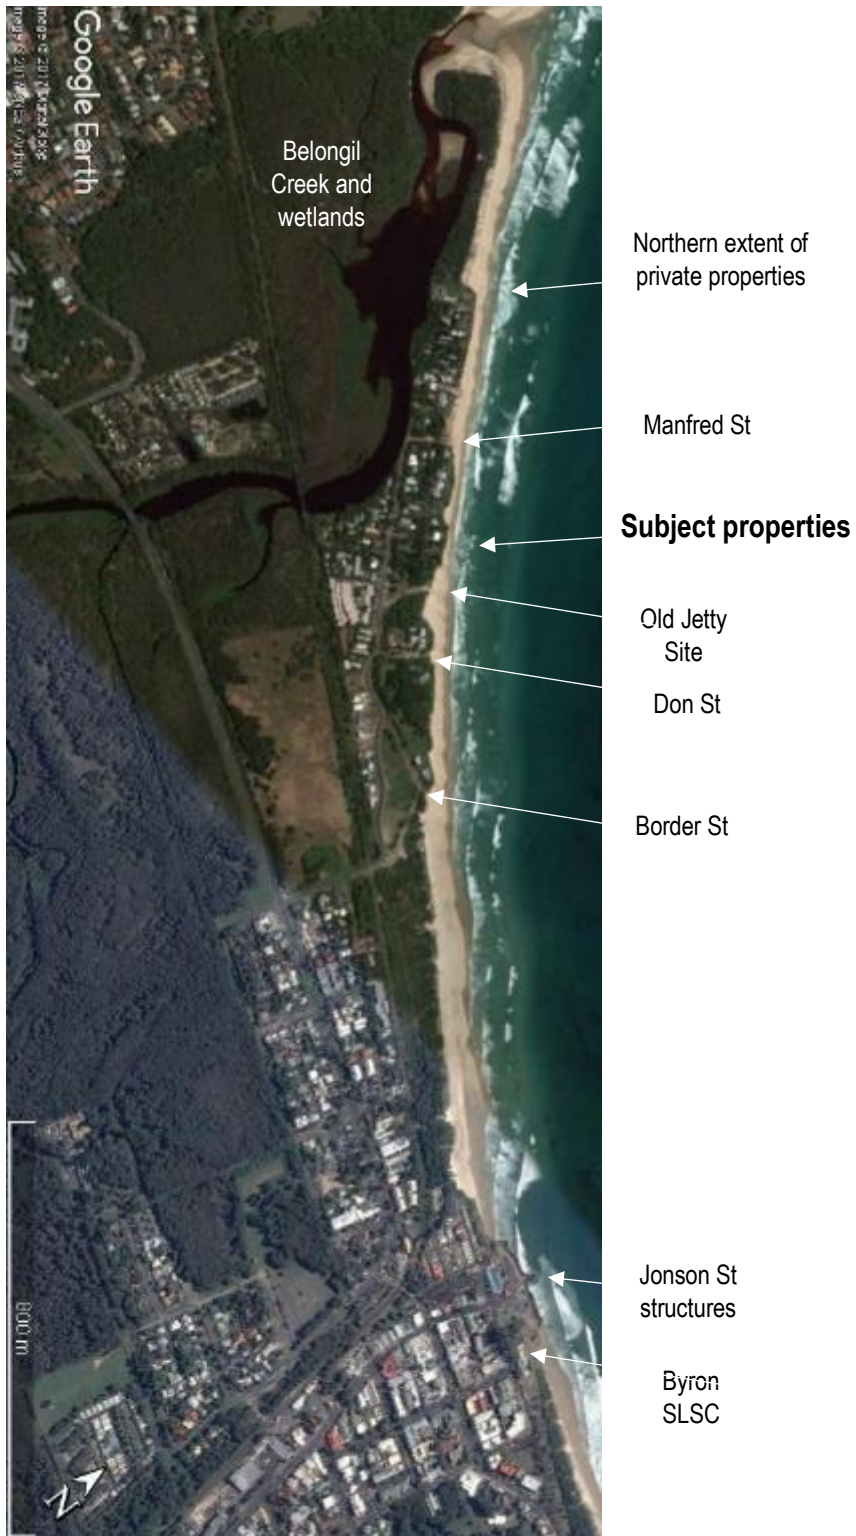
Figure 3 Locality Plan

the rock wall at the Old Jetty site from intermittent storm erosion events (Figure 3). The existing erosion protection works at, and adjacent to, the subject properties have been damaged. These works have been in a state of disrepair for some time.

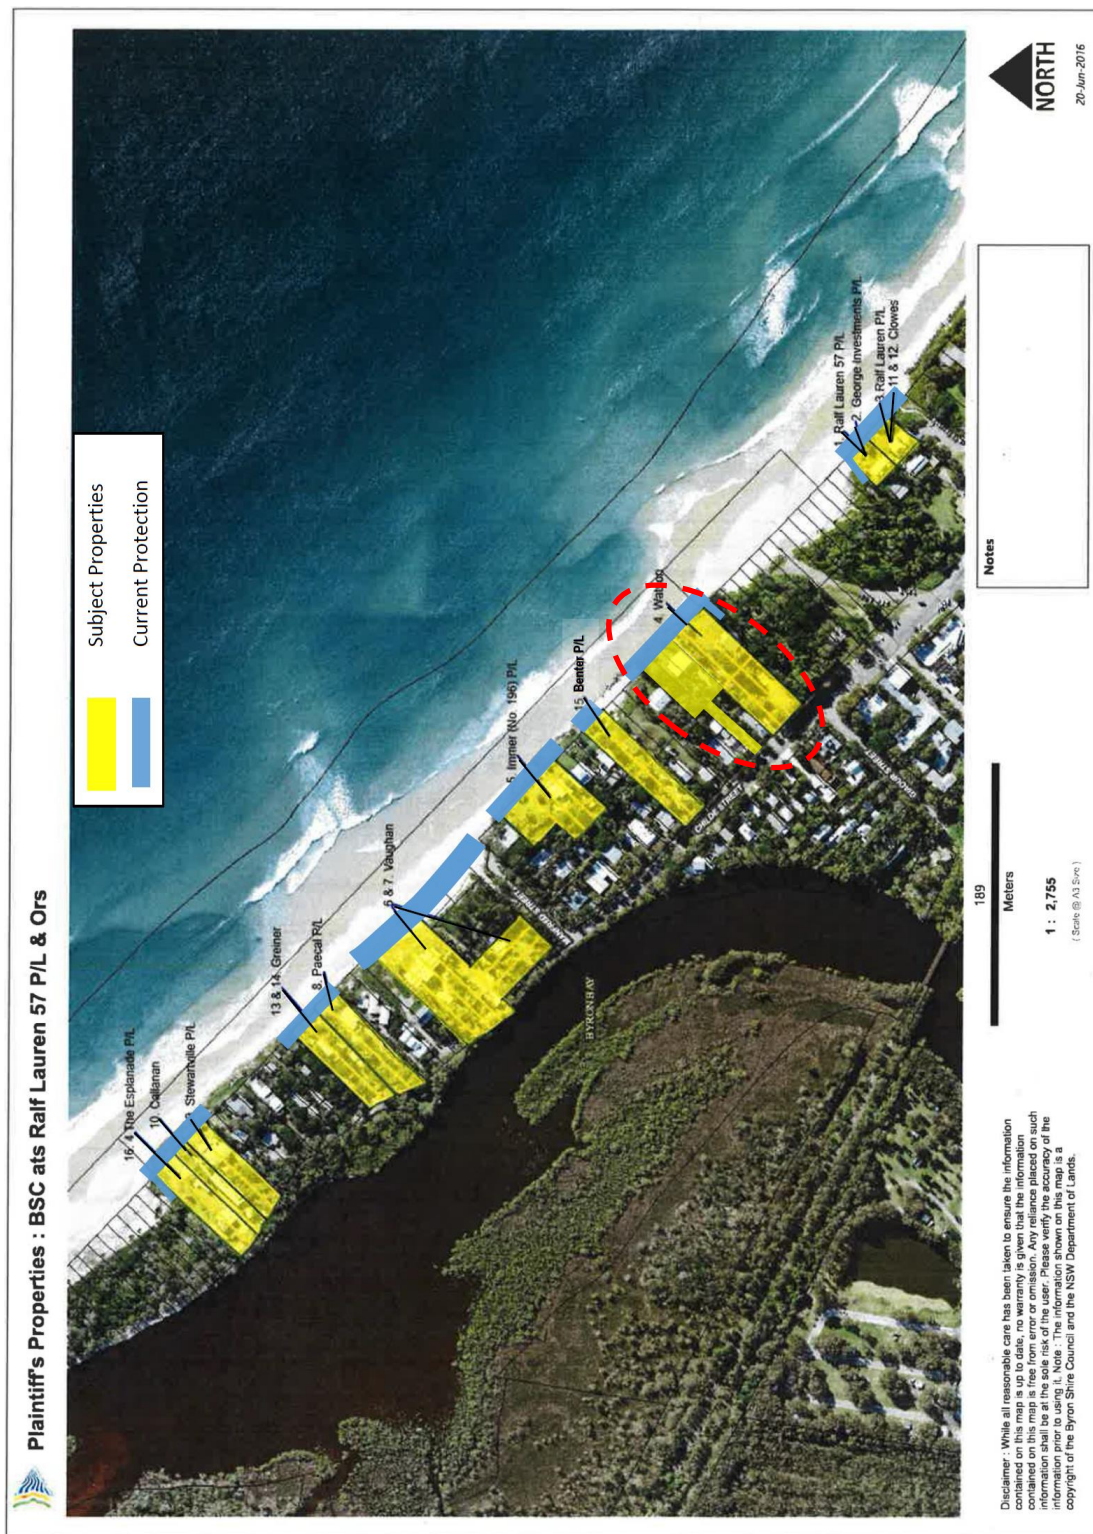
Figure 4 Schedule 1 from Court Orders (Subject properties circled in red by me)

The subject wall has a well-documented history. Recently on 12/8/16, the Supreme Court of NSW issued orders made in proceedings brought by multiple plaintiffs including the owners of 44-48 Childe Street. These orders were based on the long-documented impact of the Jonson Street structure constructed and maintained by Byron Shire Council on the down-drift beaches and seawalls at Belongil. These orders require that the subject wall and the other walls protecting the multiple plaintiff's properties must remain in place and cannot be removed as per Schedule 1 of the Court Orders (Figure 4). BSC has consented to these orders.

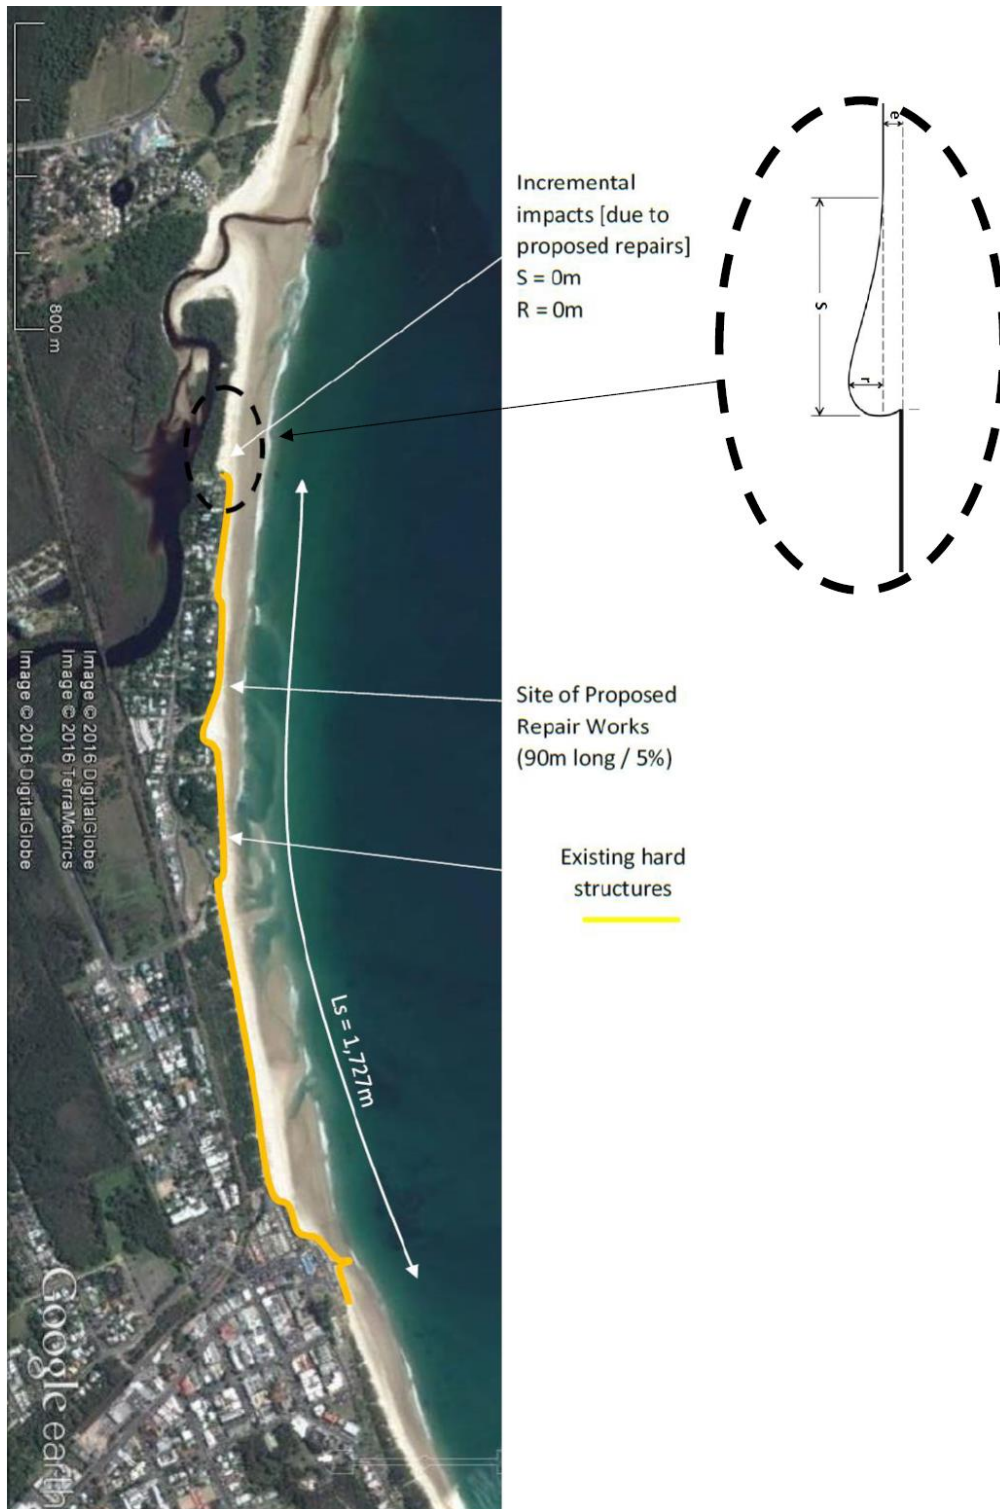
Figure 8 McDougal et al 1987 diagram applied to Belongil curved coastline

Previous studies for BSC of existing and proposed upgrading of existing walls along the Byron embayment found that the only structure that had significant end effects was the Jonson Street structures. Near to the subject site, a geobag wall has been upgraded to a much larger rock seawall recently by BSC. In the consideration of the potential for end effects of this rock seawall with a length of 100m, WRL (2013) considered the McDougal et al 1987 diagramme as well as more recent work by NSW researchers (see WRL 2013 Section 8.7.2). WRL 2013 concluded that there would be no incremental end effects beyond the status quo ie referring to the McDougal et al 1987 diagramme (Figure 8):

ICM concluded, similarly, that there will be no incremental end effects from repairing the existing wall with a length of 90m at the subject site. That is,  $r = 0\text{m}$  and  $S = 0\text{m}$  as per the McDougal et al 1987 diagramme overlaid on Belongil (Figure 8) with dimensions.
