RESPONSES TO QUESTIONS BY NSW COASTAL PANEL

RE: REPAIRS TO SEAWALL AT 28 & 28A CHILDE ST, BELONGIL
REF: DOC17/82318

Belongil Seawall Repairs

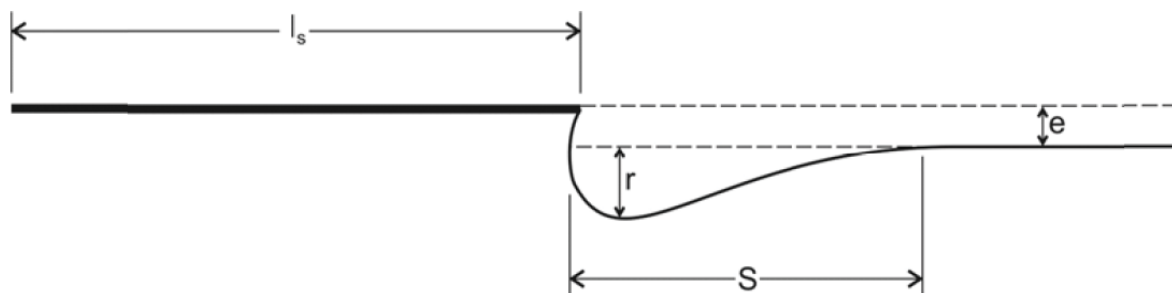
(Source: McDougal et al, 1987)

Response: McDougal et al 1987 provided the following diagram for end effects of seawalls on a straight beach:

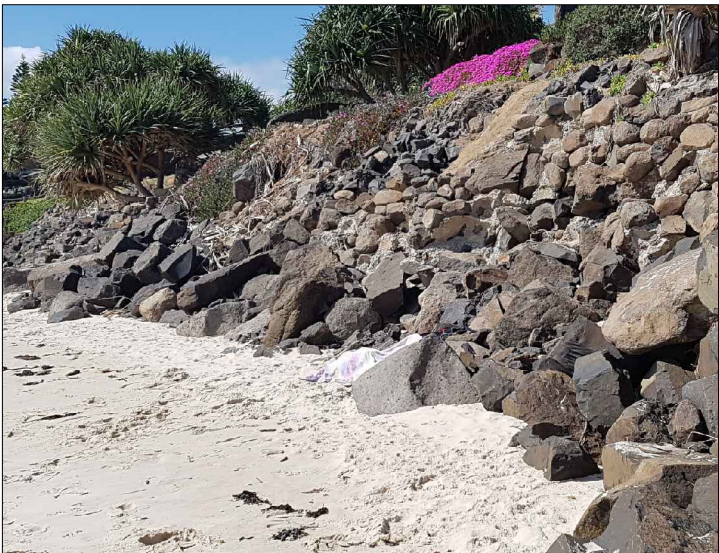
PHOTO (ICM 13/10/16)

- An inspection of the walls covered under the consent orders was carried out by ICM engineers on 13/10/16 to ascertain the present condition.
- Historical photos and surveys held by ICM were reviewed to ascertain the previous condition.
