URGENT REPAIRS TO SEAWALLS AT 40 CHILDE STREET, BELONGIL

August 2017

1. OVERVIEW

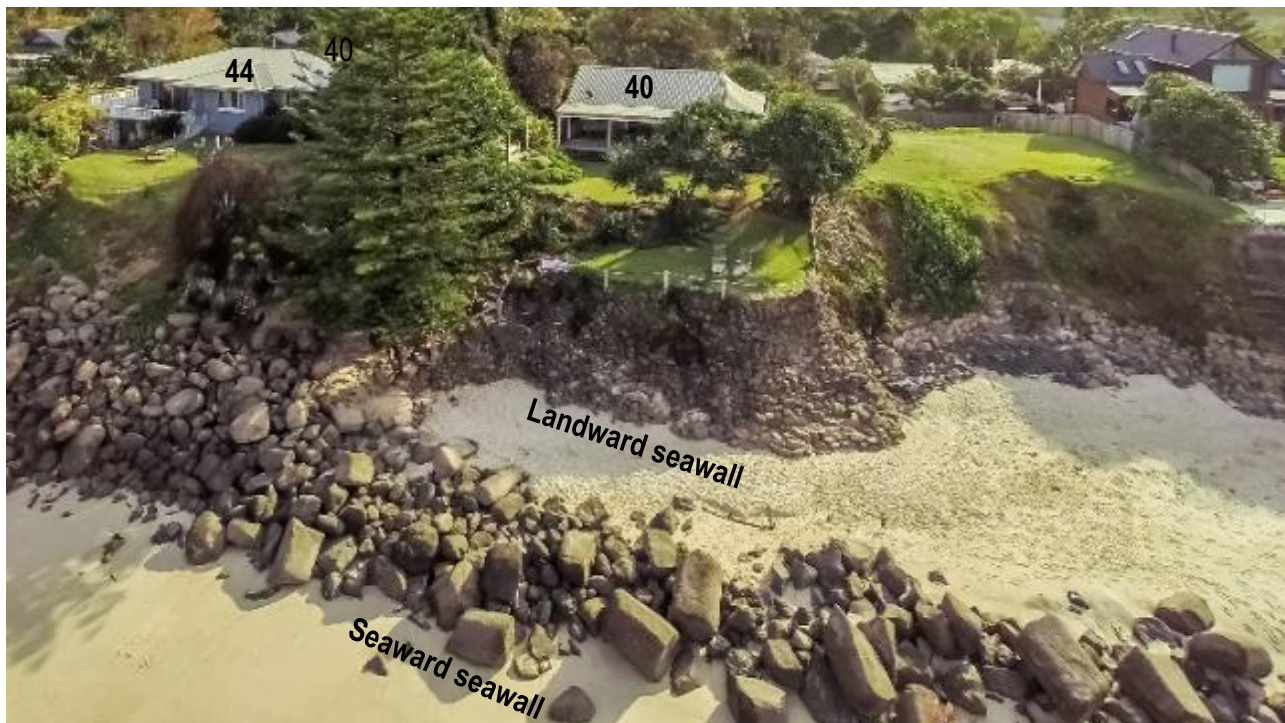
The existing erosion protection works at, and adjacent to, 40 Childe Street consist of 2 seawalls (Figure 2 and Figure 3). The seaward wall, the primary wall, has been damaged and have been in a state of disrepair for some time.

Figure 2 Recent aerial (circa 2014) showing the 2 seawalls to seaward of No 40 Childe St

The seaward wall consists of large boulders, generally in the range of 1.5-5t, (Figure 2) that effectively reduce the extent of toe scour and the wave energy reaching the second wall. From historical aerial photos, this wall was originally part of a continuous rock wall between the Old Jetty Site and Manfred Street (Figure 4) that is likely to date back to the erosion events and subsequent protection works in the late 1970's.

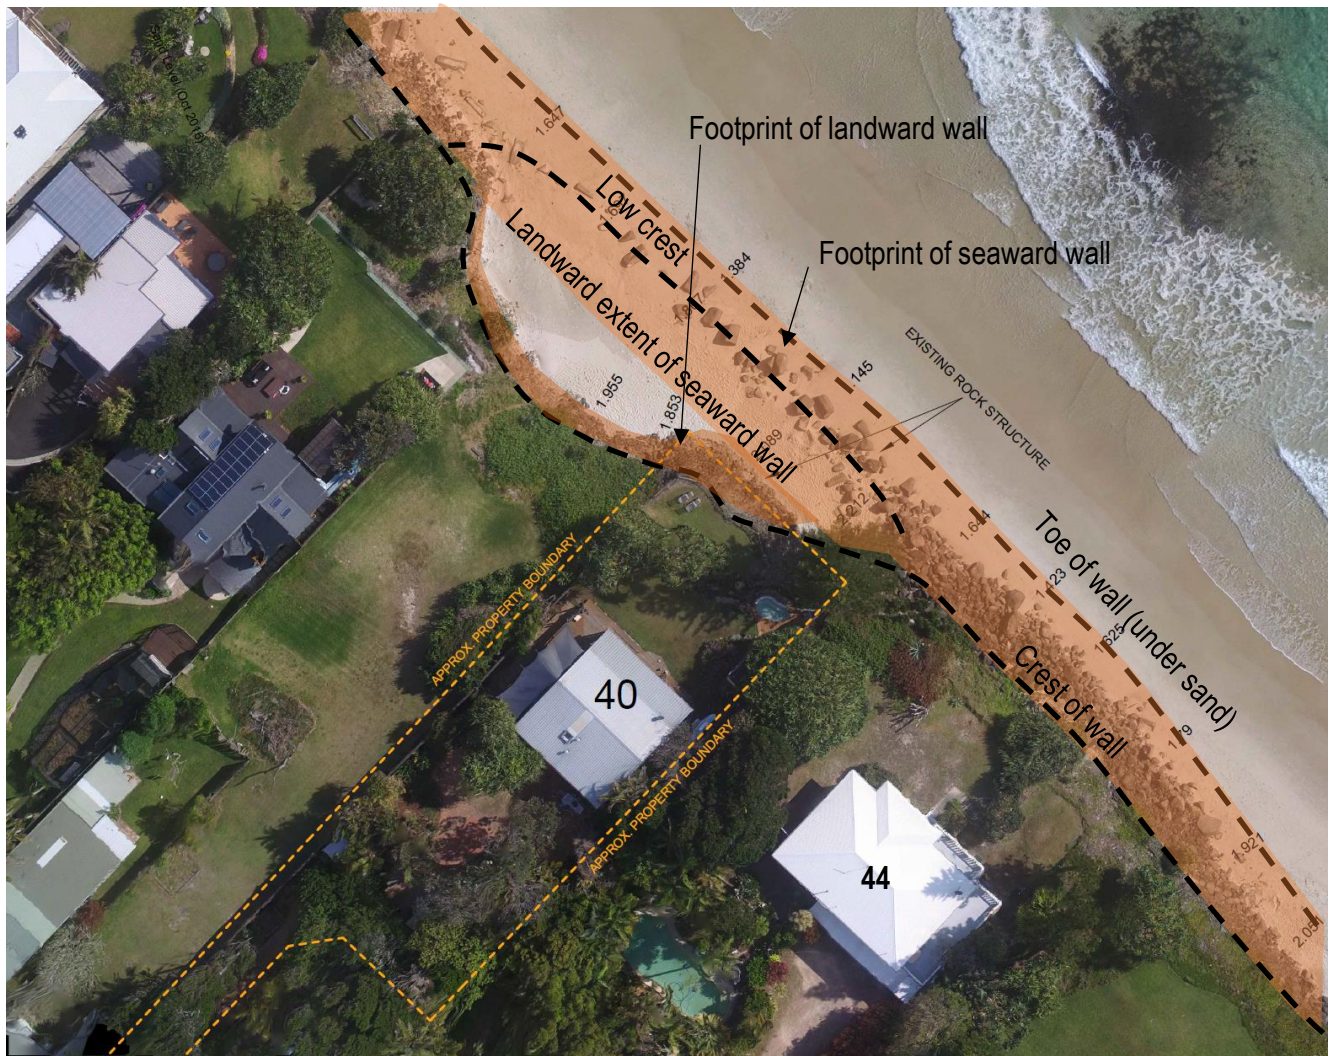
Figure 3 Recent aerial (2016) showing the 2 seawalls to seaward of No 40 Childe St (ICM photo Oct 2016)

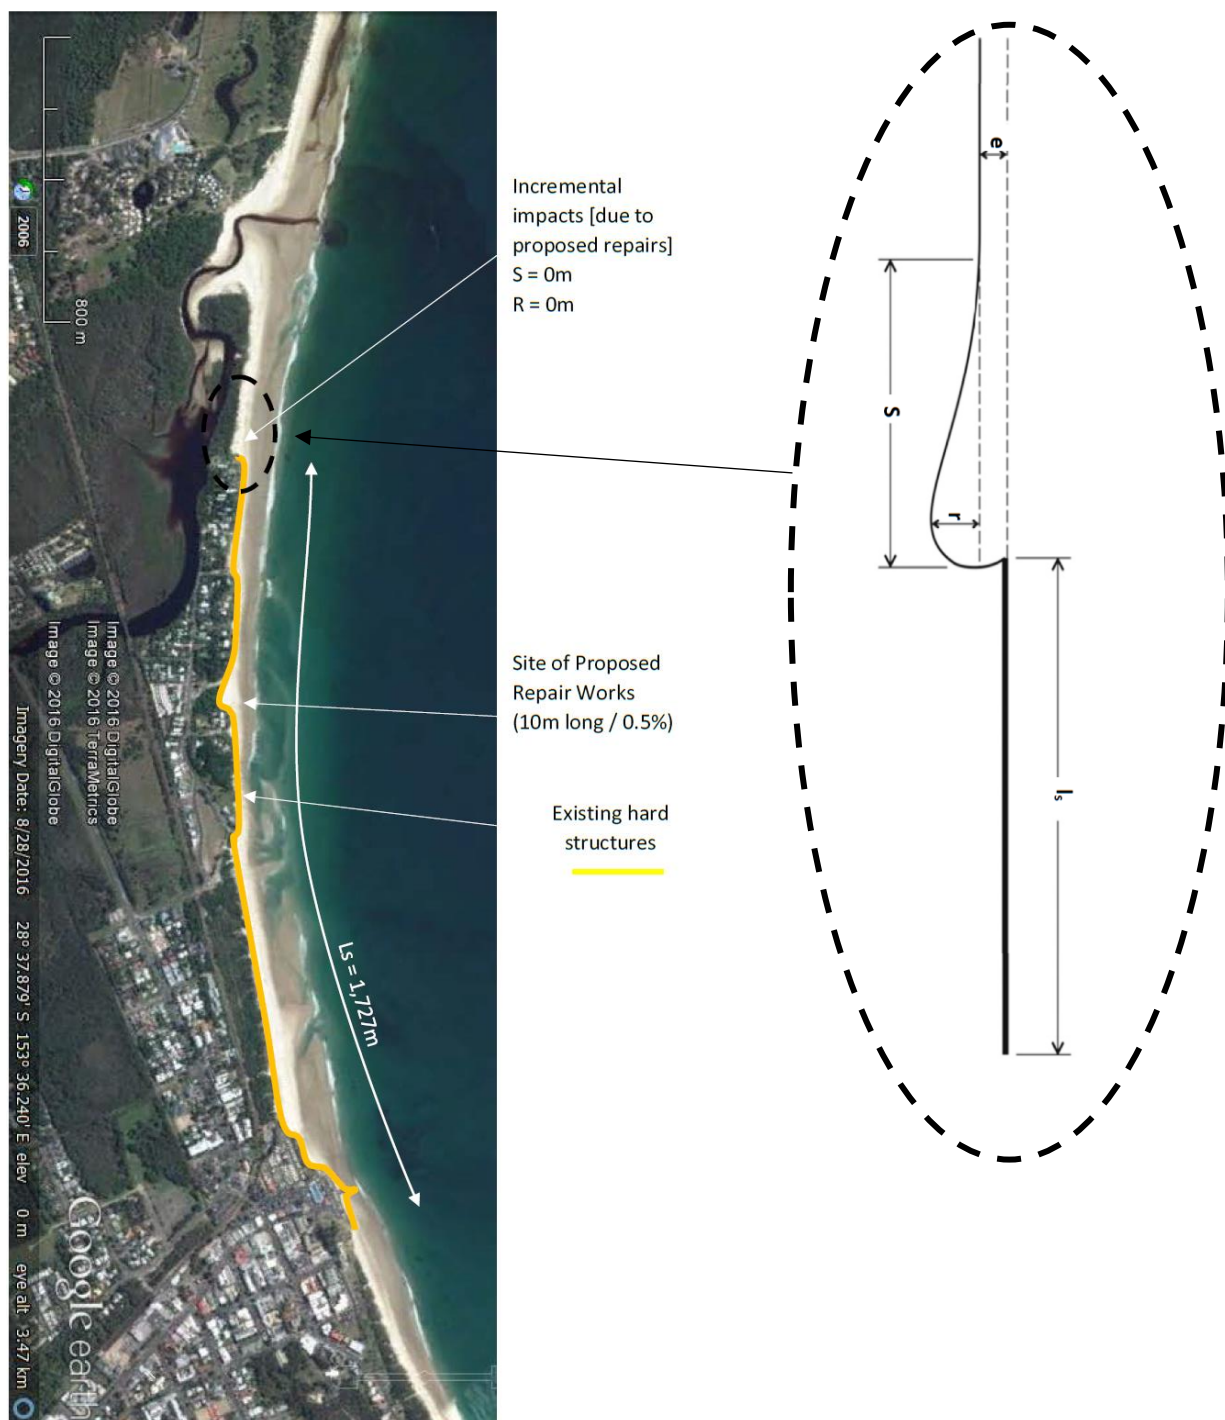
ICM concluded, similarly, that there will be no incremental end effects from repairing the existing wall with a length of 10m at the subject site. That is, $r = 0\text{m}$ and $S = 0\text{m}$ as per the McDougal et al 1987 diagramme overlaid on Belongil (Figure 12) with dimensions.

Figure 12 McDougal et al 1987 diagram applied to Belongil curved coastline
