GEOMORPHIC IMPACT ASSESSMENT

Geomorphic Impact Assessment For Proposed Seawall, Arrawarra Caravan Park, Arrawarra, NSW.

P0601565JR01_v3
January 2007

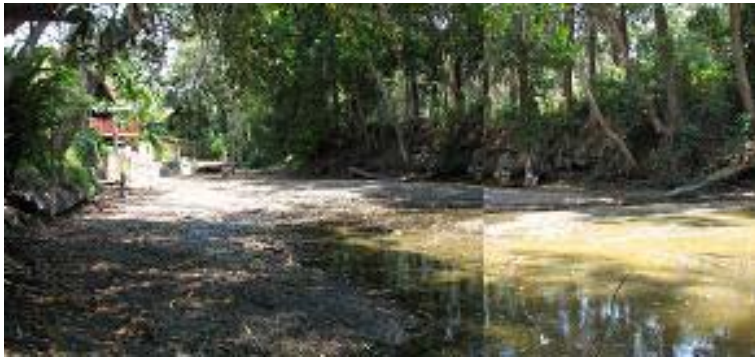
Plate Number	3
Chainage	30
Description	Western tributary joining with Yarrawarra Creek further east.
Date	28/11/06
View Direction	North West

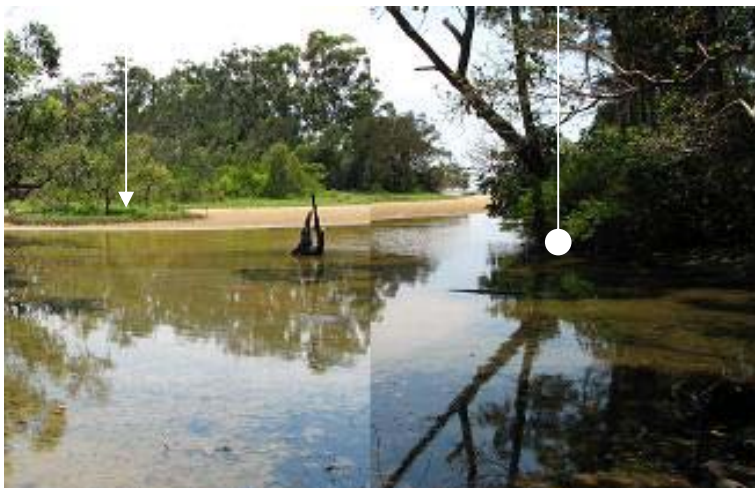
CH 40

Plate Number	4
Chainage	30-40
Description	Confluence of two additional tributaries with Yarrawarra Creek from north-west.
Date	28/11/06
View Direction	North East
