# An Assessment of Potential Unexploded Ordnance (UXO) Aboard the *M24* Japanese Midget Submarine (1942)

Prepared by Dr Brad Duncan and Tim Smith

Maritime Heritage Program  
Heritage Division  
Office of Environment and Heritage  
Parramatta February 2017

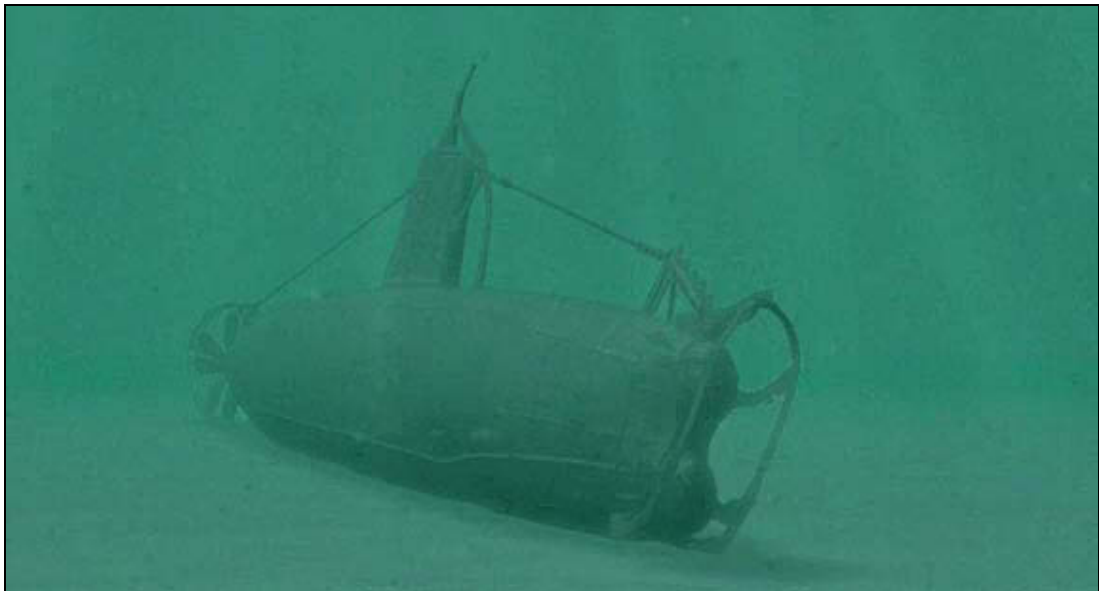
On 20 November 2006, the (then) Department of the Environment, Water, Heritage and the Arts was advised by the Department of Defence of the reported discovery of the wreck of the missing Japanese midget submarine *M24* by divers from the No Frills Divers off Sydney's Northern Beaches (offshore from Mona Vale Headland/Bungan Head, Newport – Figure 3). The submarine was found intact, with some damage to the conning tower and bow sections caused by fishing net entanglement (see Figures 4 and 5).

Figure 5: CGI model of *M24* on seabed when it first sank (Image: Animax Films).

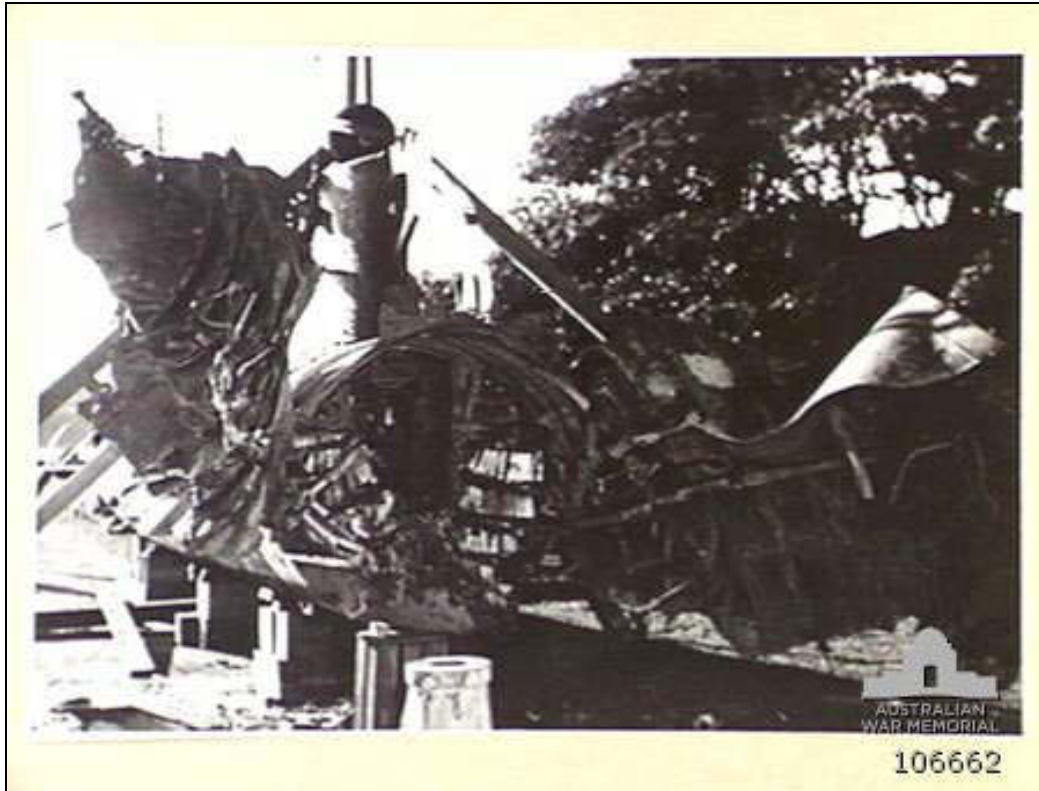
Figure 10: Picture showing exploded hull of the *Ha-14* Midget Submarine (Image: Courtesy AWM 106662).

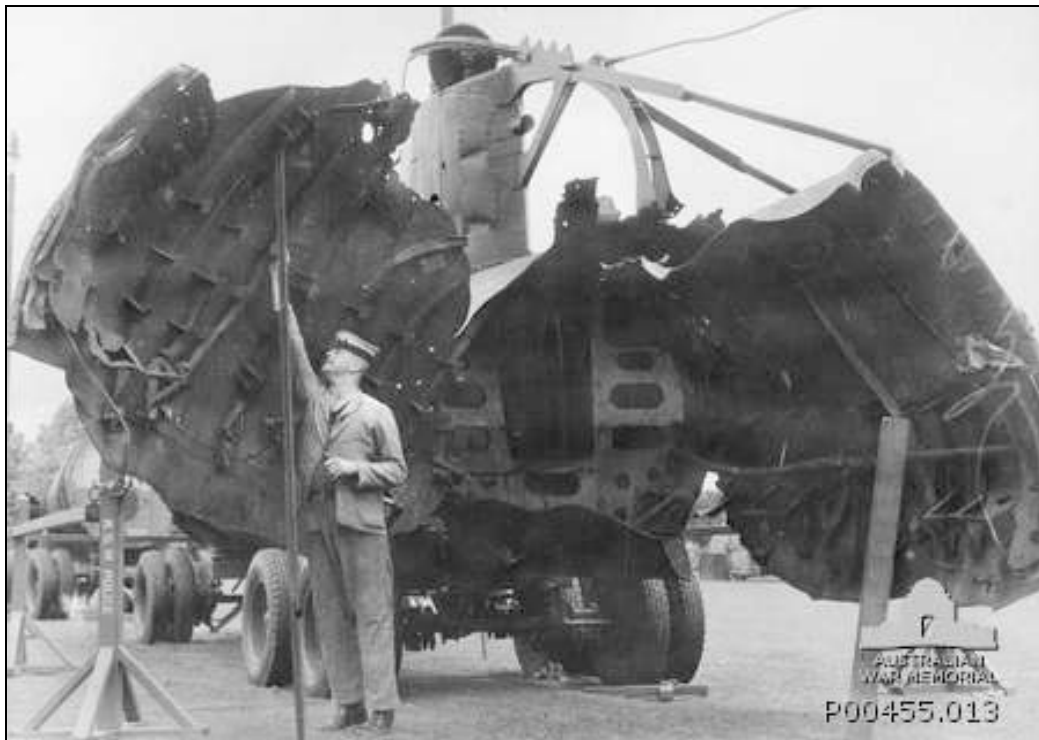
Figure 11: Picture showing exploded hull of the *Ha-14* Midget Submarine after being cleaned up for exhibition (Image: Herald Newspaper 1942 - AWM P00455.013).

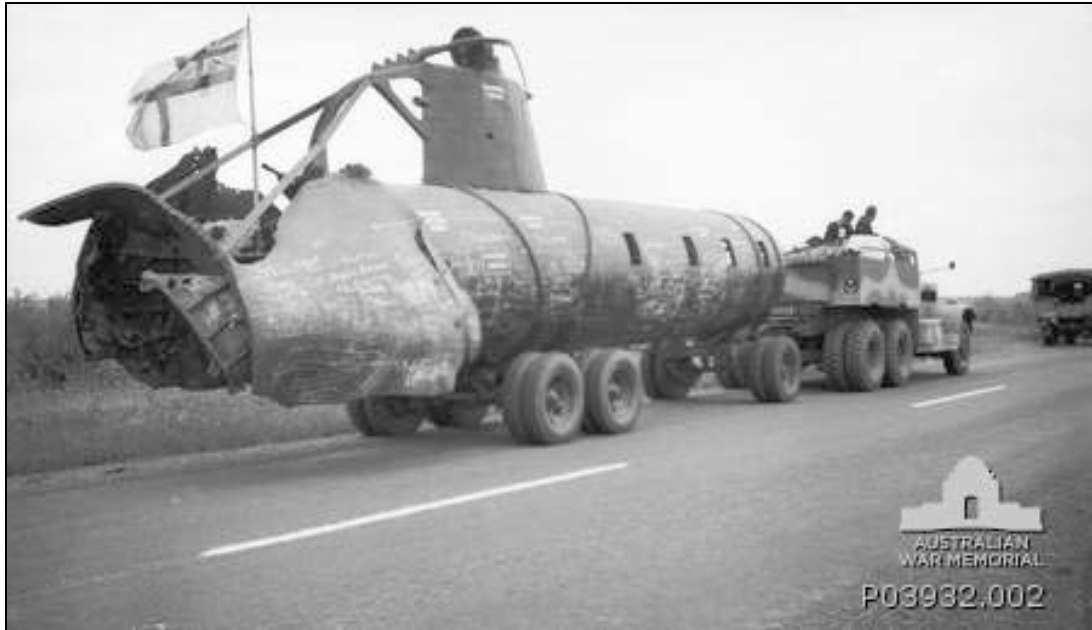
Figure 12: Midget submarine on trailer on touring exhibition showing mangled forward end of the submarine minus torpedo and engine rooms (Image: Goggs 1942 - AWM P03932.002).

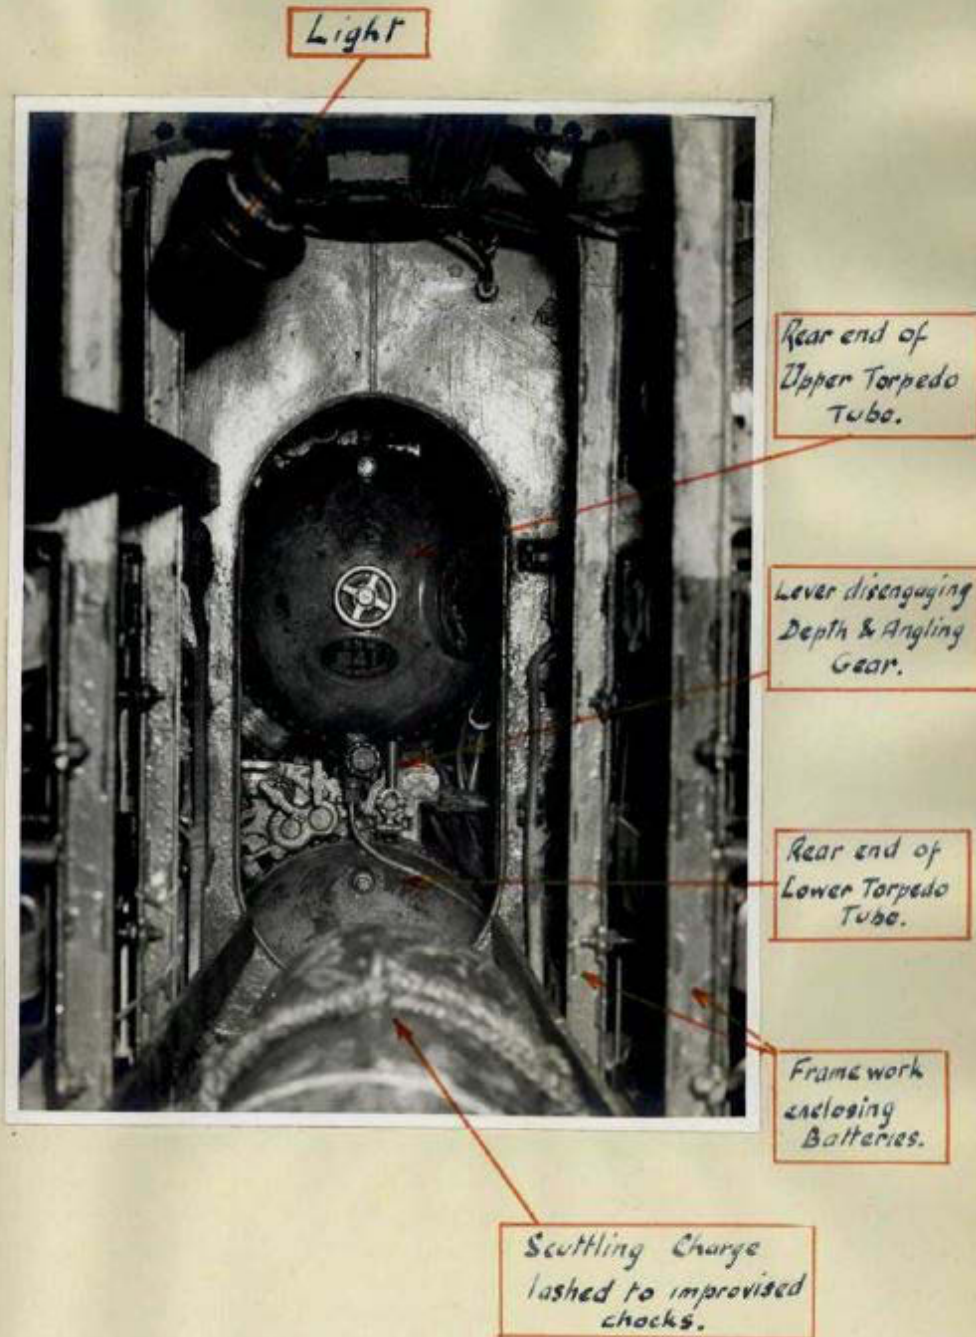
Figure 13: Scuttling charge on recovered midget submarine *Ha-21* from the 1942 Sydney raid. This image shows the forward charge roughly secured in the passageway of the forward torpedo room, close to the bulkhead separating the forward battery room and torpedo room (Image: from AWM # MP1049/2 (1942)). A similar image is also available in NAA # 485279 - Australian War Memorial AWM54, 505/6/7).

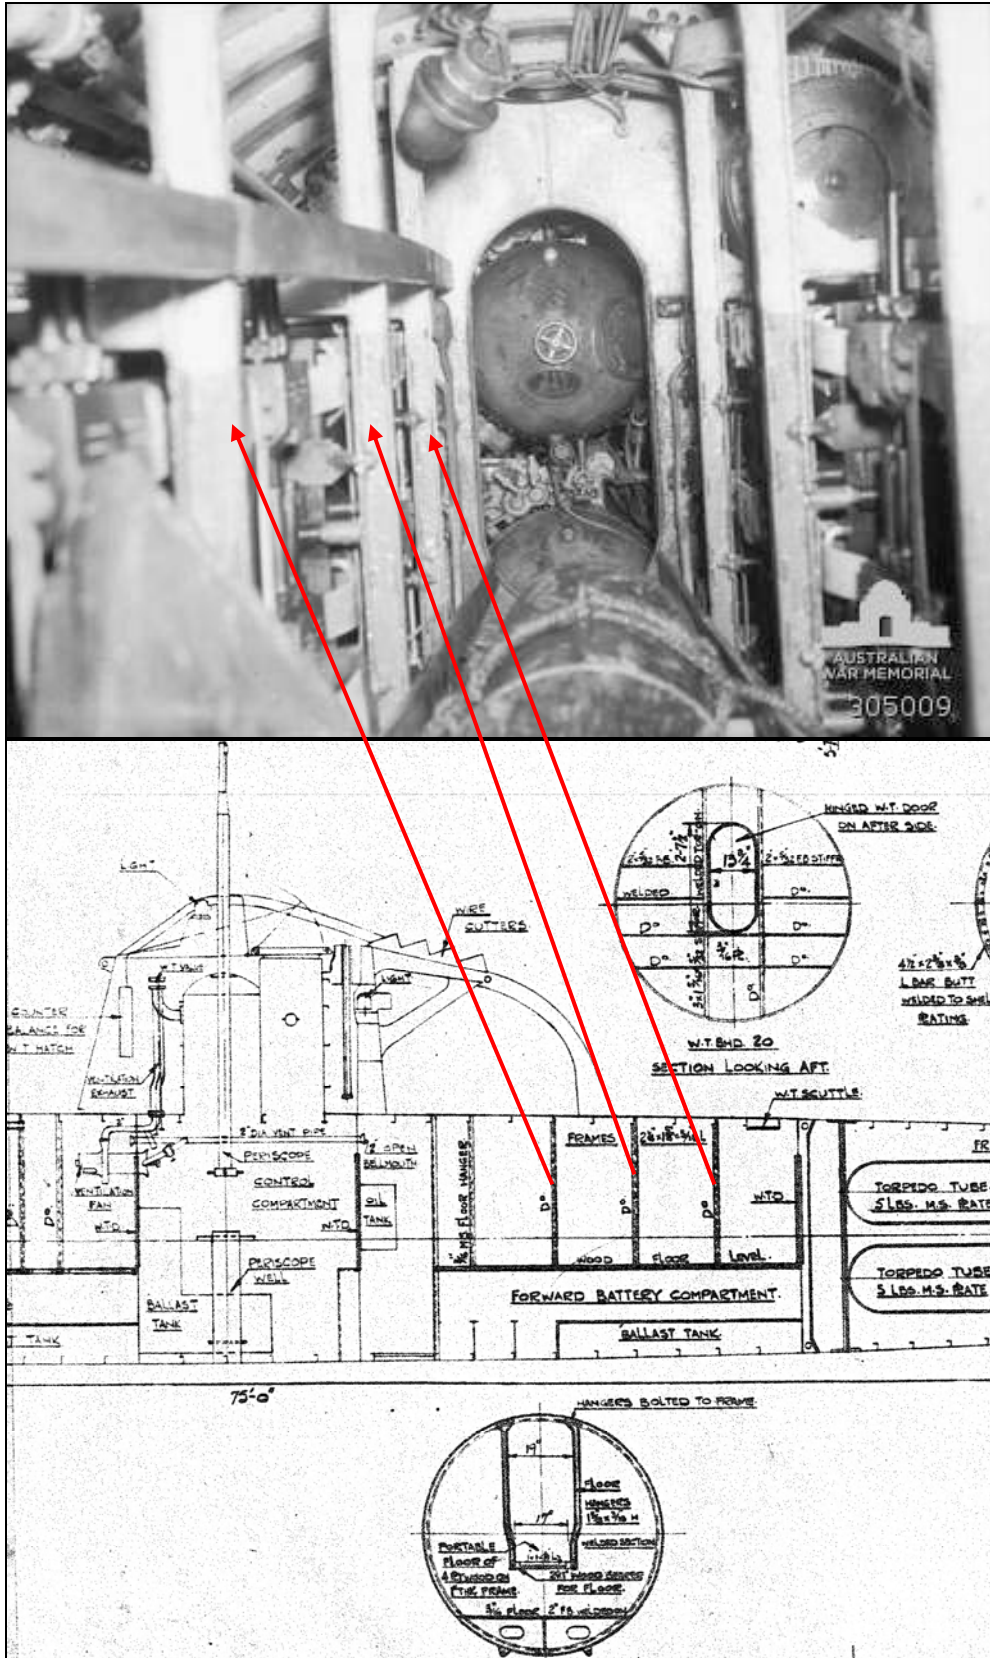
Figure 14: Scuttling charge shown into the forward battery room with the torpedo room (in the background) of *Ha-21*. This appears to be a later better lit image of the hull section shown above. Note the vertical battery bank stanchions or hangers along the edge of the passageway and their corresponding location on the plan below (Images: Australian War Memorial AWM # 305009 and NAA # 9556087).

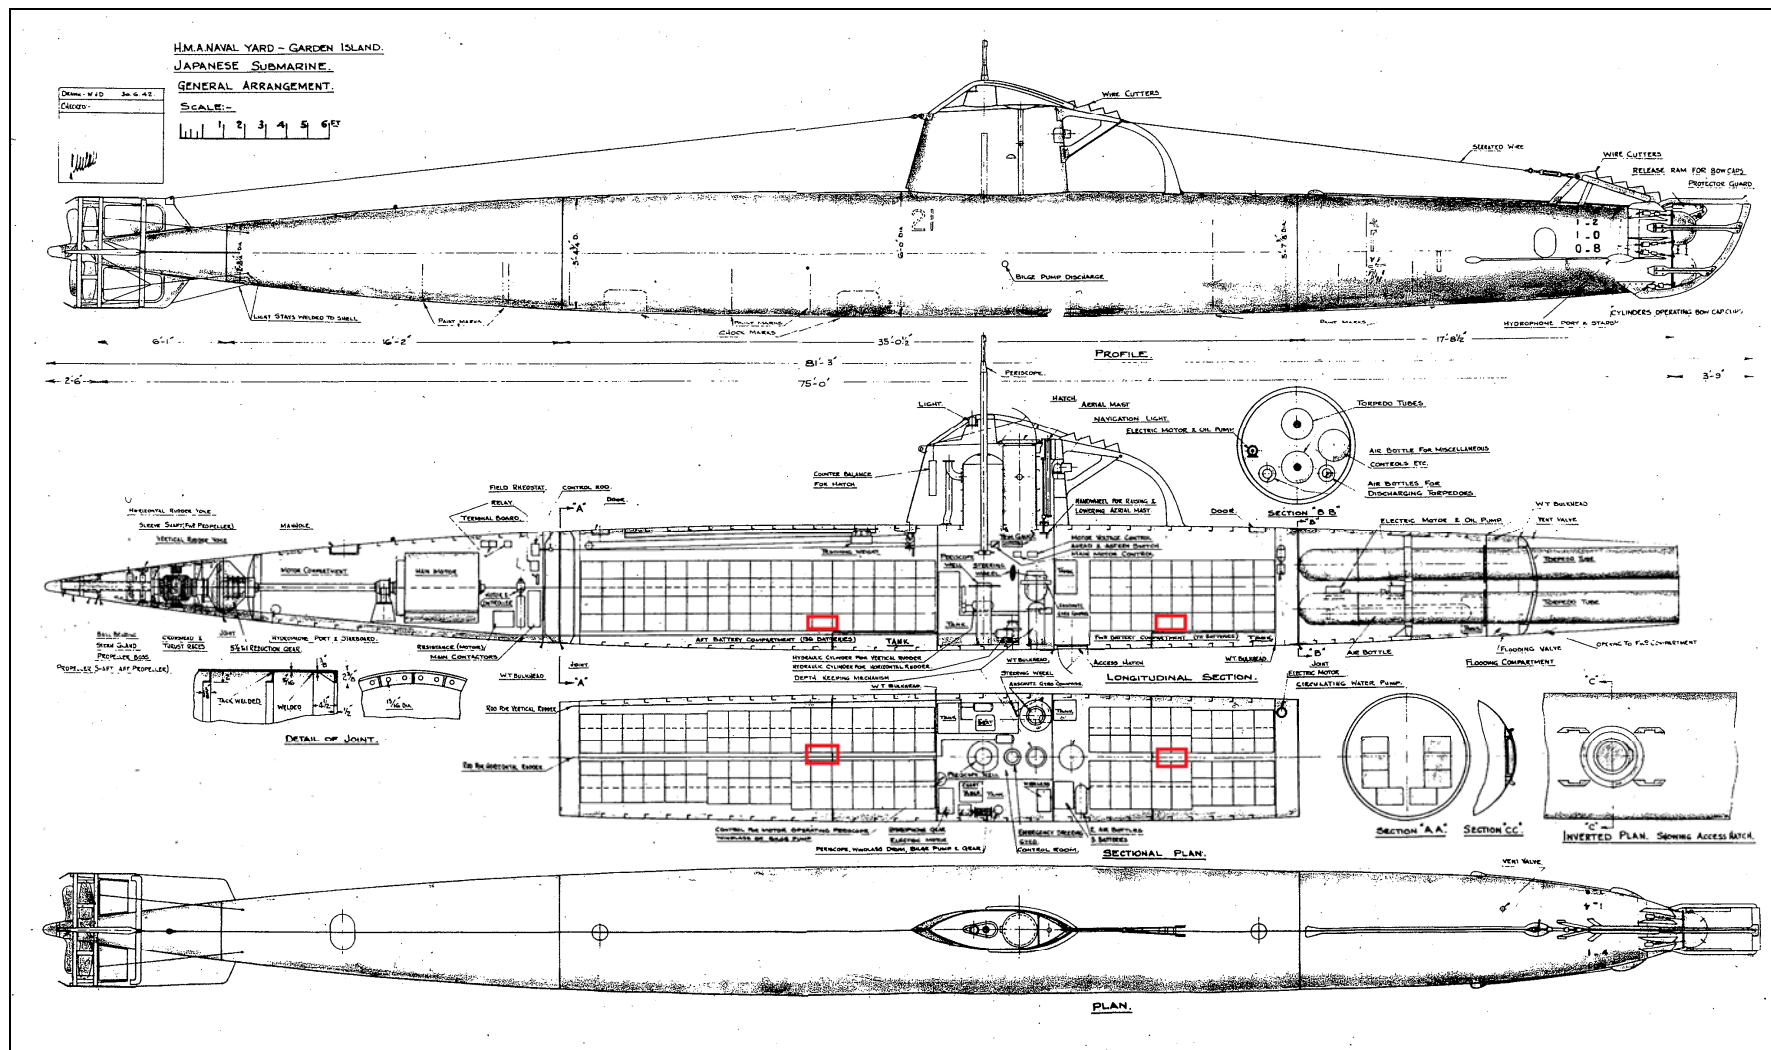
Figure 29: Interpretation of likely locations for demolition charges shown in red (Image: After plans held at Australian War Memorial, AWM54, 505/6/7, NAA # 485279).

that the was charge lying down facing forwards with detonation point closest to the control room end (see Figure 29).

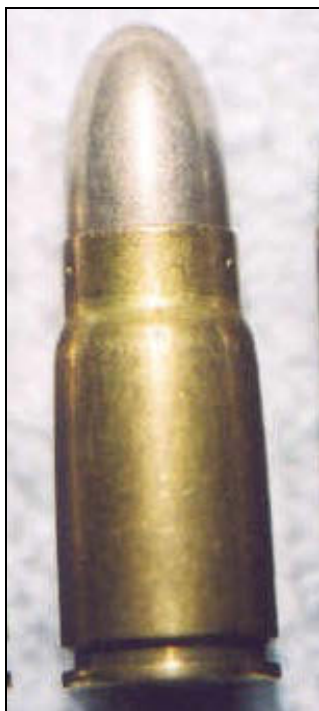
Figure 43: Japanese Nambu pistol 8mm round (Image: After Bryant 2005).

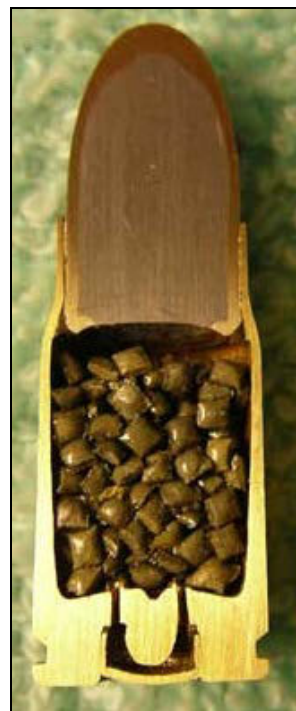
Figure 44: Cutaway section of a Japanese Nambu 8mm round (Image: After Bryant 2005).

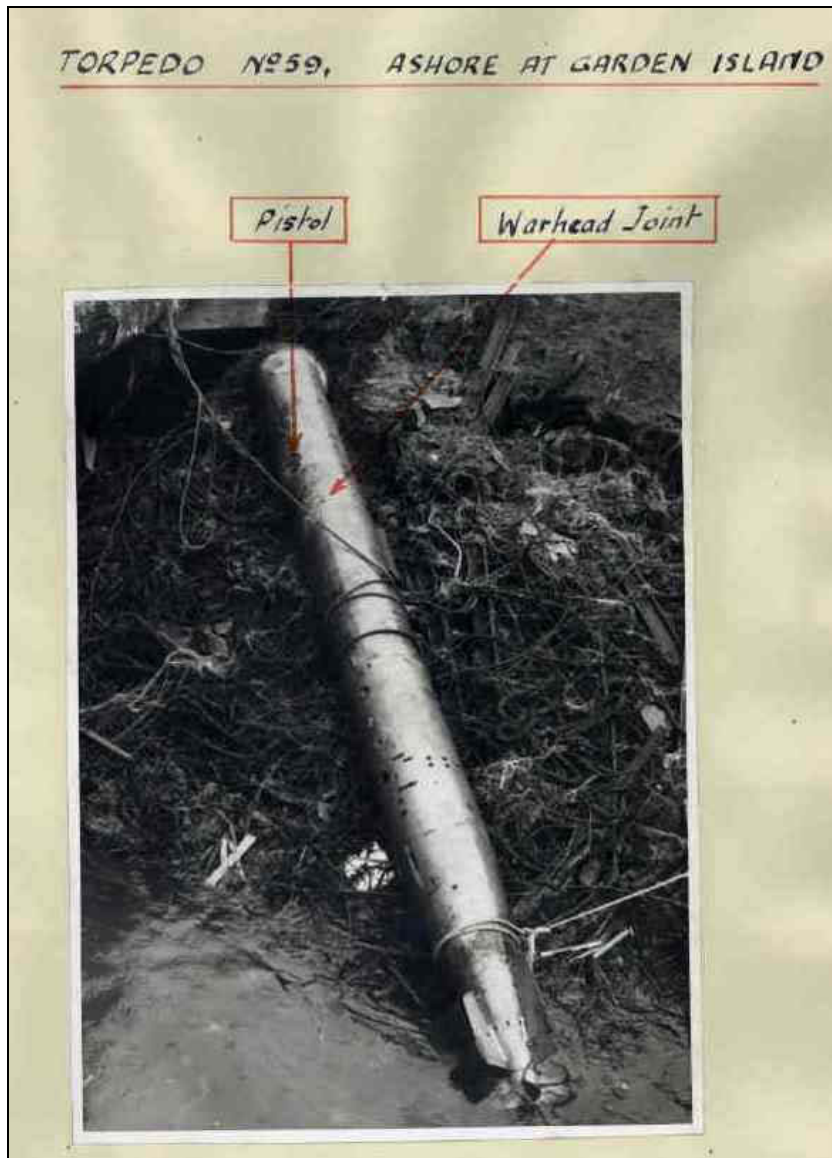
Figure 45: Torpedo from M24 Midget Submarine on Garden Island (Source: NAA# 668555, Plate 32, and AWM 305005).

Further research has concluded that the inertia pistol was fitted about 1m aft of the head of the torpedo (see Figure 45) and was not a pistol in the traditional sense (e.g. if associated with guns) that it was not fitted with cartridges. Instead the mechanism entailed an inertia spring which fired the inertia pistol when the spring reached a set pressure. It was set to arm at the minimum required safe distance from the submarine and explode using the arming range selector screw. The arming distance was calculated by water movement over an impeller rotating it a set number of turns. When the inertia spring was fully retracted, it released the inertia trigger, firing a pistol mechanism directly into the detonator, thus initiating the explosion sequence.

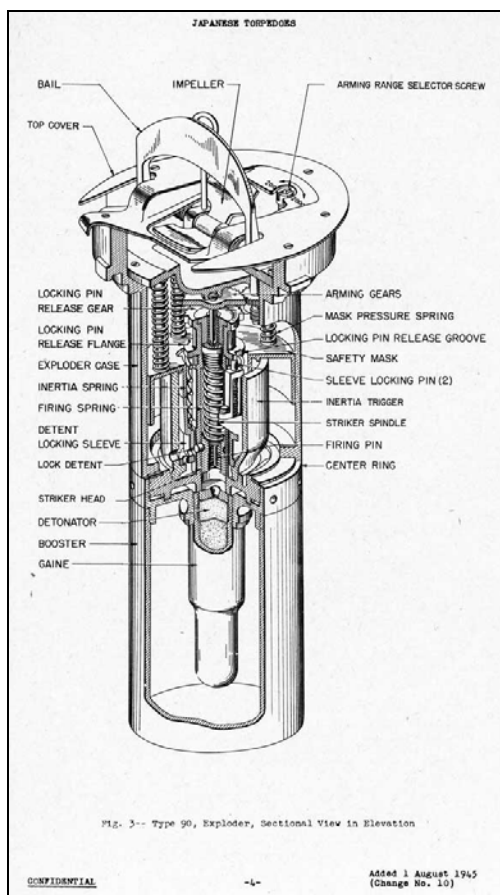
Figure 46: Type 90 inertia pistol exploder mechanism (U.S. Navy Bomb Disposal School, 1945).

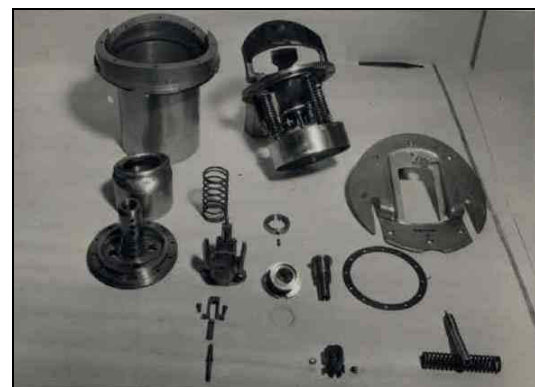
As the firing mechanism for the inertia pistol was self-contained in the torpedo, it would have been installed when the torpedo was loaded onto the vessel. Therefore, it is highly improbable that any spares, replacement explosives or inertia pistols would have been carried in areas accessible to the crew inside the *M24* submarine, and no comments on spare mechanisms inside the submarine have been found in any historical documentation to date.

Figure 47: Dismantled inertia pistol mechanism from *M24* torpedo at Garden Island (Image: from NAA #668555, Plate 34).

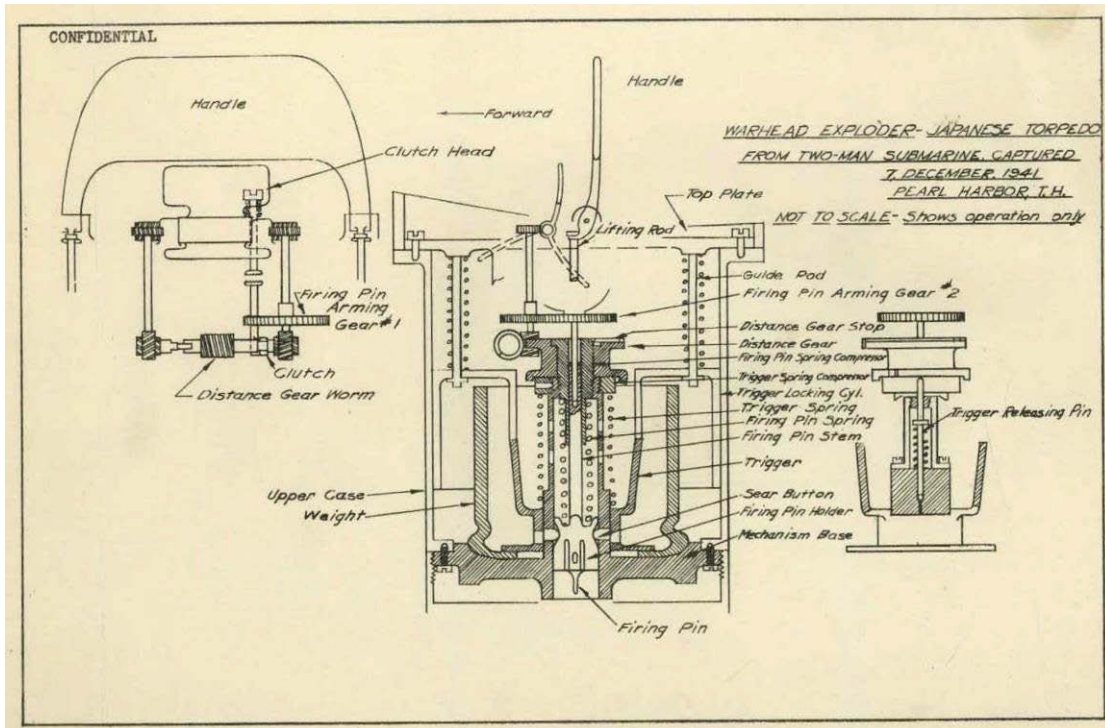
Figure 48: Details of Torpedo Exploder Mechanism from 2 man (midget) submarine at Pearl Harbour 1942 (Image: NAA MP1049/5, p.12)

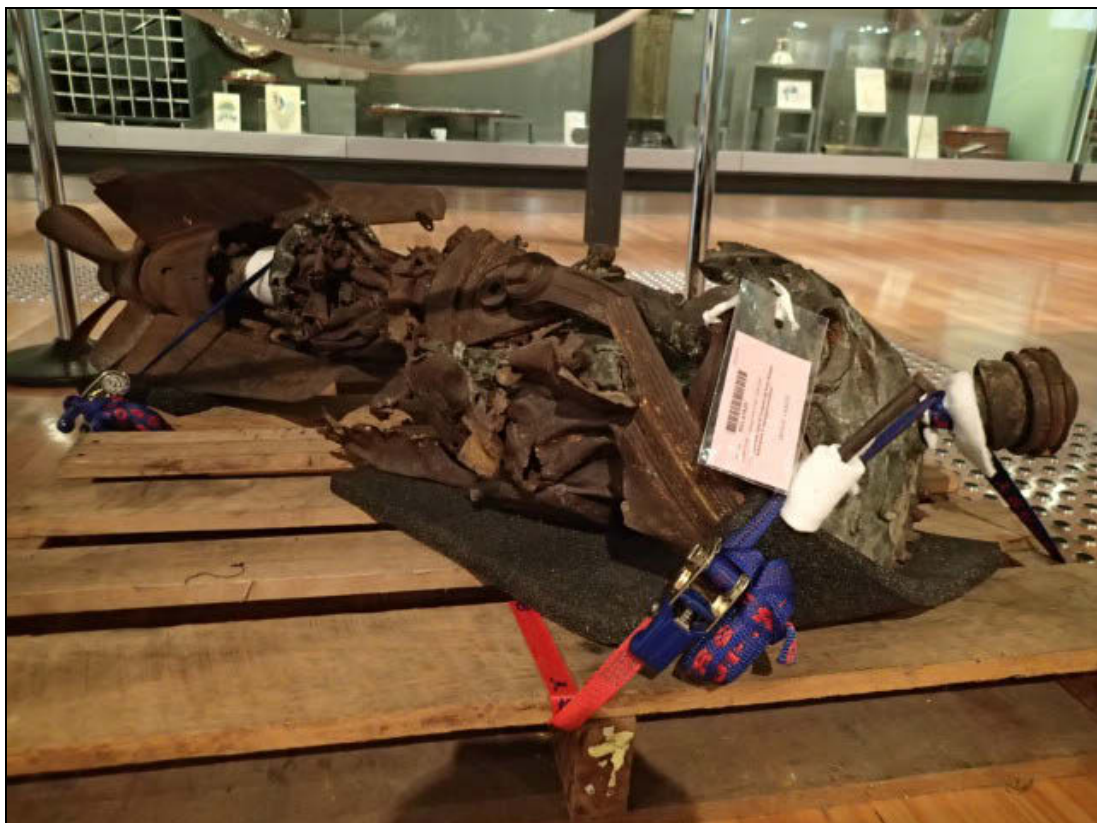
The composition of the explosive is very similar (if not identical) to that discovered in the *Ha-19* midget submarine at Pearl Harbour <sup>163</sup> (also see Tables 2-3). Figure 49 shows the remains of the torpedo from *M24* which exploded under the HMAS *Kuttabul*.

Figure 49: Torpedo from M24 which exploded under HMAS *Kuttabul* at Garden Island. The torpedo is owned by the Australian War Memorial, and currently on display at RAN Heritage Centre, Garden Island. (Image: Stirling Smith).
