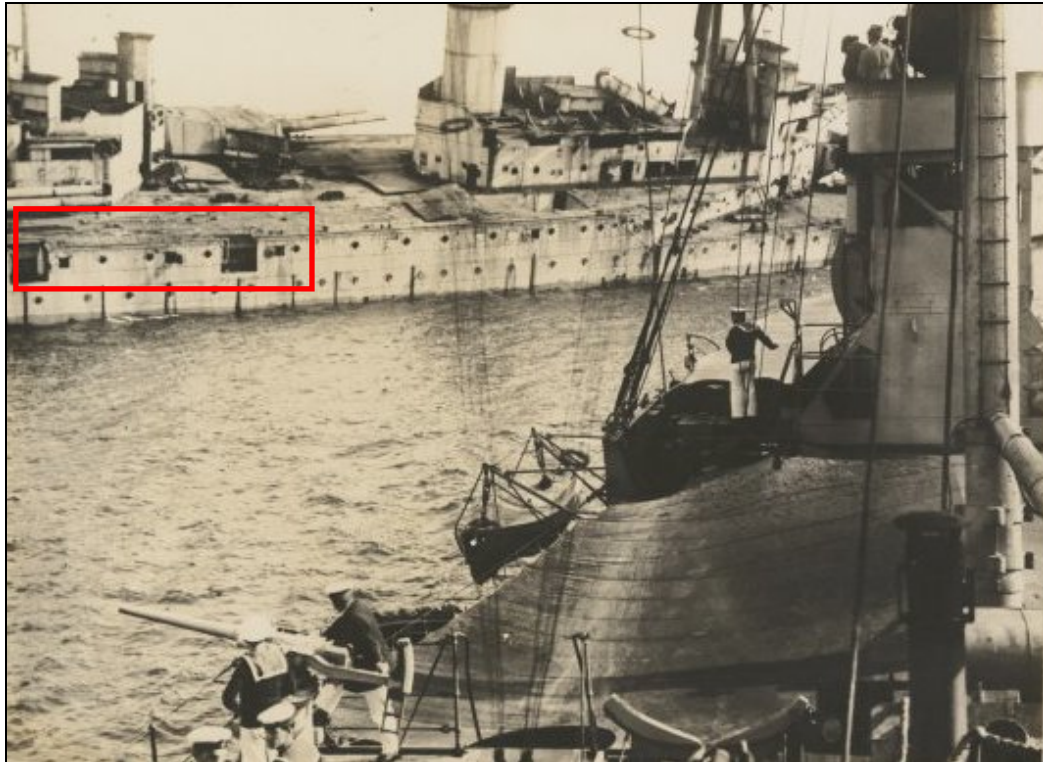
Figure 13: View of *HMAS Australia* during scuttling event showing scuttling holes on port side (Photo: pic-vn4655992v , Searle Collection, National Library of Australia Collection)

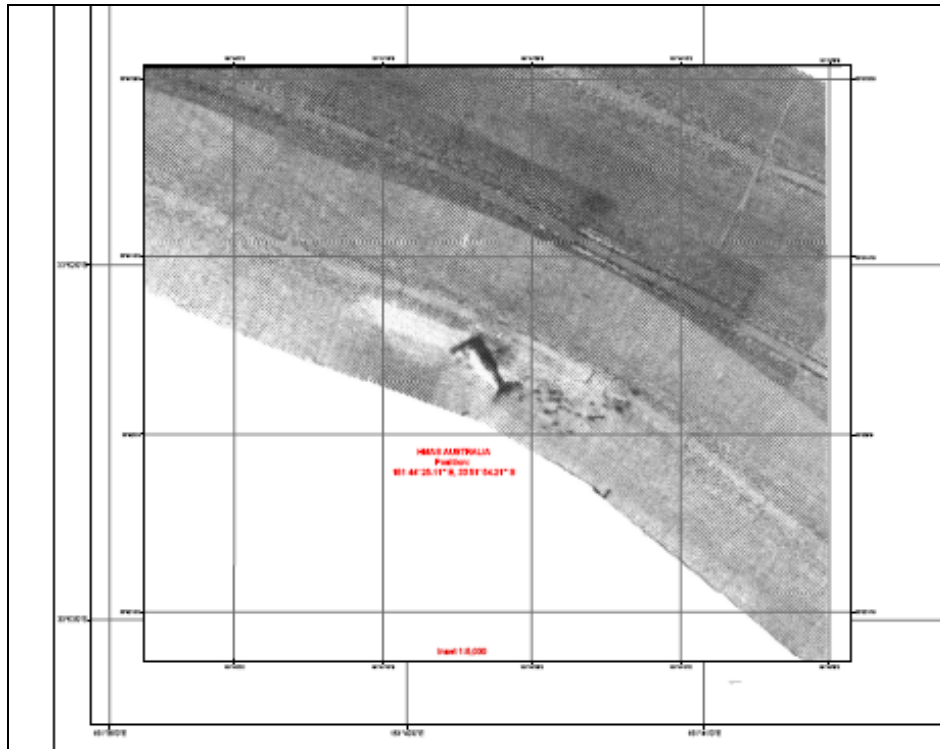
Figure 26: Side scan image of *HMAS Australia* and associated debris field laying on the seafloor (Image: Fugro Seafloor Survey Inc.)

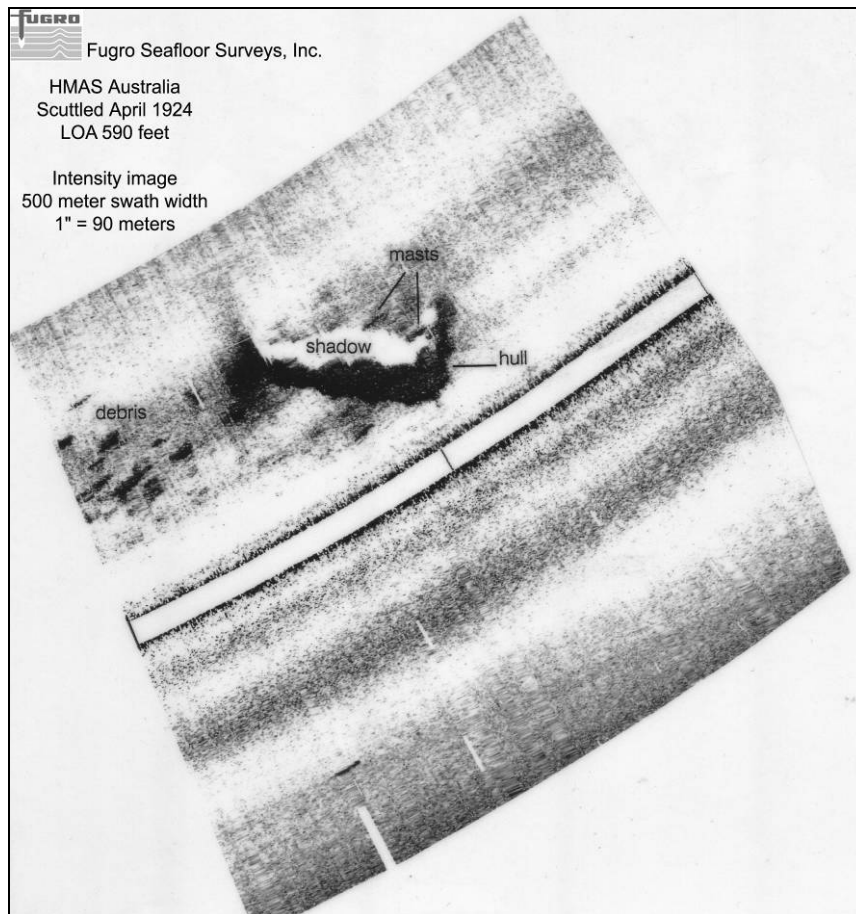
Figure 27: Side scan survey of the *HMAS Australia* wreck site and associated debris field site (Image: Fugro Seafloor Survey Inc.)
