SOLITARY ISLANDS SHIPWRECKS SURVEY

14-16 February 2000
and
14 August 2000

CONSERVATION MANAGEMENT PLAN

December 2000

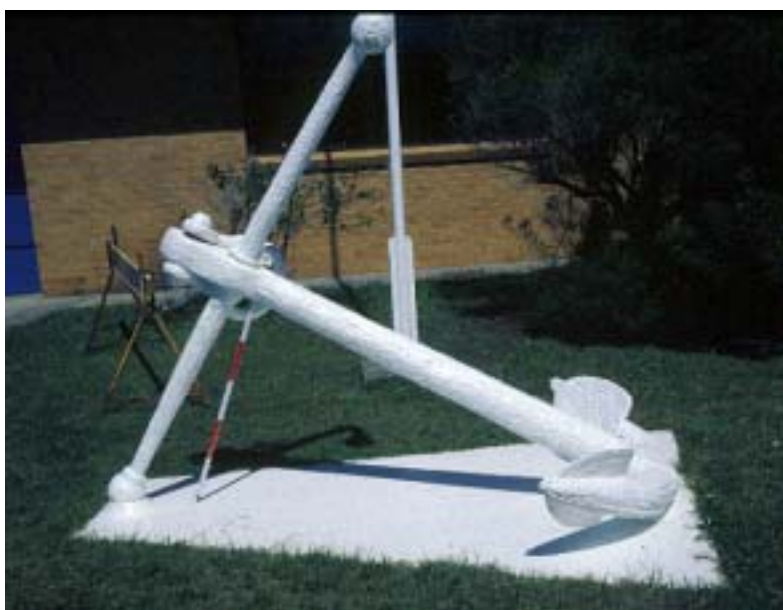
Four anchors were observed on public display at Coffs Harbour. A standard Admiralty pattern anchor (painted white) was located in front of the Coffs Harbour Water Police Building at the Marina. Another identical anchor was located adjacent to the nearby Fisherman's Co-op, a Lt Rodgers small palm anchor in a public reserve adjacent to the Coffs Harbour Yacht Club, and a large Admiralty-plan mooring anchor was documented in the grounds of the Coffs Harbour Historical Society & Museum in High Street. As these sites are readily signposted and serviced by sealed road, detailed GPS positions were not required.

Figure 7: An Admiralty Pattern anchor on display at the Coffs Harbour Water Police office. Photo: David Nutley.

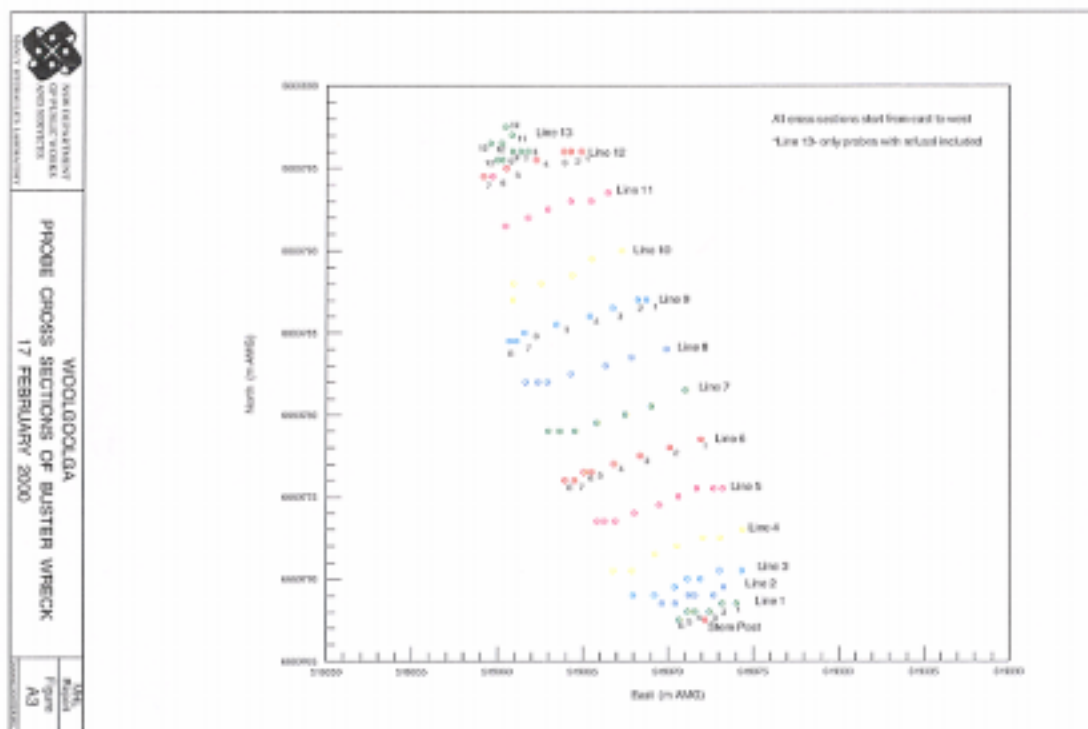
Figure 11: A chart of the plotted probe positions showing the extent of the buried portion of the timber hull. Courtesy of Manly Hydraulics Laboratory.

One of the main survey aims was the delineation of the site, including both exposed and buried portions. This was achieved by conducting an air probe survey around the site and recording the depth and location of each timber contact using a theodolite. The centre-line of the wreck was found by this process to lie on a bearing of approximately 340° with what was presumed to be the bow (from historical reports) facing north.

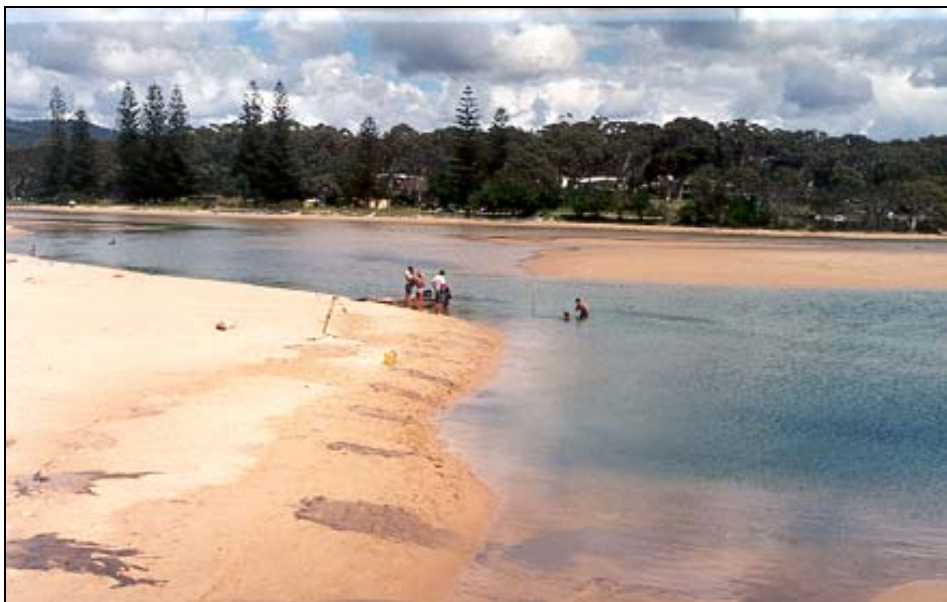
Figure 14: *View of the survey operation at Moonee Creek.*
Photo: David Nutley.

A snorkel search of the target area was conducted but no exposed timbers were identified. Using a small water pump fitted to the team's punt, a three-metre probe survey was commenced. Probes were sunk along the existing sandbank but failed to make any contact with definite buried timbers. A large area of still water within the study region could be discounted as it was composed of established clay layers probably predating the wreck event. The search was moved further out into Moonee Creek within the main part of the flow. With the help of local residents, a refined target area was examined based on the last sightings. This proved accurate and within a short time, buried timbers could be identified. These were found to lie approximately 30 centimetres under the sand bed of the creek. Probes were continued until the total extent of buried structure could be delimited. It proved to be an extremely small area measuring approximately 3 x 5 metres in extent.

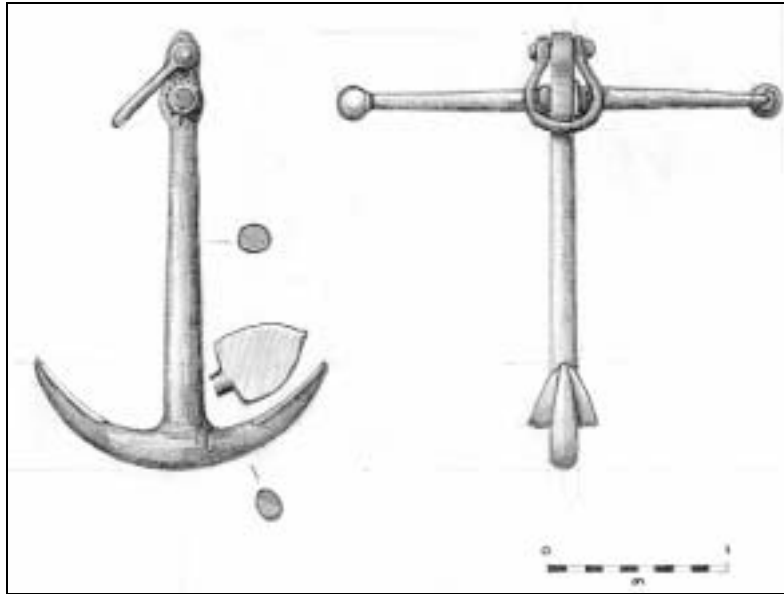
A prominently displayed iron anchor is mounted outside of the Water Police headquarters at Coffs Harbour. Painted white on a concrete plinth, the anchor is of the common "Admiralty Pattern". Developed by Admiral Sir William Parker for the Royal Navy, the design was introduced in 1841 (Upham, 1983:19). Known as the standard or new-style anchor, it is the most commonly observed type on vessels from that period.

Figure 19: Admiralty anchor (painted white) at Coffs Harbour Water Police. Recorded by D. Nutley and T. Smith. Drawn by Tim Smith.
