# Darling Baaka River Health Project 2023 to 2025

## Chapter 3 Geomorphic condition

Department of Climate Change,  
Energy, the Environment and Water

EH 2025/0168 September 2025

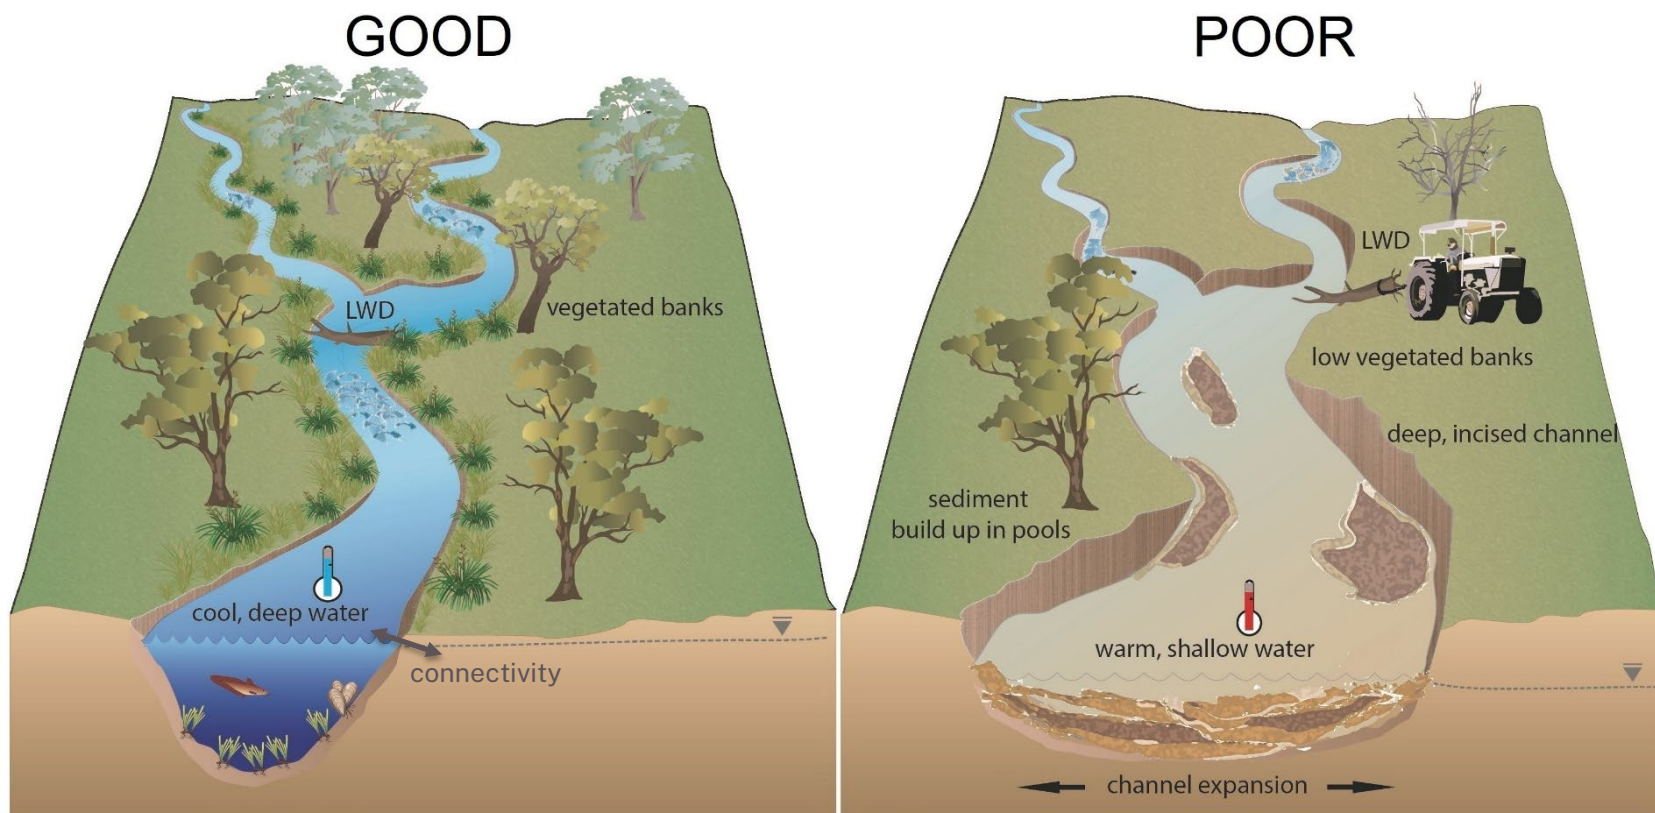
**Figure 1** Good versus poor river geomorphic condition (Source: DPE 2023a)

Left: Good geomorphic condition, with large woody debris (LWD) present, strong connection between healthy floodplain, channel and groundwater. Right: Poor geomorphic condition, with large woody debris absent, loss of groundwater and floodplain connection as channel incises into its bed

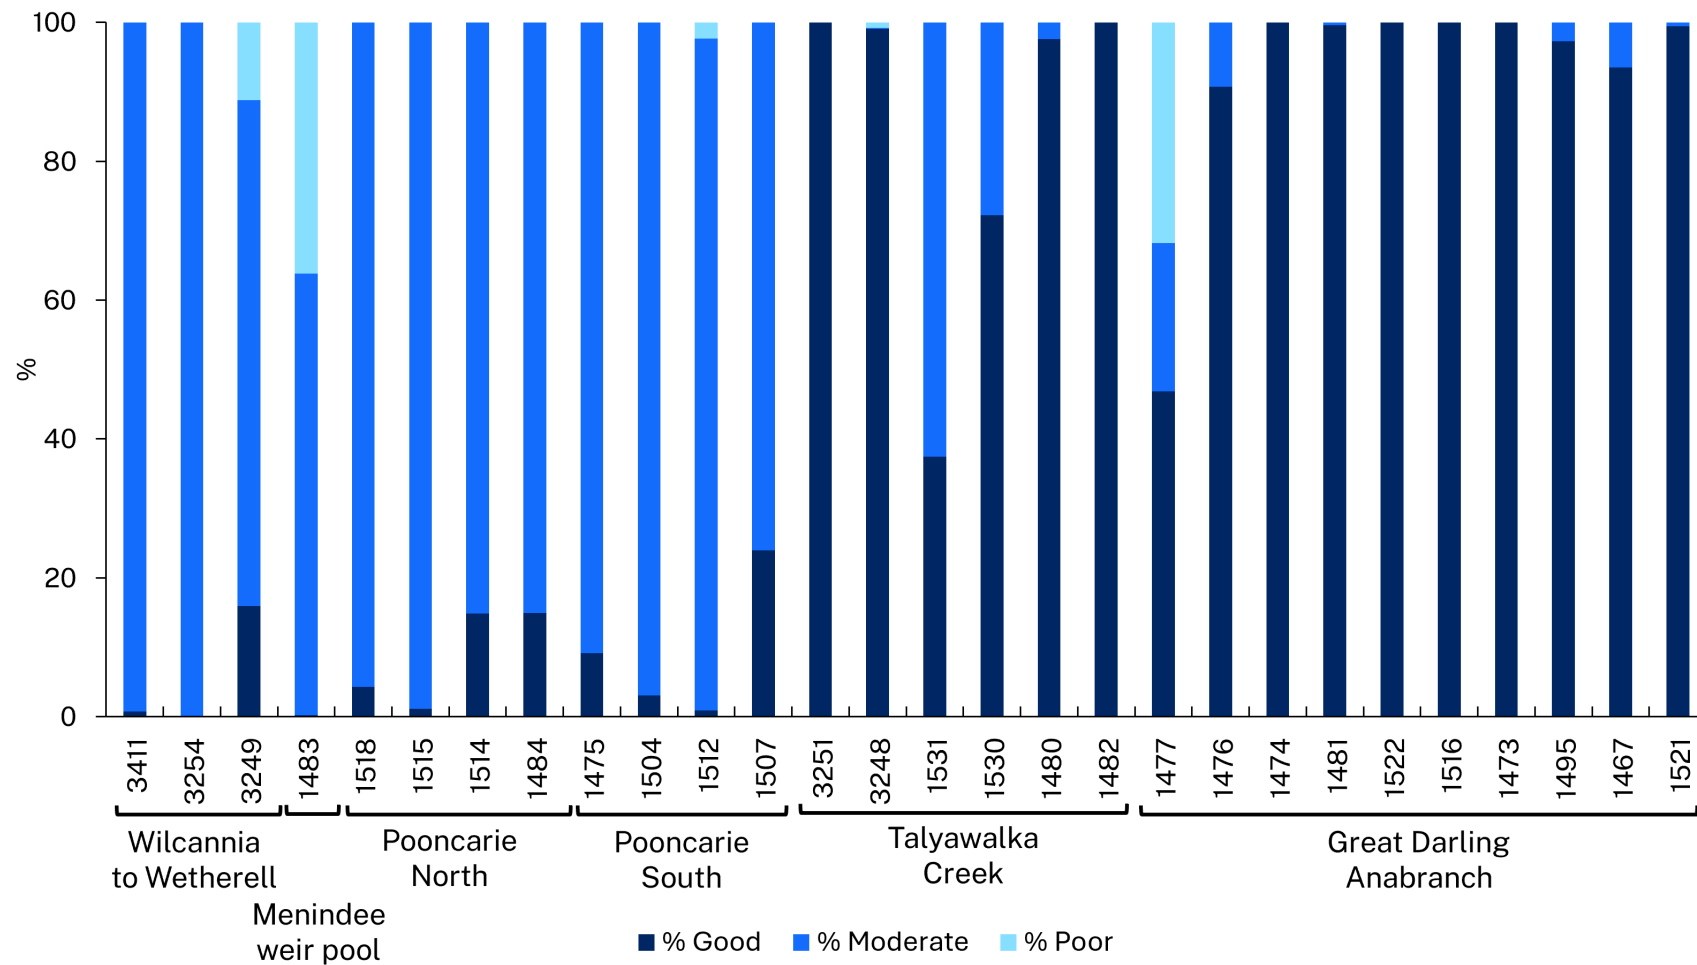
**Figure 5** Proportional river lengths in each of the geomorphic condition indicator grades

The most significant degradation of geomorphic condition was recorded in the Lake Wetherell subcatchment (1483) (Table 6; Figure 5). In this subcatchment Main Weir and its associated embankments impound the lower Darling Baaka River, resulting in semi-permanent inundation of the floodplain in the downstream section of Lake Wetherell. Geomorphic processes are highly altered under such conditions with very low potential for geomorphic recovery. Further upstream, the backwater effects associated with Lake Wetherell extend well into the Wilcannia Downstream subcatchment (3249). In these reaches, the channel is over-widened with evidence of eroded notches and undercutting

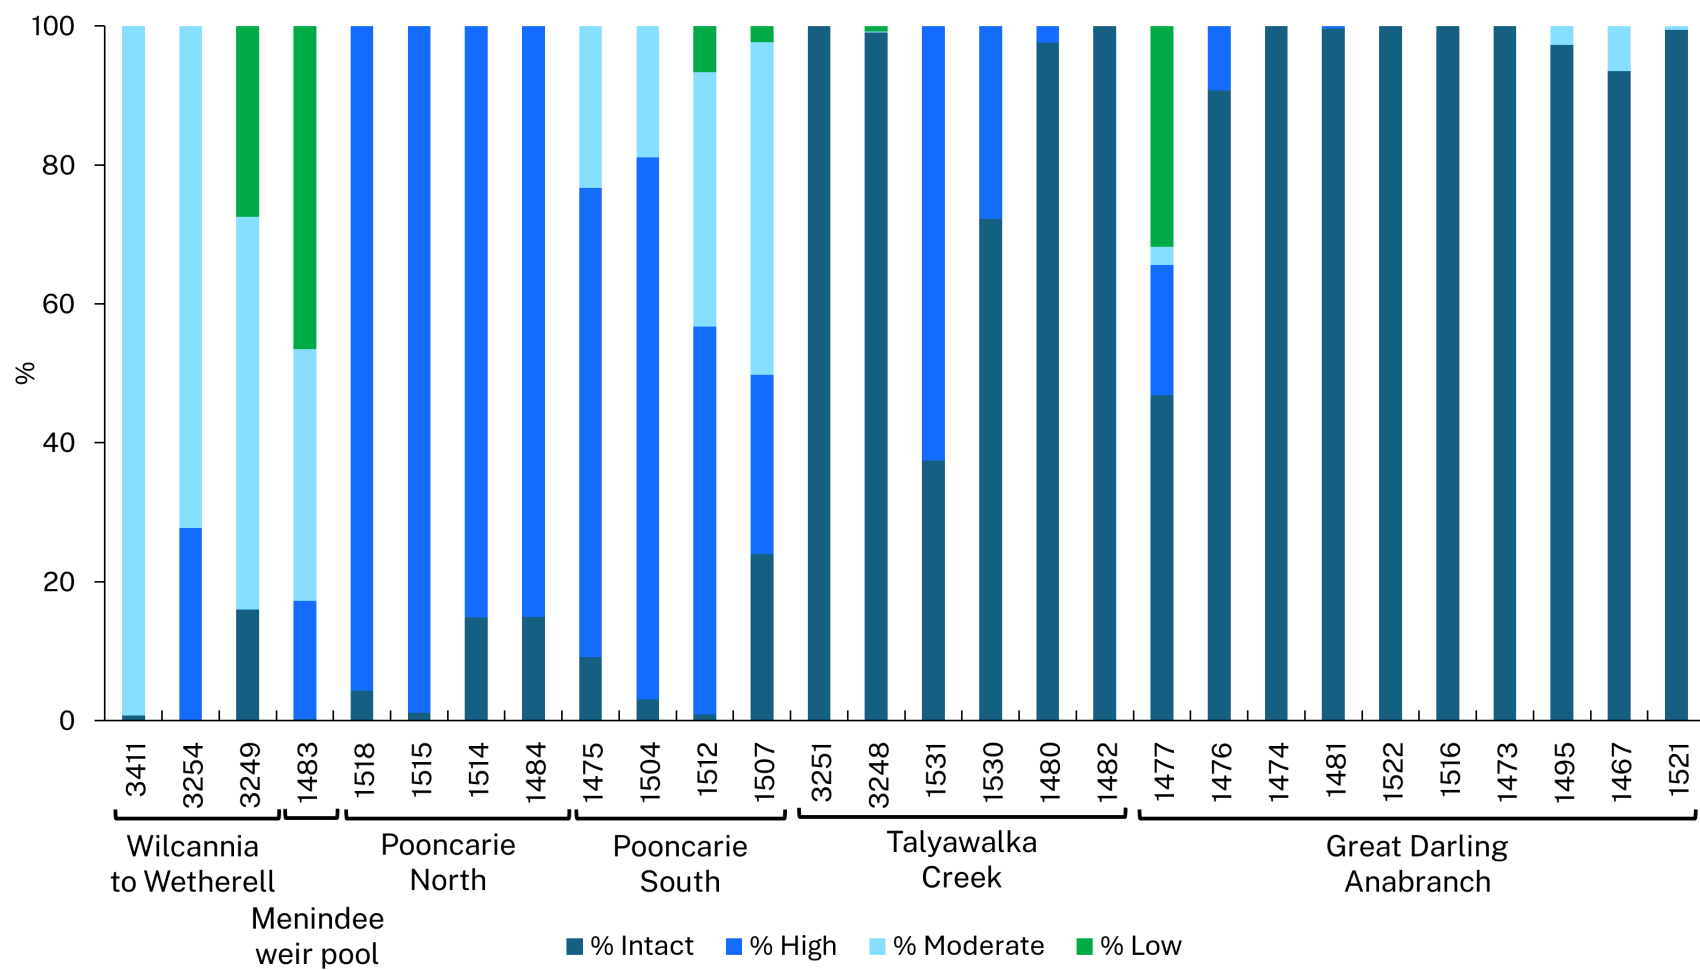
**Figure 6** Proportion of river lengths in each of the recovery potential categories

The reaches between Menindee and Wentworth have been identified as high recovery potential reaches, meaning that disturbances to geomorphic condition have occurred, but these areas have high potential to improve quickly. This region has a substantially lower frequency of alluvial gullies than upstream reaches and the relatively well-established riparian vegetation buffers indicate a high recovery potential (Table 7; Figure 6).
