Hazardous Building Materials Report

Revised Exhibition Draft
The Gap, Watsons Bay

Project 85743.01
July 2017

Pre-demolition Hazardous Building Materials Report Various Locations – The Gap National Park

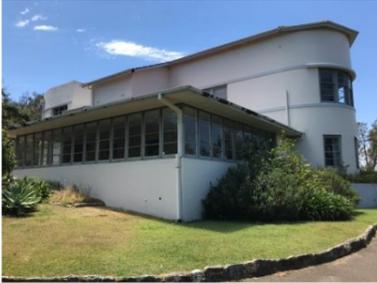
Location Description	Sample No	Asbestos Type	Friability Status	Product Type	Recommendation (A1 - A4)*	Comments / Action	Photo
Verandah soffit	27	No Asbestos detected	Non Friable	Flat Asbestos Cement Sheet	-	-	-
<p>The Officers' Mess is a masonry building with two sections; the older original building is to the west and consists of a double brick, two storey, masonry construction with a hipped tiled roof and timber floorboards. The extension to the east is a masonry and suspended concrete two storey building connected by a central hallway.</p>
