Requests for information – Minor Applications

1.5 Trewern, 40 Childe St. CP17-010

PROJECT NAME: BELONGIL SEAWALL REPAIRS

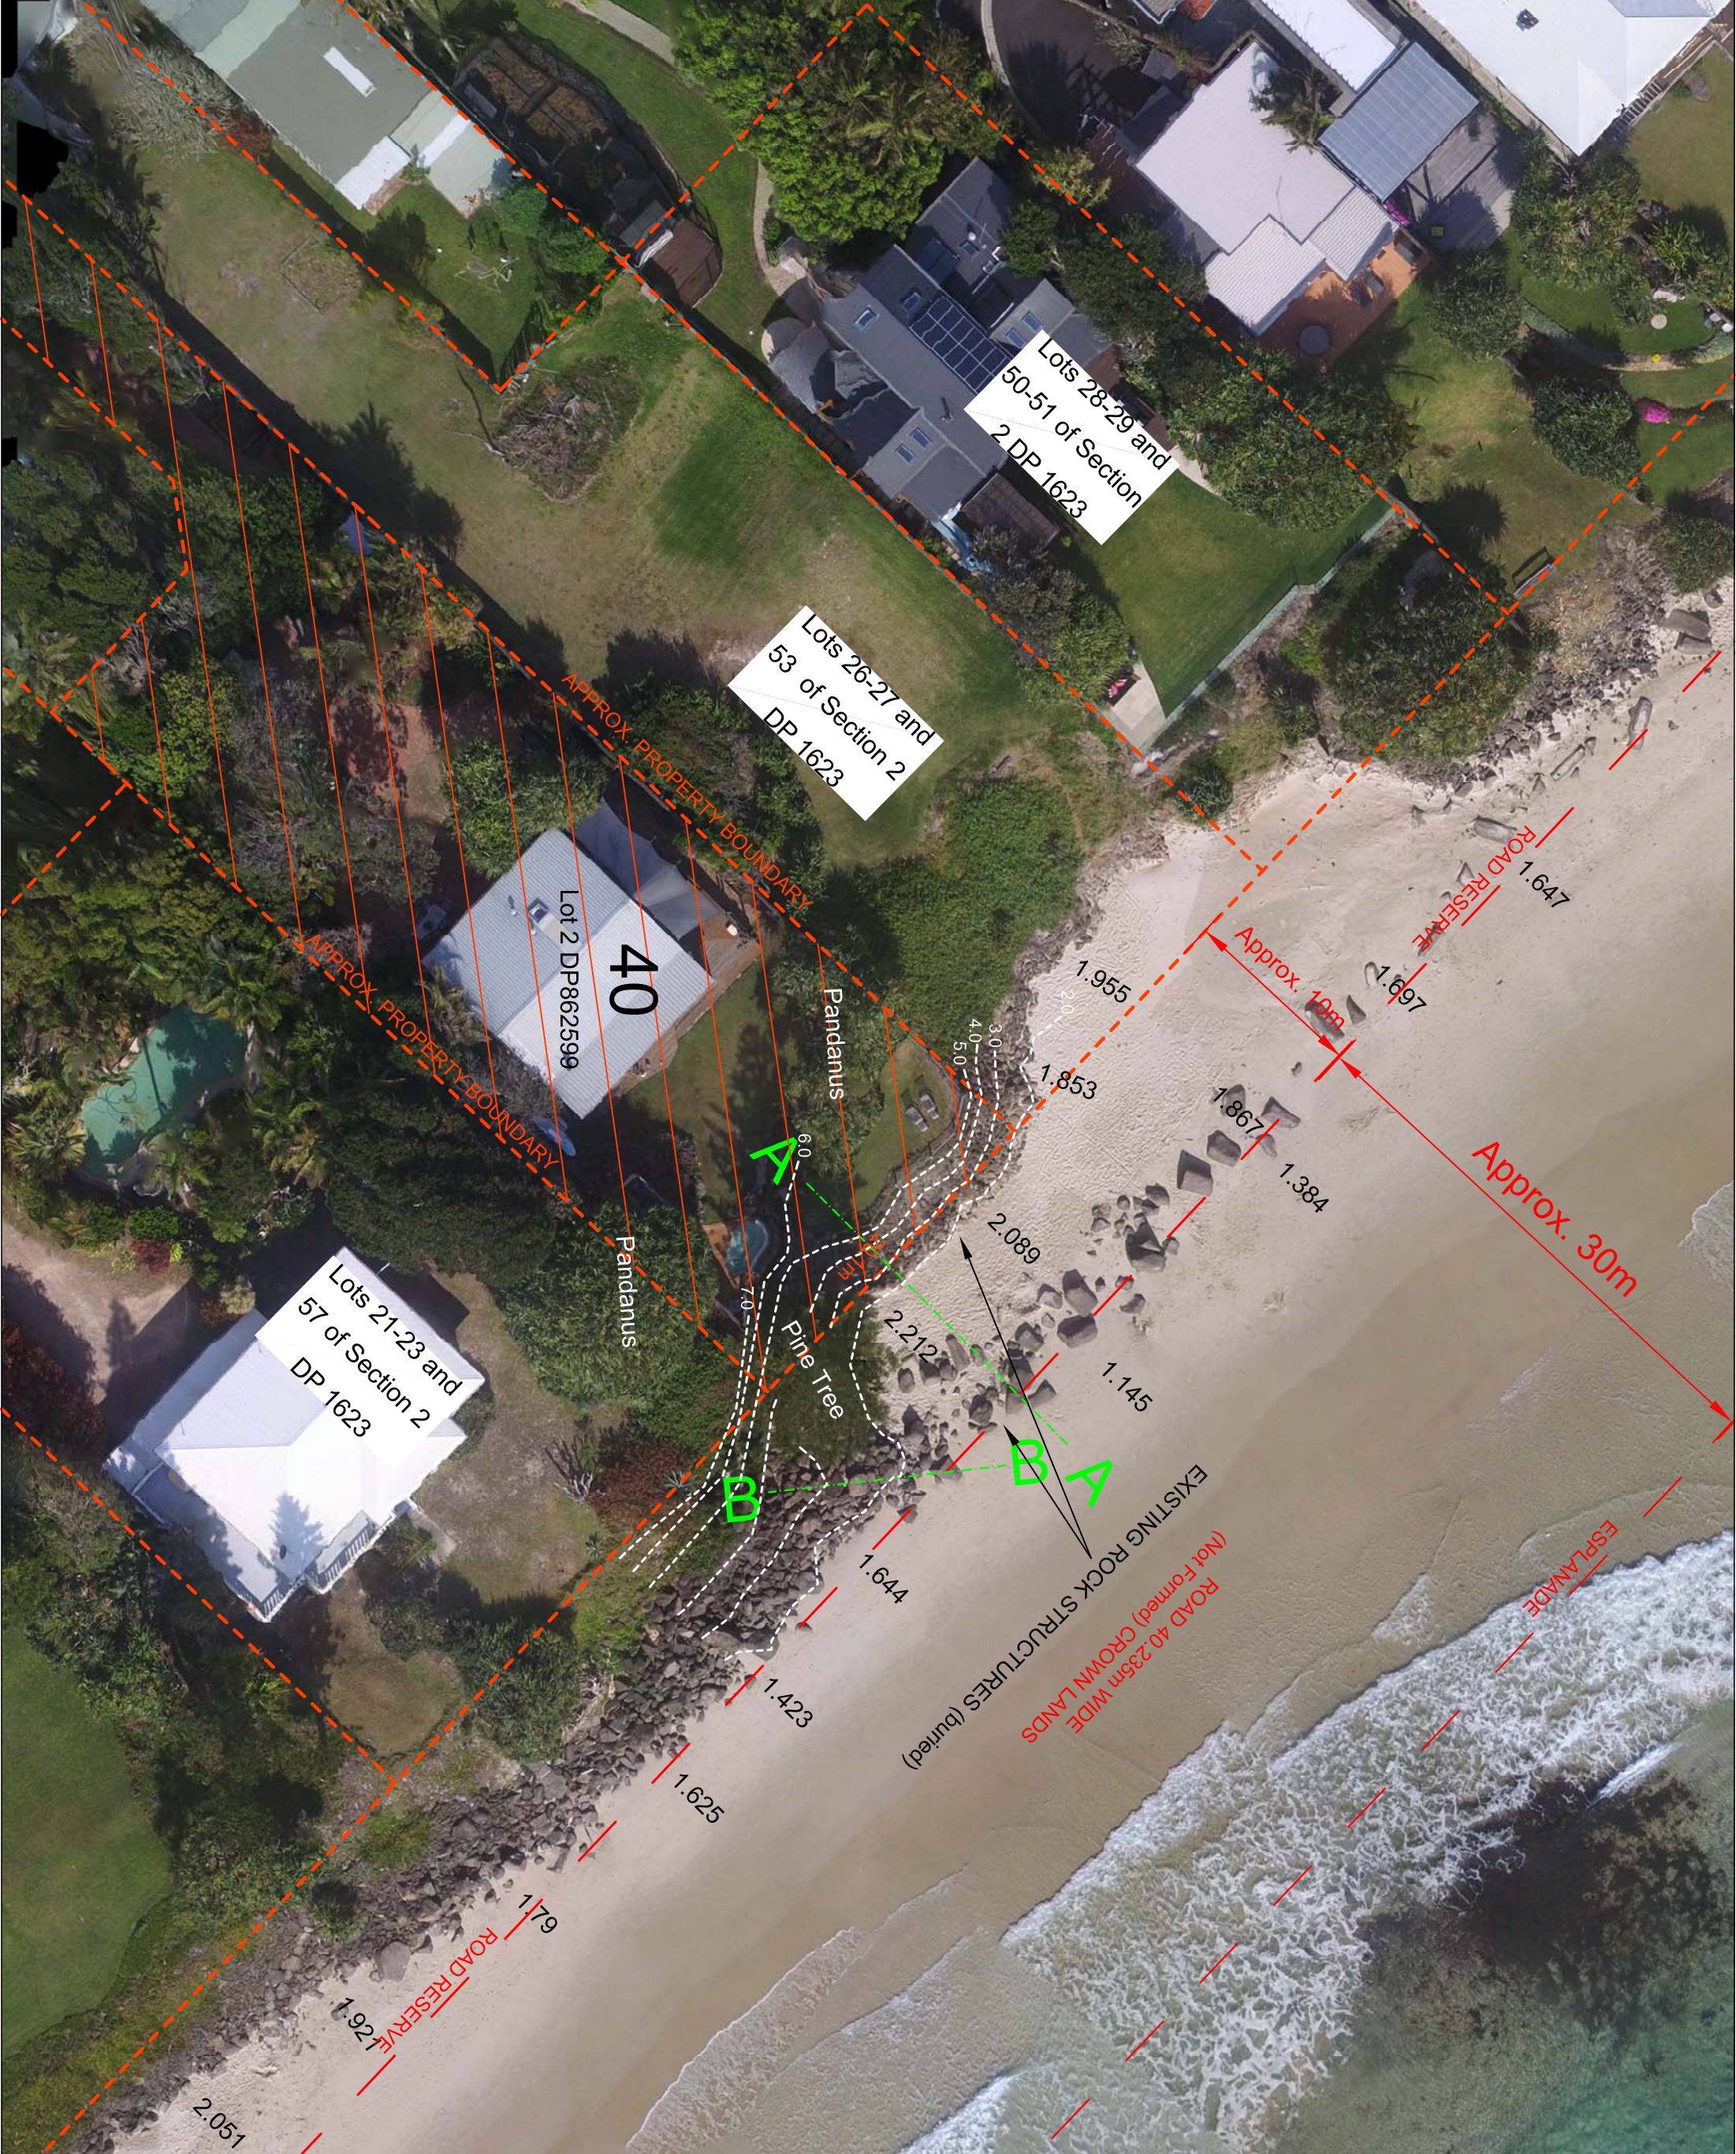
ATTACHMENT 1.5 A

- NOTES**
- Aerial Imagery and levels from 13th October 2016 Survey
 - Cadastral data from NSW Globe KML for Google Earth, NSW Land & Property Information Contours from 13th October 2016 Survey 1m contour intervals
 - NOTE: Caution must be taken when interpreting interpretative contours as they do not reflect the void ratio or roughness factor of the boulder wall landscaping or vegetation.

#	Request for information	Response
1.	A current survey indicating the heights of the current structure (the face of the wall "as is"), property boundaries, footprint of the proposed works and the current sand level	<p>We have already provided this information. The details requested have been provided in the technical drawings previously provided and there has been little or no change:</p> <ul style="list-style-type: none"> • height of current structure and face of wall: Drawings BSR-CS2-UW-002, 003 and 005 show these details. ICM have also added contours of the visible section of the seawall face of the wall in drawing BSR-CS2-UW-002 (Rev a - Attachment 1.5 A) but it should be noted that these contours are smoothed as the wall face is very rough with 20-30% voids between large boulders. • property boundaries: Drawing BSR-CS2-UW-002, 003 and 005 show these details. The seaward boundary and corners will be pegged before repairs are commenced. • footprint of the proposed works: BSR-CS2-UW-004, 006 and 007 show the footprint. • existing sand level: BSR-CS2-UW-002, 003 and 005 show beach sand levels at the wall as at 13/10/16 (post June 2016 storms) and there has been a slight increase in sand (about 0.3m) since that date to 17/1/18.
