## GREEN CAPE LIGHTHOUSE SCOPE OF WORKS

### 3.0 Detailed Scope of Works and Heritage Impacts

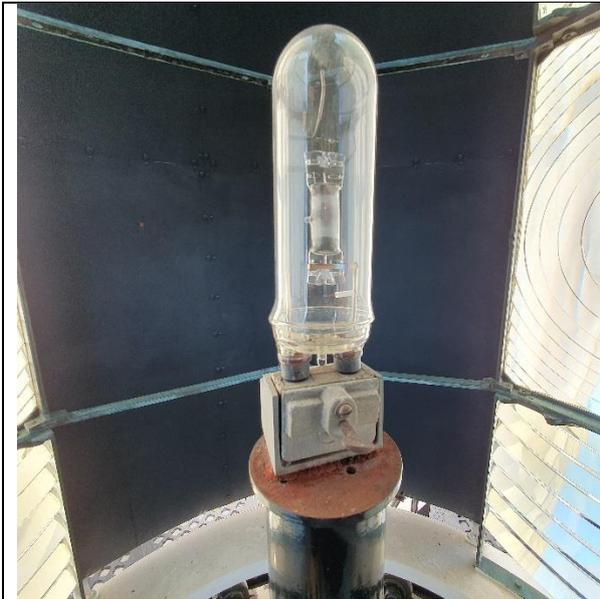
*Photo 1 - Existing Green Cape light source (incandescent lamp)*

The existing incandescent lamp mounted on a stem pole will be replaced with a more efficient high-powered LED light source. A new LED mounting assembly is required to allow focusing of the light source and lens, therefore requiring removal of the existing black stem pole. The exact makeup of the mounting will be determined during detailed design.

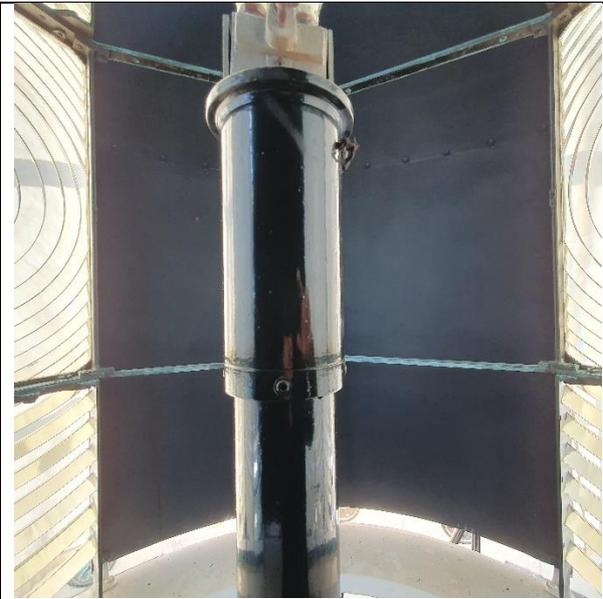
*Photo 2 - Existing Green Cape light source stem*

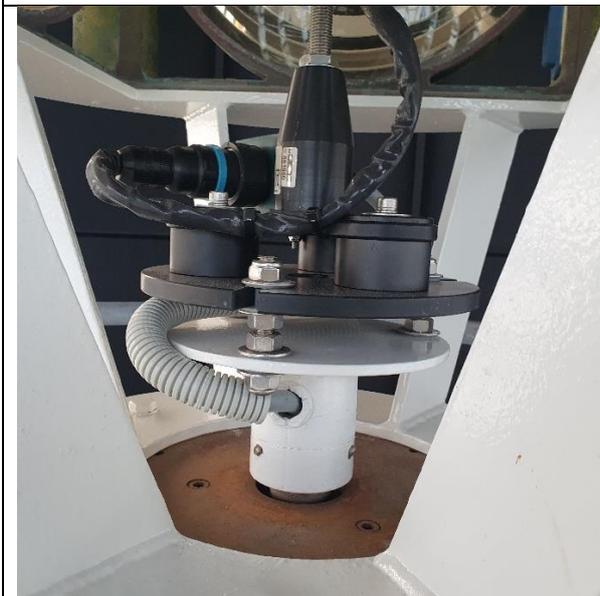
*Photo 3 - Example of mounting bracket for LED light source on a stem*

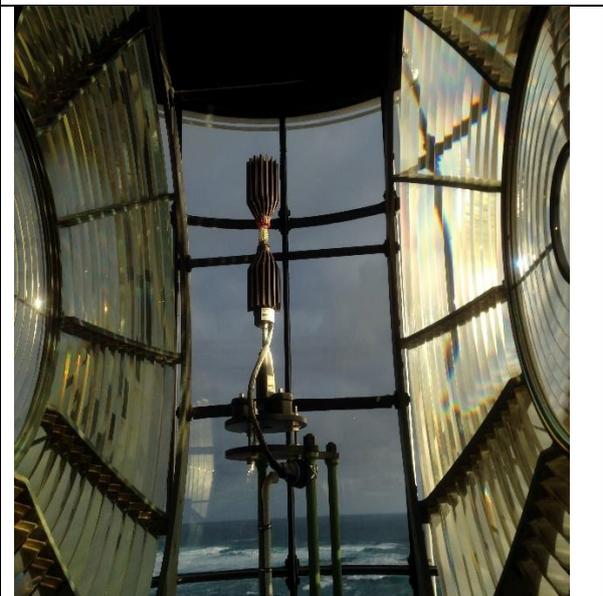
*Photo 4 - Example of LED light source aligned at correct focal height*

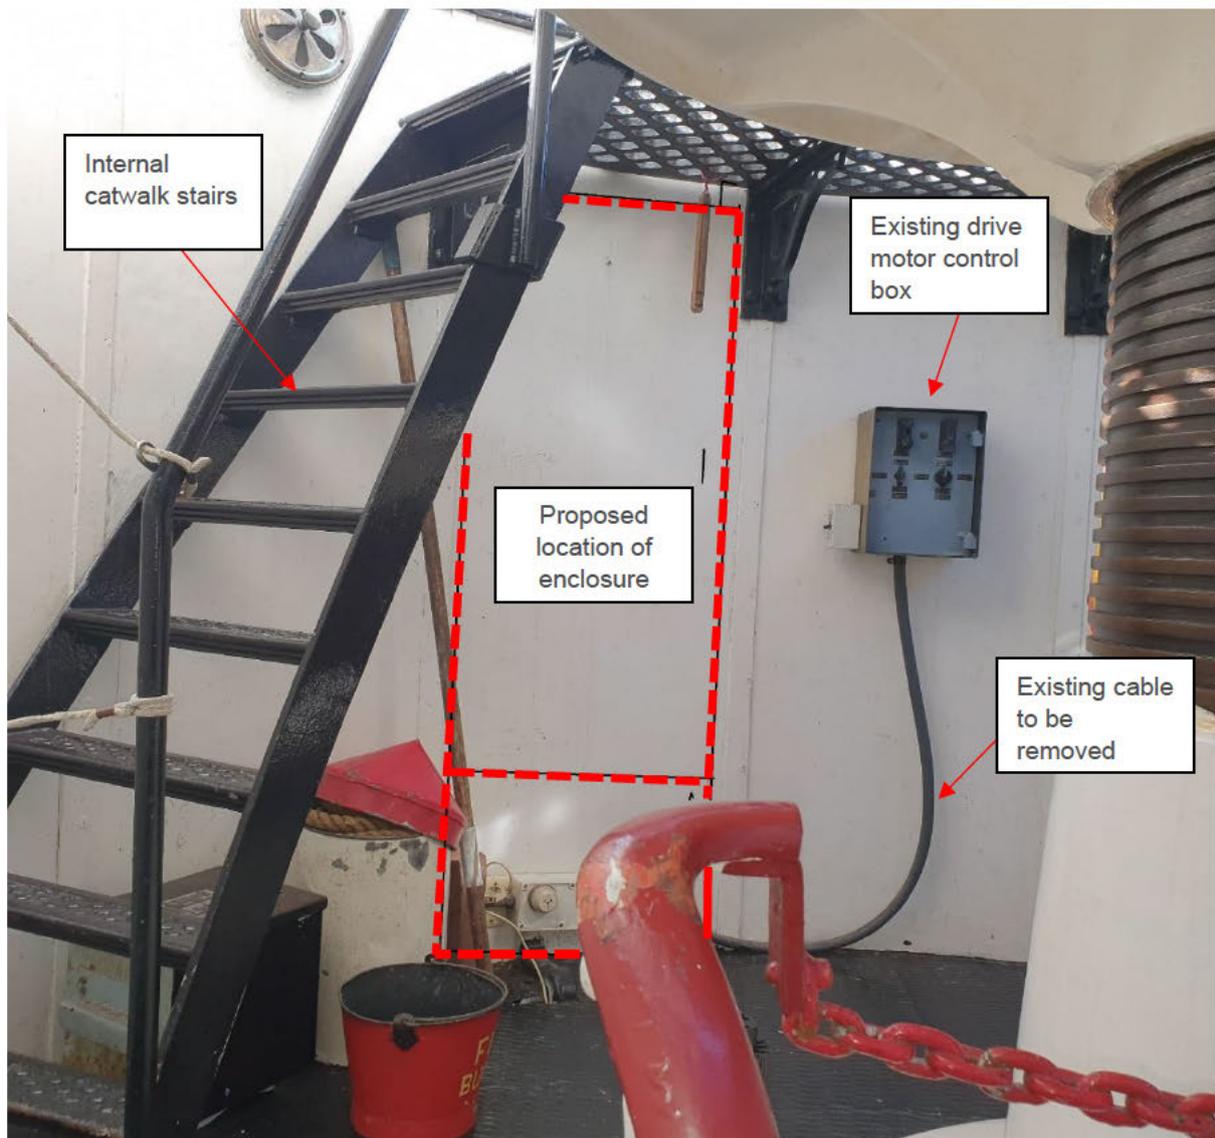
Photo 8 - Proposed location of enclosure in lantern room.

A purpose-built free-standing enclosure will be installed in the lantern room situated between the existing drive motor control box and internal catwalk stairs. AMSA proposes to remove the existing drive motor cable. The enclosure will be powder coated white and will house the AMSA equipment circuit breakers, LED light source controller and drive motor control equipment.

The new enclosure will also have a bracket attached towards the top of the enclosure and extend up and be secured through the catwalk opening. A low-profile bolt arrangement will be used mitigating any trip hazards.

The enclosure will have a minimum of two doors. The size of enclosure and orientation of doors to be adjusted to suit location. Depth of enclosure will be approximately 250mm.

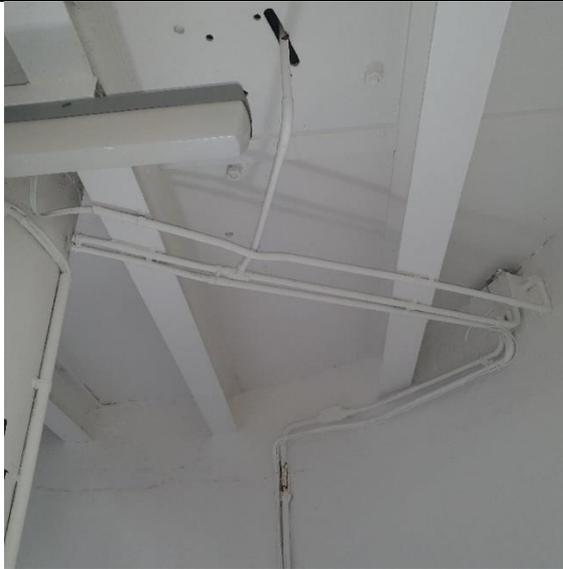
*Photo 9 - Existing conduit arrangement below lantern room. Proposed removal of electrical junction box below floor*

There are two electrical junction boxes situated above and below the lantern room floor at the point where the new enclosure will be positioned. AMSA proposes to remove both junction boxes and rearrange the circuit connection so that access to those is available at the bottom of the new enclosure.

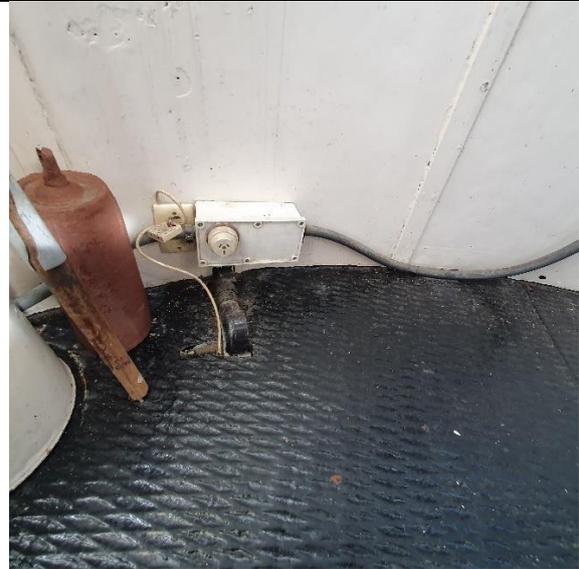
*Photo 10 - Electrical junction box in location of proposed enclosure. Proposed removal of electrical junction box within lantern room*

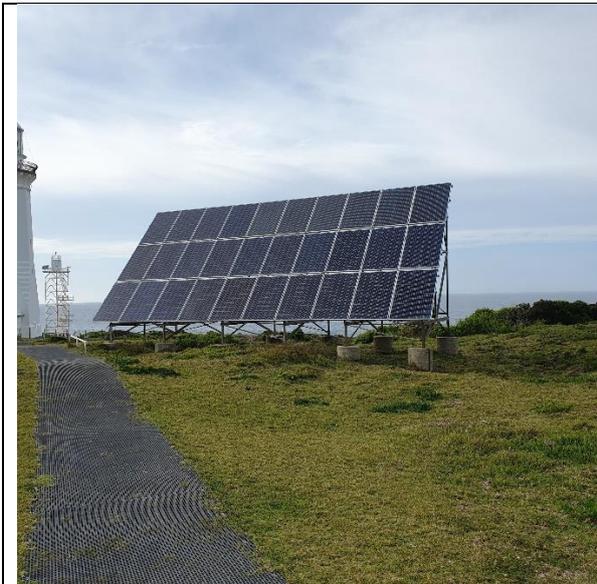
*Photo 11 - Existing NPWS solar array*

The existing solar panels and aluminium mounting racking will be removed and replaced with new solar panels and racking. The number of solar panels will be reduced to twenty-seven (27), creating three (3) rows of nine (9) panels. This will allow the new solar panels to fit into a similar footprint as the existing, whilst providing more solar charge power. There will be a minimal change in the overall size and projected surface area of the solar array and it is assumed that the existing solar frame is fit for purpose, is structurally sound and designed to sustain site wind loading.

The existing NPWS solar array is 7.74kw. The top two (2) rows of nine (9) solar panels (18 in total) providing approximately 8kw of solar power will be dedicated to NPWS off grid power supply system. The bottom row of nine (9) solar panels will be dedicated to AMSA (providing 4kw of solar power). The new solar panels and racking will utilise the existing frame and footings. Existing conduits to the Powerhouse will be utilised.

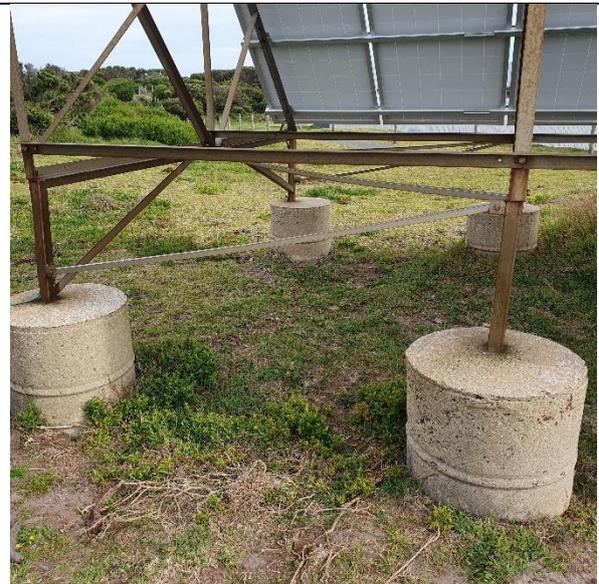
*Photo 12 - Existing footings*

The solar array and rack is of no heritage significance. No changes are proposed to the footing foundations and surrounding soil.

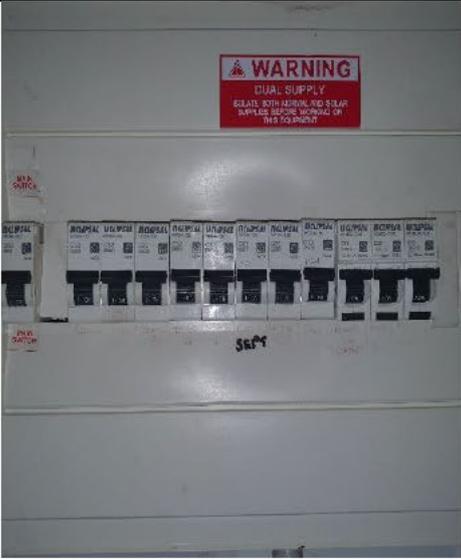
<p><i>Photo 14 - NPWS power distribution board located in the Powerhouse. Additional circuit to be installed for AMSA equipment</i></p>	<p><i>Photo 15 - Utilisation of cable management in power distribution room</i></p>

The power supply to the AMSA inverter/charger will be provided from the NPWS main switchboard located in the existing Powerhouse power distribution room. The existing cable trays and conduits located within the NPWS power distribution room will be utilised for the supply cable which will then be routed through the ceiling cavity.

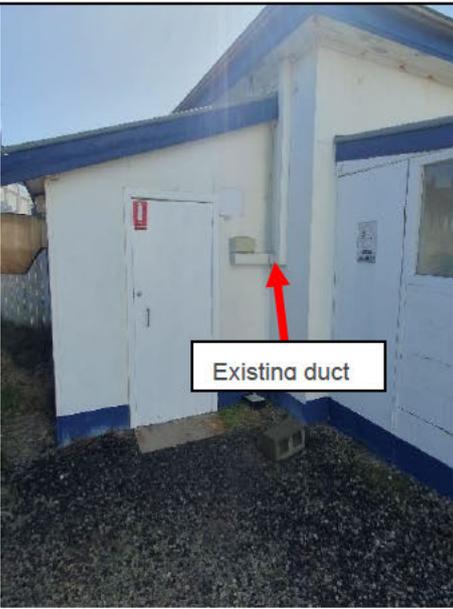
<p><i>Photo 16 - Utilisation of existing duct between the Powerhouse battery room and power distribution room</i></p>

The appliance inlet connection point will be mounted external to the battery room. AMSA will utilise an existing duct that is located on the outside of the building and routed through the ceiling cavity (refer to Photo 16).

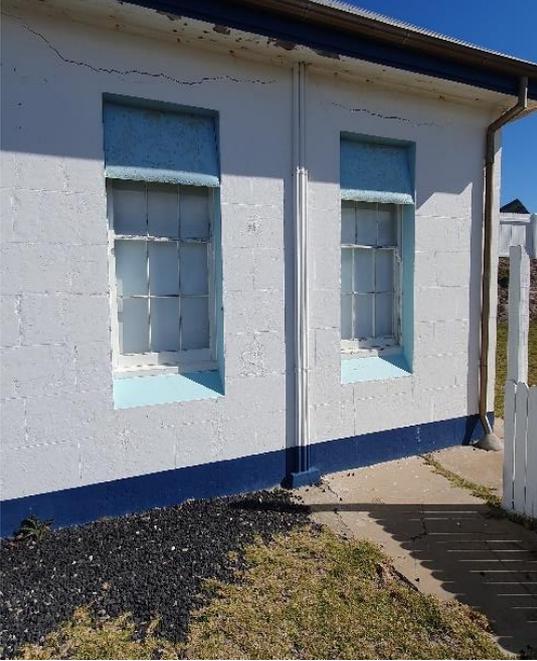
<p><i>Photo 17 - Utilisation of existing conduit at Powerhouse</i></p>	<p><i>Photo 18 - Utilisation of existing conduit at lighthouse</i></p>

The cabling required to feed the AMSA equipment in the lighthouse will utilise the existing conduits between the Powerhouse and lighthouse and it is assumed that the conduit entry is situated within the ceiling cavity.

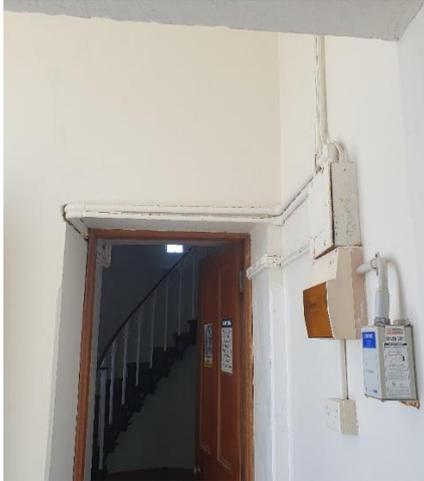
*Photo 19 – Lighthouse ground floor power distribution board*

The conduits originate from the ground floor distribution board and run in parallel to each other from the ground floor to the lantern room.

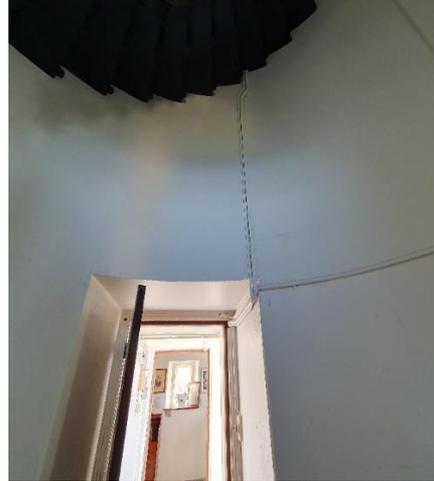
*Photo 20 – Existing 2 x vertical steel conduit proposed for replacement*

There are two existing conduits that utilise penetrations through the staircases feeding the existing lens drive motor and optic lamp. Both conduits were identified to be damaged from corrosion.

AMSA proposes to remove both conduits and replace with rigid white PVC conduit of a similar size and install using the same path, penetrations and if possible mounting fixing points.

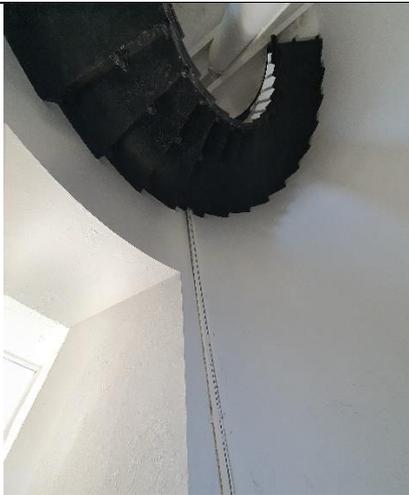
*Photo 21 – Conduits proposed for replacement (showing path towards lantern room)*

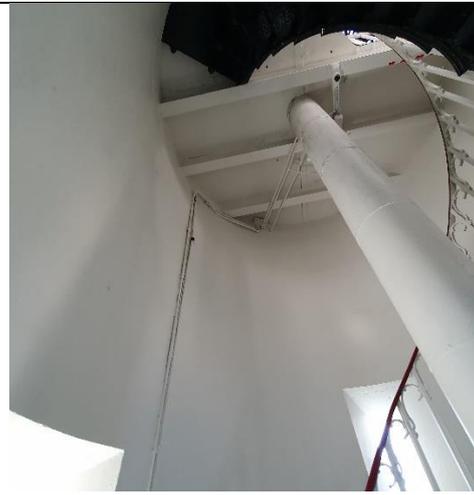
*Photo 22 – Conduits proposed for replacement (showing path to underside of lantern room)*

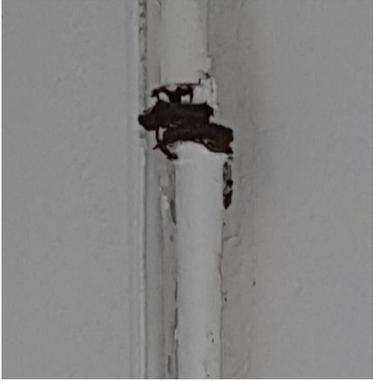
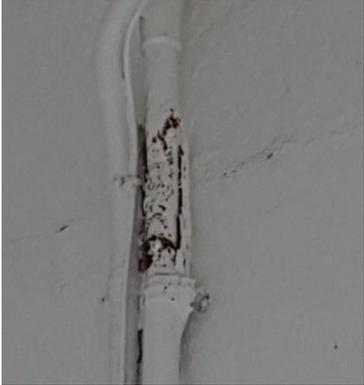
<p><i>Photo 23 – Corrosion on conduit proposed for replacement</i></p>	<p><i>Photo 24 – Corrosion on conduit proposed for replacement</i></p>

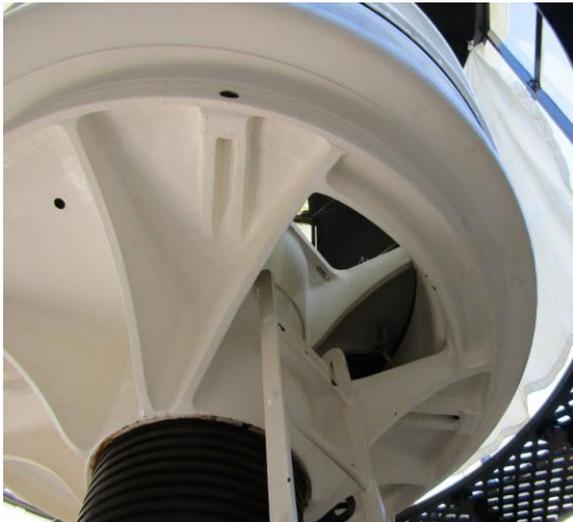
*Photo 25 – Existing Green Cape Mercury-Float Pedestal*

The Green Cape Lighthouse has an existing mercury-float pedestal which is used to rotate the lantern. AMSA will inspect and service the mercury-float pedestal including:

- Service/clean the mercury-float pedestal by draining, filtering and replenishing the mercury,
- Inspect and service the roller wheels (if required), and
- Undertake any paintwork to the pedestal (if required).

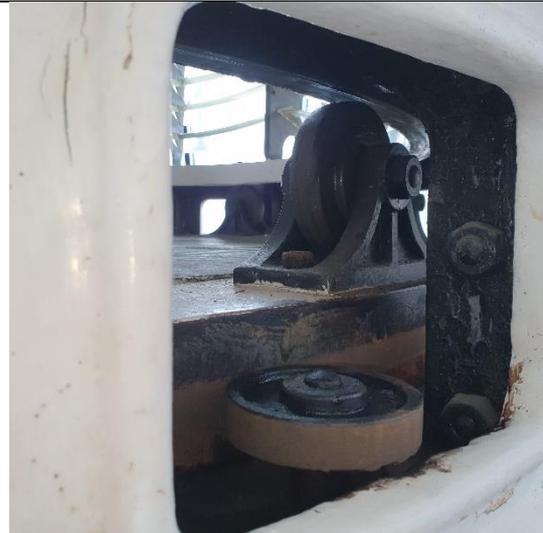
*Photo 26 – Existing roller wheels*

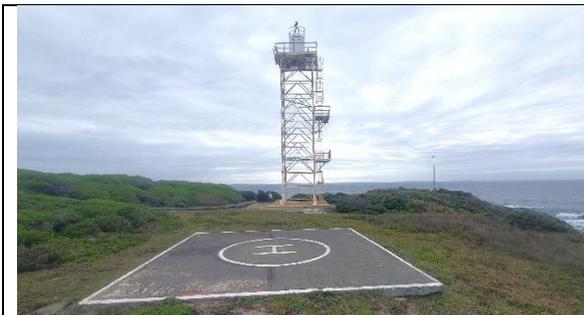
*Photo 27 – Existing steel lattice tower with helipad*

AMSA proposes to dismantle and remove the existing steel lattice tower, transfer the materials off site and dispose of at an appropriately approved waste facility. The condition of the tower is dilapidated and deteriorating, and the removal of the lattice tower would therefore significantly increase the visual and scenic landscape of Green Cape.

A helicopter would be utilised for the removal of the steel lattice tower and the existing helipad may be utilised during this process (photo 26 below). The steel lattice tower would be dismantled by ground crew in manageable sections within the helicopters lift capacity, and the tower sections will be sling loaded via helicopter to a truck on standby located on an existing hard stand location (likely to be adjacent to Green Cape Road, north of the study area). It is anticipated that the demolition will be completed within approximately 2 days (weather dependant), and tower fixings will be cut off flush with the slab. If required, refuelling of the helicopter will be limited to the hardstand area and helicopter operation would be during daylight hours only. During helicopter sling loading, public access to the lookout and track may be restricted.
