Metalwork

Introduction

This information sheet deals with the care and conservation of metals used in building, including cast and wrought iron as fencing and decorative panels, steel-framed windows and roof plumbing. For further information refer to the references at the end of the sheet, and to the separate information sheets on *Corrugated Roofing*, and *Slating, Tiling and Roof Plumbing*.

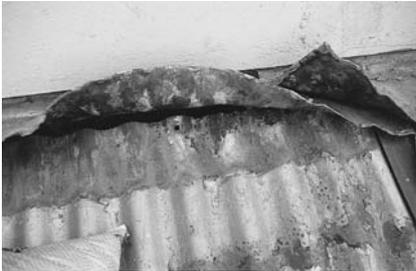
Galvanic corrosion of original corrugated metal sheeting.

The further apart two metals are on the series, the greater will be the galvanic reaction. Combining two distant metals in a damp environment will lead to rapid corrosion of the less noble metal. This is why metals such as zinc (or galvanised steel) and copper should never be used together. Lead flashings and cappings, traditionally used in conjunction with galvanised steel roofs, can cause corrosion if the roofing is replaced with modern steel sheeting coated with a zinc–aluminium alloy.

Even if the two metals are not touching, corrosion can still occur. Water can provide an electrical bridge, or carry in solution a small amount of the nobler metal to the other, where it precipitates or plates out and causes corrosion. Thus, water running off a copper roof into galvanised gutters will lead to rapid corrosion of the zinc galvanising and then the steel of the gutters.

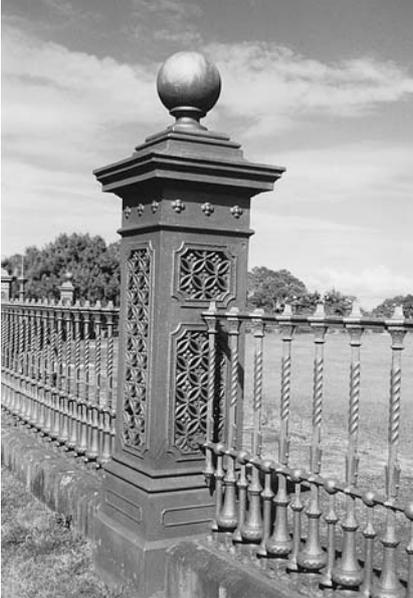
Ornate palisade fence, Centennial Park reservoir, Sydney.

A common conservation measure needed for palisade fences is to replace stays that may have been misguidedly removed to allow easier access for lawnmowers and the like. The stays are needed to brace the fence and ensure its lateral stability.

Crevice corrosion can occur where the shafts penetrate the rails, and also between the spearheads and the top rail. Careful filling and painting of these areas is required to eliminate crevices where corrosion may occur.

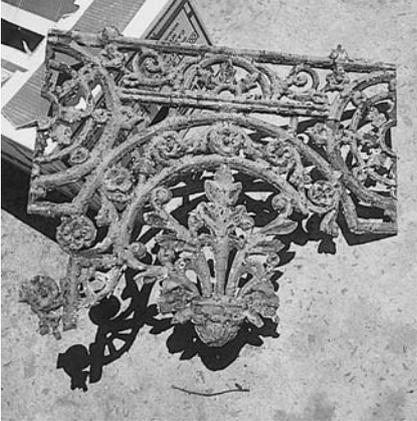
Remnants of cast iron lacework can be used to identify original patterns.

Decorative ironwork, such as iron lace of the 19th century, was almost all cast iron, which developed from earlier, elaborately shaped wrought iron work. Conserving cast iron lace often requires replacement of missing sections, or sometimes complete reconstruction of a verandah long since removed. The original pattern of the cast iron may be found by careful searching of the site for remnants of the original material, examining early photographs, or inspecting adjacent identical buildings, such as in a terrace. Spacings of columns, uprights and rails can often be determined by looking for evidence of fixings in floors, pavements or walls.

Foundries can reproduce ironwork using existing pieces as patterns, although care is required because slight shrinkage occurs when the iron cools. A better result may be obtained by producing a new pattern for the casting.

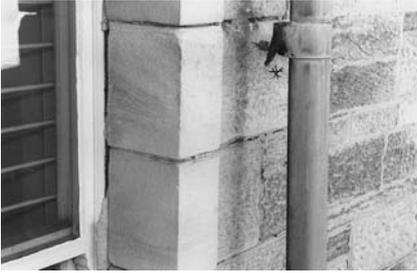
Loose fixings.
