# Timber repairs

## Wood and water

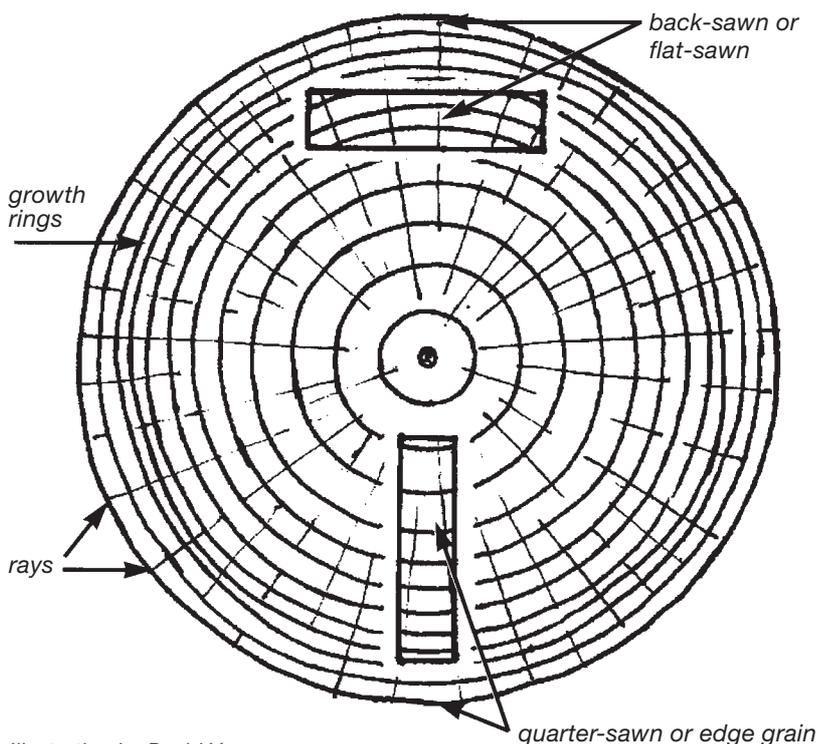
### **Back-sawn and quarter-sawn timber**

*Back-sawn timber (tangentially cut) will swell and shrink in response to changes in moisture levels to a much greater degree than the radially cut, quarter-sawn timber.*

Most swell or shrinkage occurs tangentially (around the circumference of the log), where it can be up to 12% of the original size, compared to up to 6% radially. The amount of swell or shrinkage also varies between

species and with different growth conditions. Boards cut tangentially (back-sawn or flat-sawn) will swell in width up to twice as much as boards cut radially (quarter-sawn) and are less suitable for use in exposed locations such as weatherboards. Fortunately, wood swells very little longitudinally (0.1%-0.2%), or it would have to be specially treated to be used for building or furniture.

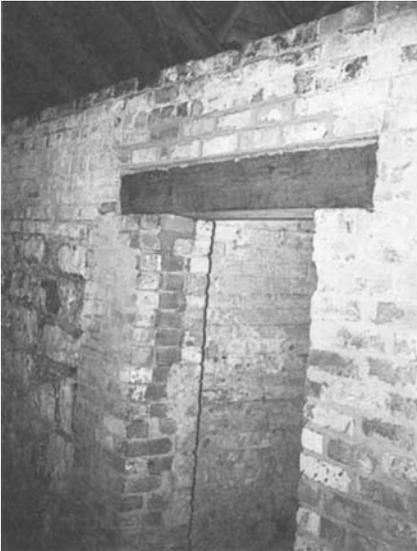
*This replacement lintel was green (unseasoned) when installed as part of repair works. It has now dried and shrunk, leaving a 20mm gap and unsupported brickwork above.*

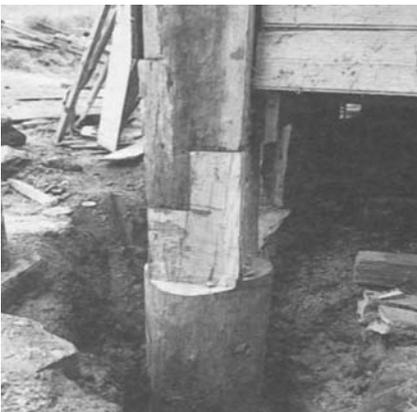
*Replacing the rotten base of a post while retaining as much of the original as possible. Note the light outer sapwood and the darker heartwood of the new post base. The use of fungicidal rods and external 'bandages' should be considered when undertaking work such as this, particularly as the sapwood has no inherent durability. Posts not carrying a heavy structural load should not be set in concrete, but in free-draining gravel and earth.*

To repair rotted timber and to be certain of removing all active fungi, remove the visible decayed zone together with any surrounding area affected. Apply fungicides to the remaining timber as a precaution.

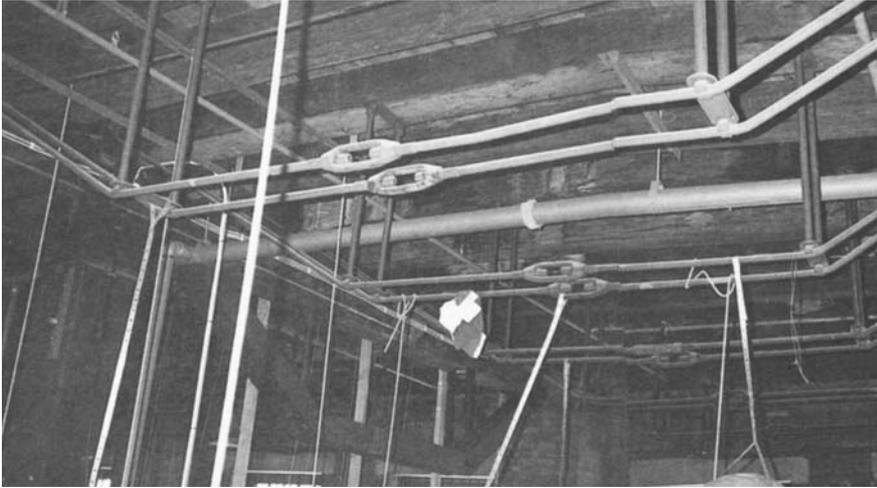
*Trussed girders used to strengthen beams at Walsh Bay wharves, Sydney.*

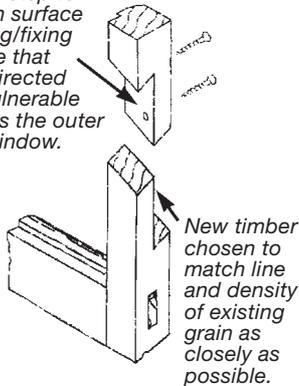
#### (i) Patching the bottom rail

Splayed splice joint with undercut and step to give optimum surface area for gluing/fixing and to ensure that moisture is directed away from vulnerable areas towards the outer face of the window.

Doors and windows typically suffer from rot at the base of the frame and door leaf or window sash, and also from loosening of joints. After any necessary patching of pieces which are beyond repair, the joints should be made tight by replacing wedges and regluing. On window sashes, minor decay combined with loose joints can often be repaired by removing the decay and repairing with epoxy, and using brass angle brackets let into the surface on the inner face.

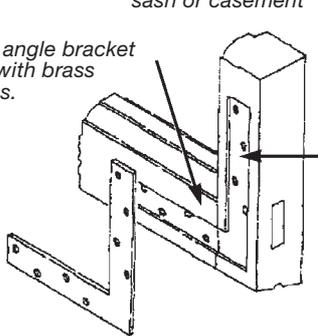
#### (ii) Reinforcing a loose corner with a brass angle

Bracket let into (or fixed on surface of) timber on inner face of sash or casement

Brass angle bracket fixed with brass screws.
