RESTORING THE DEGRADED RIPARIAN CORRIDOR AND SILT PLUG AT POPES GLEN

overview of the project

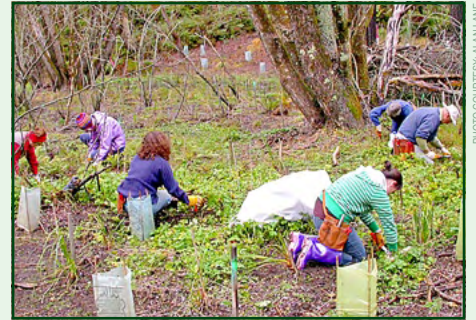
Planting out the rehabilitated areas

To revegetate the site, seed from surrounding native bushland was collected and

propagated by the local community nursery. Planting of a diverse mix of species occurred once the weeds were removed from each section of the silt plug. The plantings were done at a high density in order to prevent the reoccurrence of weeds.

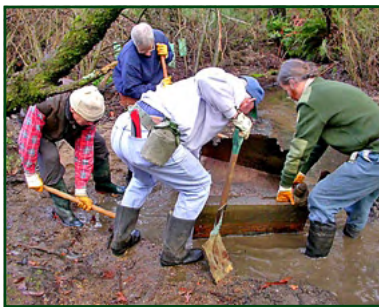
Workers removing silt
