Corrugated roofing

Introduction

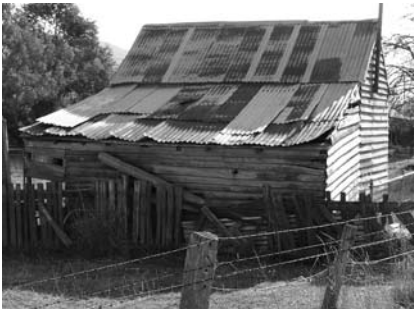
Patterns of rusting on an old corrugated roof.

Of the other types of corrosion affecting corrugated steel, the most important is crevice, or oxygen concentration cell corrosion. Crevices or narrow gaps are formed where galvanised sheets are overlapped at joins. These hold water (by capillary attraction), and with time the concentration of oxygen in the water deep inside the crevice becomes lower. The adjacent metal is then less noble than the same metal at the open end of the crevice.

Although only one metal (zinc) is involved, the result is that the less noble area deep in the crevice corrodes in preference to that near the open end. The practical effect is that zinc is lost from the area of the crevice at a much faster rate than elsewhere. This is an important reason why rusting of corrugated sheets usually occurs first at the overlapping joins.
