Ecosystem Health

Key Points

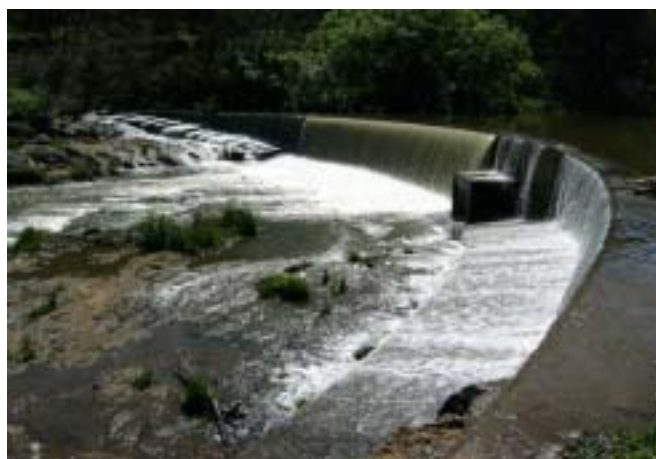
Figure 5.3 – Berrima Weir is an example of a weir that was identified as a barrier to fish – requiring a detailed review in the Initial Weir Review project.

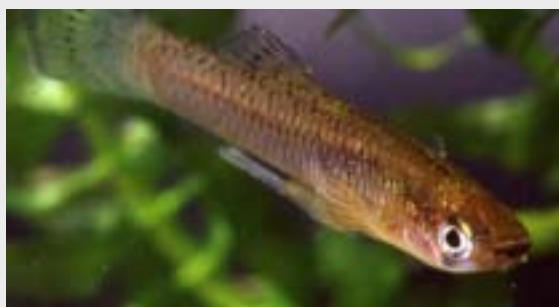
Figure 5.5 - Mosquito fish (*Gambusia holbrooki*)

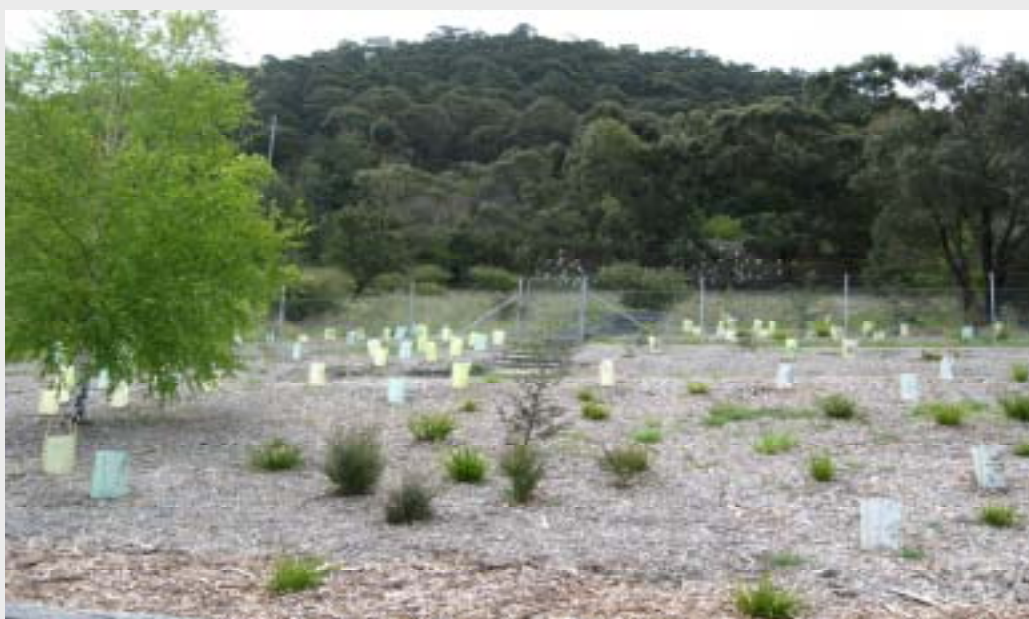
Figure 5.9 – Rehabilitation of Copper winged butterfly habitat beyond the fence of the Lithgow and district community nursery
