Water Research
Laboratory

Peer Review of Revised DA Documents regarding Old Bar Erosion Protection Works

Peer Review of ICM Statement of Environmental Effects: Old Bar – Erosion Protection Works

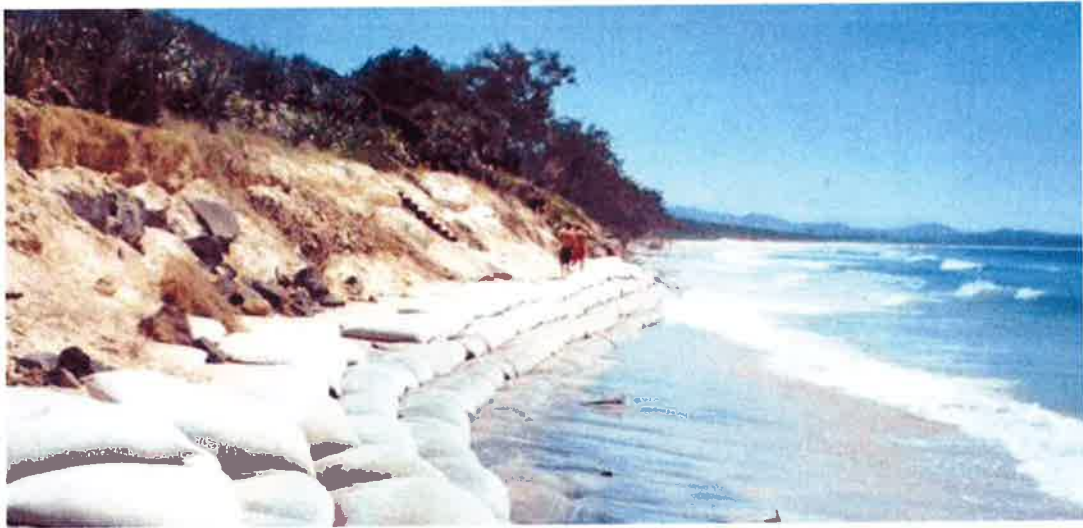
Figure 1: Traversing geotextile container walls, Belongil January 2002 (photo: James Carley, WRL)

WRL concurs with the benefits of geotextile structures as listed. Short of a formal boardwalk on the crest, geotextile structures on suitable slopes provide better alongshore access than rock rubble structures (see Figure 1 of this review as an example). However, it should be noted that while softer than rock, 2.5 m³ containers weigh approximately 5 tonnes when wet, so any unstable container has the potential to kill or injure.

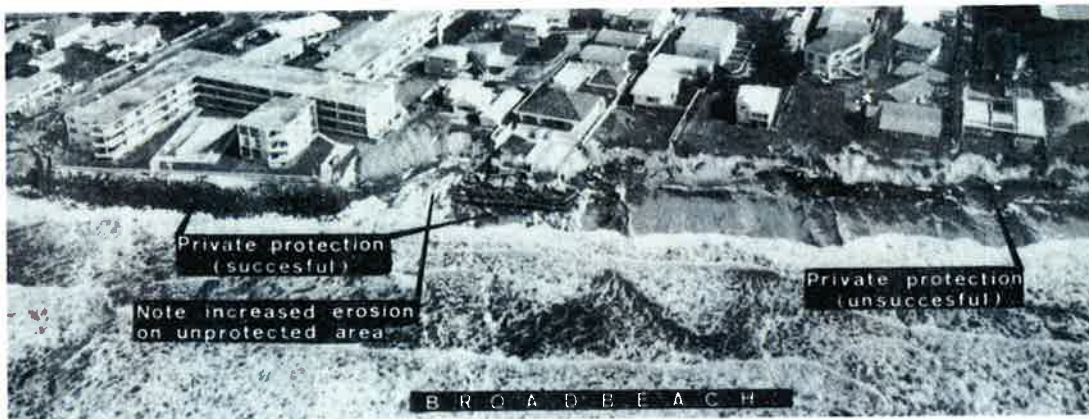
Figure 2: End effects and potential flanking of seawalls, Gold Coast 1967 (Source: Delft, 1970)

The ICM SEE proposed alignment (ICM SEE Figure 17) appears to be within private property boundaries. It is noted that (without the possible future extensions) the proposed alignment could

suffer flanking damage at its ends (Figure 2 of this review) due to ongoing recession and extreme storm erosion. This is likely to occur for any short seawall without substantial returns on the ends.
