REMOVAL OF WILLOWS AND CORAL TREES AND RIPARIAN RESTORATION

overview of the project

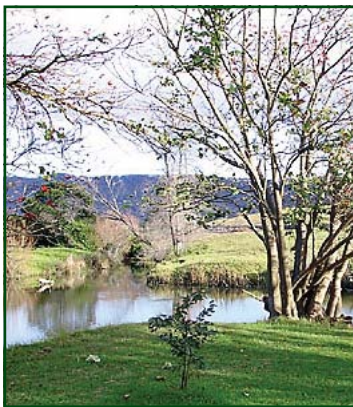
Coral tree on the banks of Robins Creek

Sites selected for tree removal were either identified as having a flood risk due to trees growing in the creek, or were sites where Bushcare groups or contractors were currently working. Council staff and tree removal contractors used chainsaws to remove trees from the 26 priority sites. At two sites with particularly steep banks, a crane was used to lift cut trees out of the creek. Immediately after cutting, the stumps were

treated with herbicide (Bioactive Roundup) to prevent regrowth. The stumps were left in the ground to reduce the potential for erosion, particularly on creek banks and steep slopes. Cut trees were either chipped onsite and used as mulch for weed control, or taken to Council's tip for recycling.
