GREENING UP THE GULLY

overview of the project

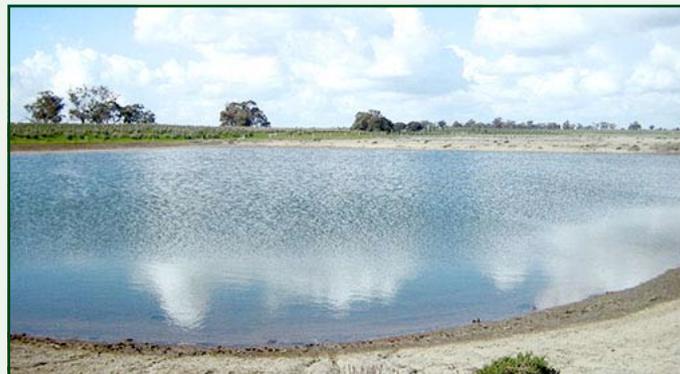
Green Gully evaporation basin

Rehabilitation of the gully was achieved through the installation of 50 hectares of tile drains and by the construction of a large evaporation basin. Tile drains are a special type of plastic hose containing small holes for catching water which were placed under the surface of the soil

to collect excess water and pipe it to the evaporation basin. Within months of the tile drains being completed there was a significant reduction in watertable depths and by completion of the project the watertable was reduced to a depth that allowed plants to successfully grow again and the soil structure to recover.
